Mercedes-Benz

Campaign No. 2019080012, August 2019

SUBJECT: **Model C-class (205 platform), E-Class (213 platform), E-Class Coupe (238 platform), and CLS-Class (257 platform)**
Model Years 2018-2019
Replace Steering Rack

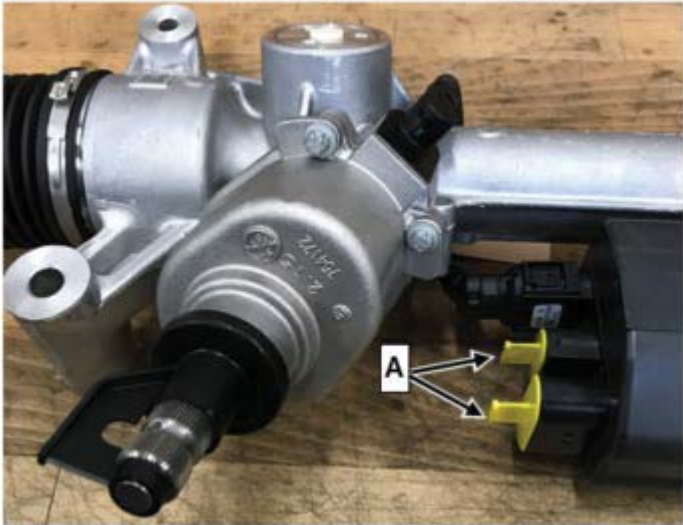
Figure 1

i To prevent dirt from entering the connector couplings or damage from ESD (electrostatic discharge), it is **absolutely essential** to fit the yellow dust caps (**A, Figure 1**) on the connector couplings of the steering gear to be returned. The **caps** from the **new** steering gear are to be used for this.

i If these dust caps are **not** fitted, it will **not** be possible to carry out an analysis.
This could affect the warranty process.
