Mercedes-Benz

Campaign No. 2019080011, August 2019

SUBJECT: **Model E-Class (213 platform), E-Class Coupe (238 platform), and CLS-Class (238 platform)**
Model Years 2018-2019
Replace Steering Rack

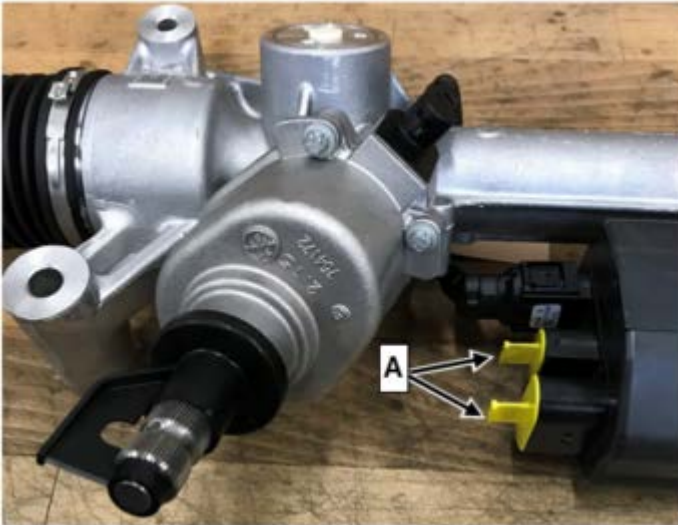
Figure 1

i To prevent dirt from entering the connector couplings or damage from ESD (electrostatic discharge), it is **absolutely essential** to fit the yellow dust caps (**A, Figure 1**) on the connector couplings of the steering gear to be returned. The **caps** from the **new** steering gear are to be used for this.

i If these dust caps are **not** fitted, it will **not** be possible to carry out an analysis. This could affect the warranty process.
