Safety Recall

Code: 82C1

Subject	Auxiliary Heater Connector
Release Date	March 07, 2019
Affected Vehicles	U.S.A.: Certain 2015 MY Audi A7, 2015-2016 MY Audi A6 Sedan CANADA: Certain 2015 MY Audi A7 and A6 Sedan <i>Check Campaigns/Actions screen in Elsa on the day of repair to verify that a VIN qualifies for repair under this action. Elsa is the <u>only</u> valid campaign inquiry & verification source.</i> <ul style="list-style-type: none">✓ Campaign status must show “open.”✓ If Elsa shows other open action(s), inform your customer so that the work can also be completed at the same time the vehicle is in the workshop for this campaign.
Problem Description	The auxiliary heater connector may not have been properly inserted into the auxiliary heater. This can lead to increased contact resistances in the connector area and result in a thermal overload, which may cause smoldering and the risk of a fire.
Corrective Action	The auxiliary heater electrical connection will be inspected and, if necessary, the auxiliary heater and the connector will be replaced. Expected replacement rate is <u>very low</u> (approximately 1%).

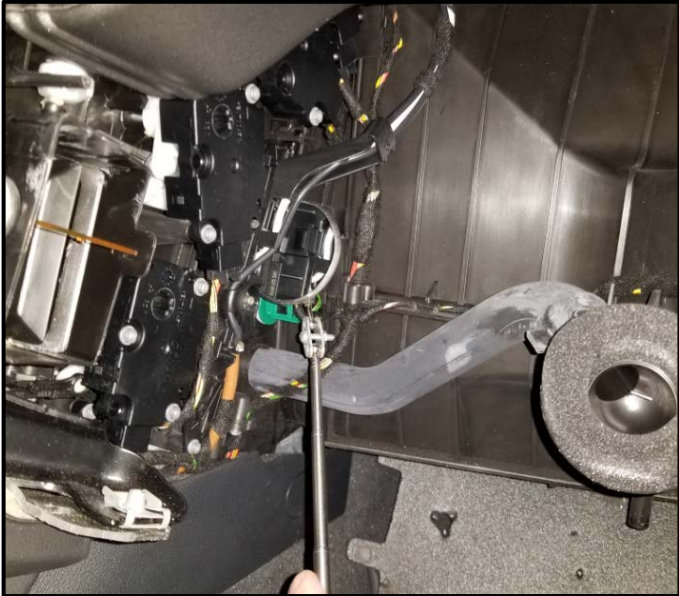
- Remove glove compartment and inspect Auxiliary Heater Element -Z35- connector.

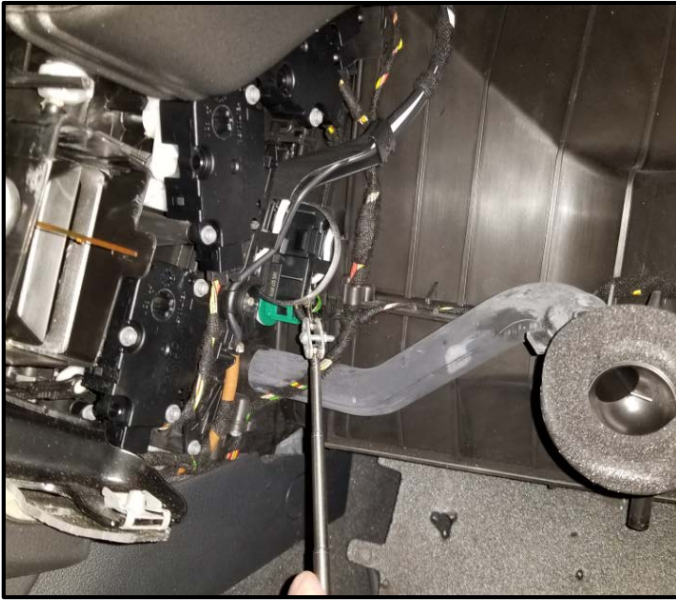
Inspect -Z35- connector:

- Using a mirror, inspect the condition of the connector locking tab.

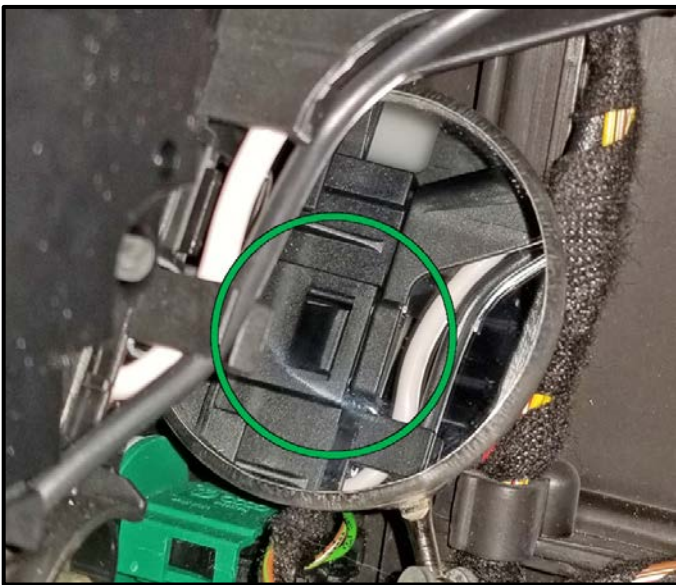
- If the locking tab is fully engaged <circle>:
 - Proceed to Section E (Vehicle Reassembly)

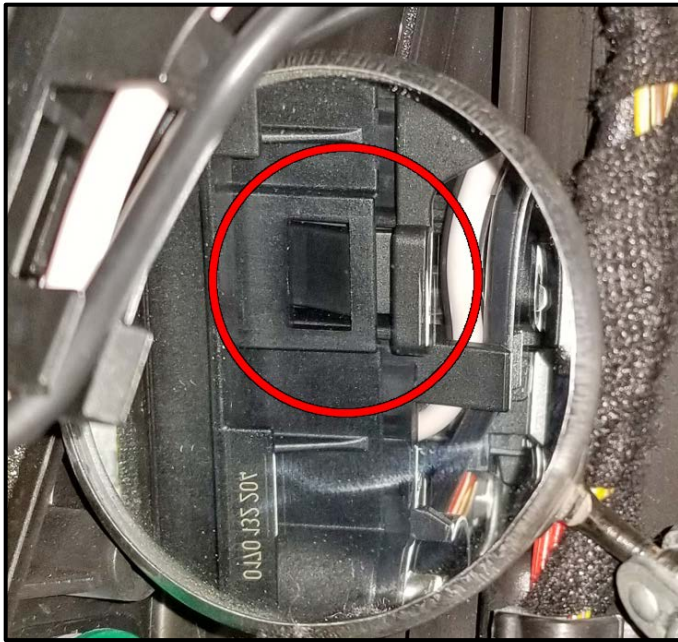
- If the locking tab is not engaged <circle>:
 - Take a photo of the connector which clearly shows it is not fully engaged.

The Auxiliary Heater Element -Z35- and the connector housing are on technical block. An ATA WEB Ticket must be created to order the parts.

- Proceed to Section D (Auxiliary Heater Element -Z35- Replacement)
