TECHNICAL INSTRUCTIONS

SAFETY RECALL JSL

PASSENGER AIRBAGS COULD DEACTIVATE

CERTAIN 2008 – 2019 LX 570

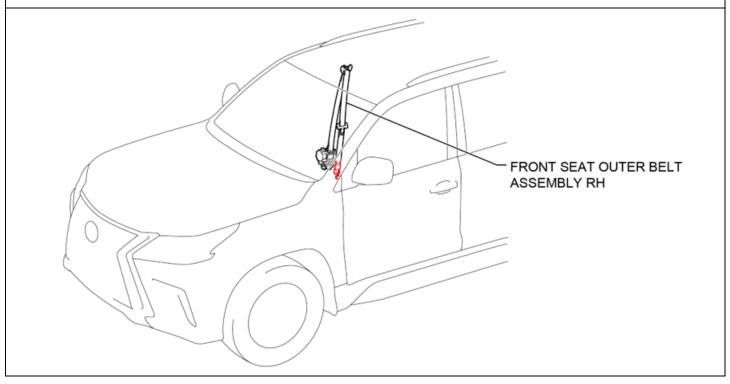
The front passenger occupant classification system has a seatbelt tension sensor that could malfunction over time and could cause the airbag warning light and the passenger airbag "OFF" indicator to illuminate. In addition, the front passenger airbag, passenger knee airbag, and the passenger seat-mounted side airbag may be deactivated. If these airbags are deactivated, there is an increased risk of injury to the occupant in the event of a crash.
