TECHNICAL INSTRUCTIONS

SAFETY RECALL JSL

PASSENGER AIRBAGS COULD DEACTIVATE

CERTAIN 2008 - 2019 LX 570

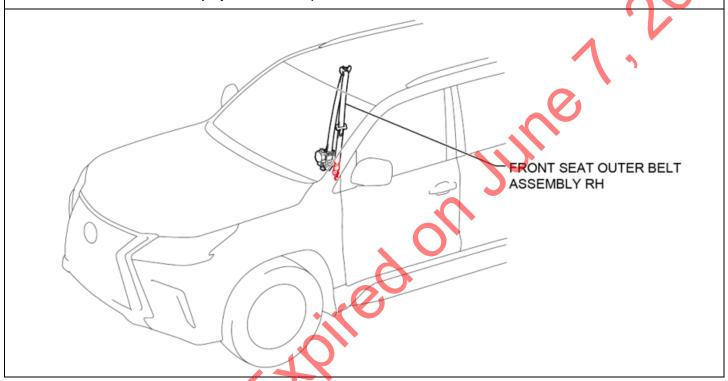
The front passenger occupant classification system has a seatbelt tension sensor that could malfunction over time and could cause the airbag warning light and the passenger airbag "OFF" indicator to illuminate. In addition, the front passenger airbag, passenger knee airbag, and the passenger seat-mounted side airbag may be deactivated. If these airbags are deactivated, there is an increased risk of injury to the occupant in the event of a crash.
