GROUP	NUMBER
RECALL	19-01-003
DATE	MODEL(S)
JANUARY, 2019	ELANTRA GT (PD)

Technical Service Bulletin

2018MY ELANTRA GT (PD) PANORAMIC SUNROOF MOTOR INSPECTION AND REPLACEMENT (RECALL CAMPAIGN 179)

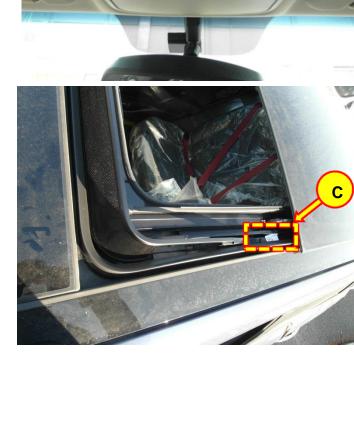
3. Reference the LOT NO. label (C) on the side of the panoramic sunroof above the driver's seat.

4. Check the last 6 digits (a) on the LOT NO. label from the vehicle to those listed in the table below. If the last 6 digits are listed on the table, the panoramic sunroof motor will need to be replaced according to the following procedure. If they are not listed the, inspection is complete.

If the LOT NO. label is illegible or missing, replace the motors according to the procedure starting on page 6.

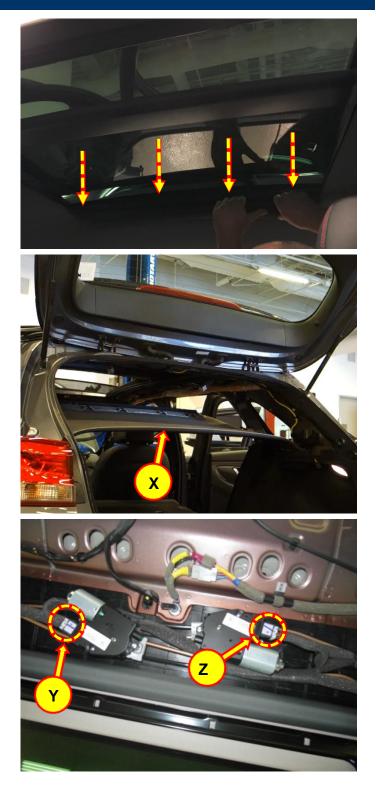
20. With the clips released, allow the roof (X) trim to rest. Locate the glass motor and the roller blind motor placed in the middle-rear roof section.

21. Disconnect the glass motor (Y) and the roller blind motor connectors (Z).

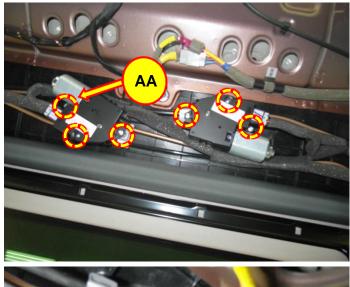
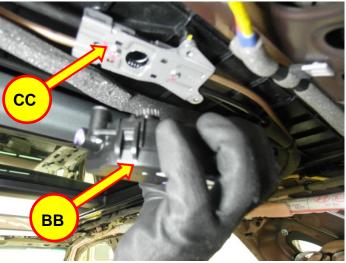
Glass motor gear and roller blind motor gear sizes are different.

22. Loosen and remove the Torx screws (AA) for both the glass and roller blind motors.

23. Remove the glass motor (BB) and roller blind motor (CC)

- 24. Install the new motors and reinstall the removed parts in the reverse order of removal.
- 25. Perform the panoramic sunroof reset procedure as directed in the owner's manual.
