GROUP  
Safety Recall Campaign

NUMBER  
SC172 (Rev 3, 08/30/2019)

SUBJECT: HIGH PRESSURE FUEL PUMP OUTLET  
INSPECTION (SC172)

This bulletin provides the procedure to inspect the connections of the High Pressure Fuel Pipe to the fuel pump outlet for fuel leaking and, if necessary, replace the fuel pipe with a new one on certain vehicles listed below that received an engine replacement under Recall No. 17V224 (SC147), under Product Improvement Campaigns (PI1802 / PI1803) or under warranty. The previous engine replacement may not have been properly performed, and in some cases, the high pressure fuel pipe may have been damaged, misaligned or improperly torqued during the engine replacement procedure, allowing fuel to leak. Leaking fuel increases the risk of fire.

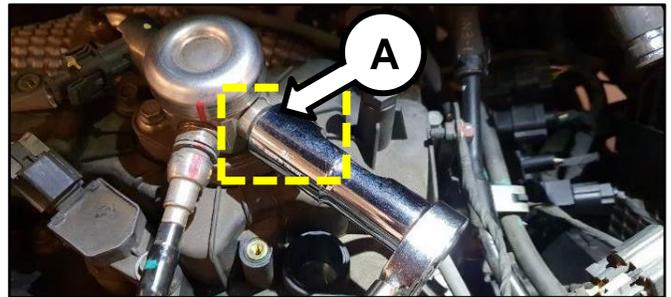
7. If the SST socket rotates, **DO NOT RE-TORQUE**. Proceed to the 2.4L GDI High Pressure Fuel Pipe Replacement procedure on page 5.

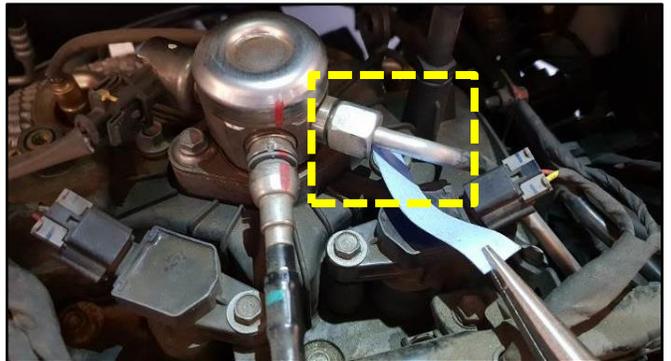
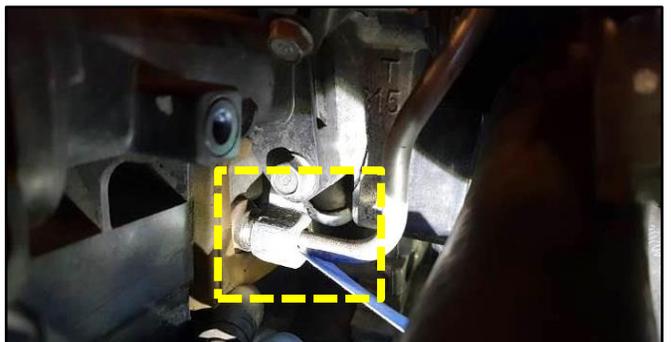
Fuel Leak	No Leak

- If the wiped section of the oil test paper becomes a darker shade, proceed to the 2.4L GDI High Pressure Fuel Pipe Replacement procedure.
- If the oil test paper color does not change, reinstall all removed components in the reverse order of removal and reprogram the customer's radio presets. No further action is required.

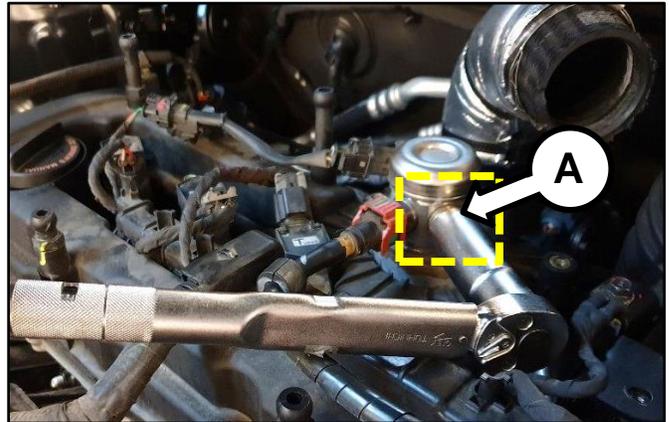
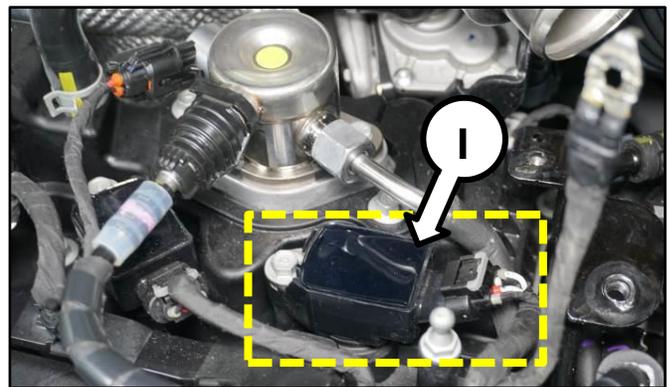
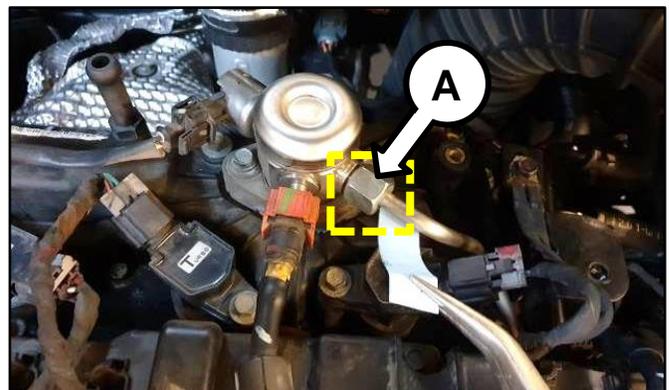
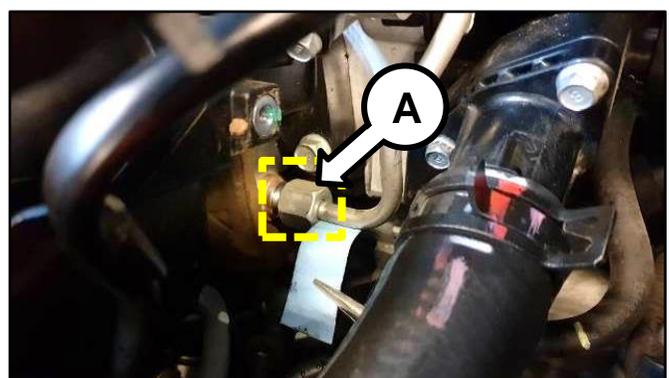
Fuel Leak	No Leak

- If the wiped section of the oil test paper becomes a darker shade, proceed to the 2.0T GDI High Pressure Fuel Pipe Replacement procedure on page 13.
- If the oil test paper color does not change, reinstall all removed components in the reverse order of removal, refill and bleed the cooling system, and then reprogram the customer's radio presets. No further action is required.

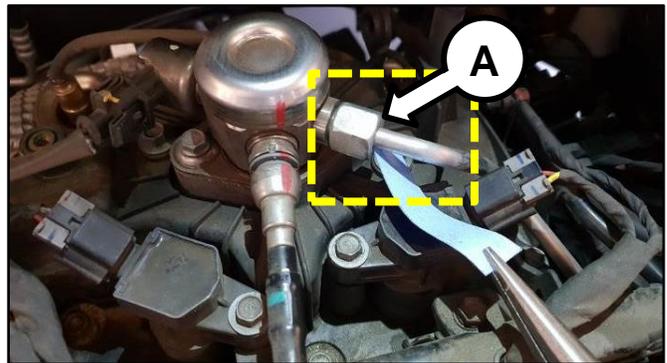
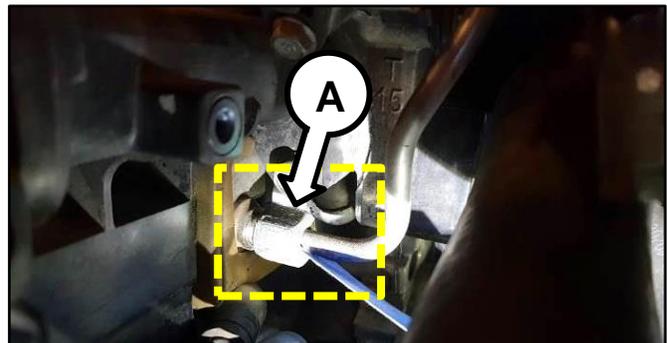
Fuel Leak	No Leak

- If the wiped section of the oil test paper becomes a darker shade, proceed to the “JFa/UMa/QL 2.0T GDI High Pressure Fuel Pipe Replacement Procedure” on page 19.
- If the oil test paper color does not change, reinstall all removed components in the reverse order of removal and reprogram the customer’s radio presets. No further action is required.
