GROUP
Safety Recall Campaign

NUMBER
SC172 (Rev 1, 02/18/2019)

SAFETY RECALL CAMPAIGN

SUBJECT: HIGH PRESSURE FUEL PUMP OUTLET
INSPECTION (SC172)

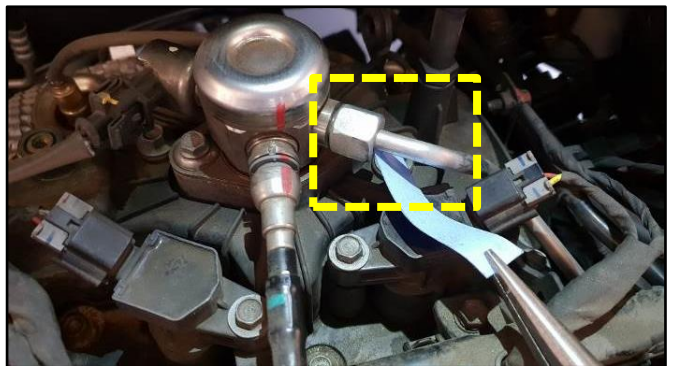
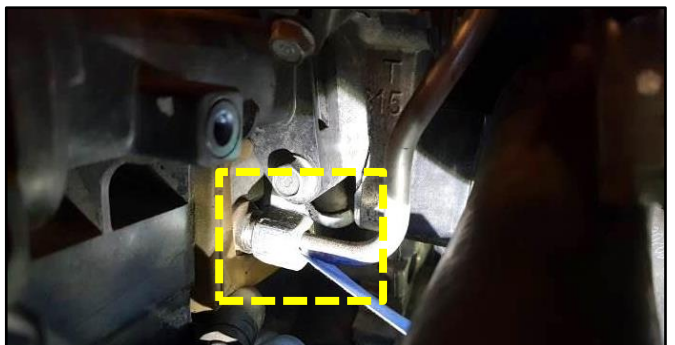
Fuel Leak	No Leak

- If the wiped section of the oil test paper becomes a darker shade, proceed to the 2.4L GDI High Pressure Fuel Pipe Replacement procedure.
- If the oil test paper color does not change, reinstall all removed components in the reverse order of removal and reprogram the customer's radio presets. No further action is required.

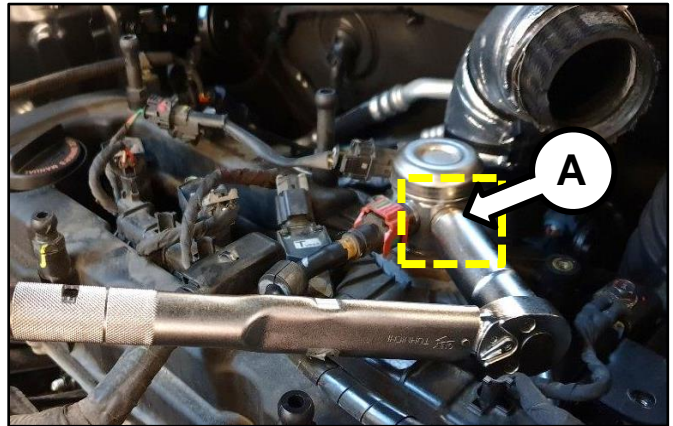
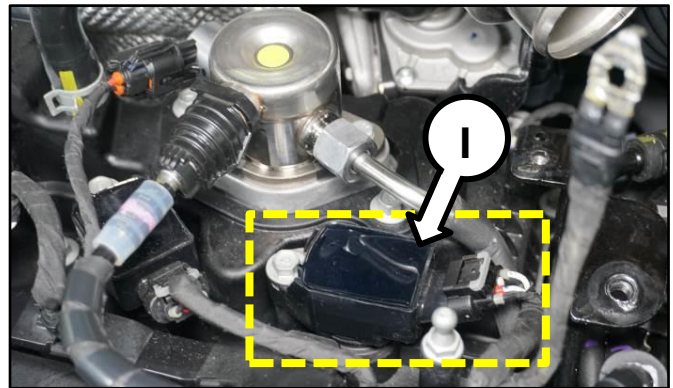
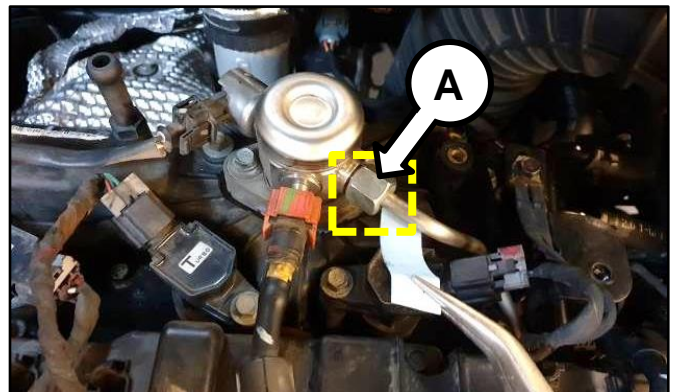
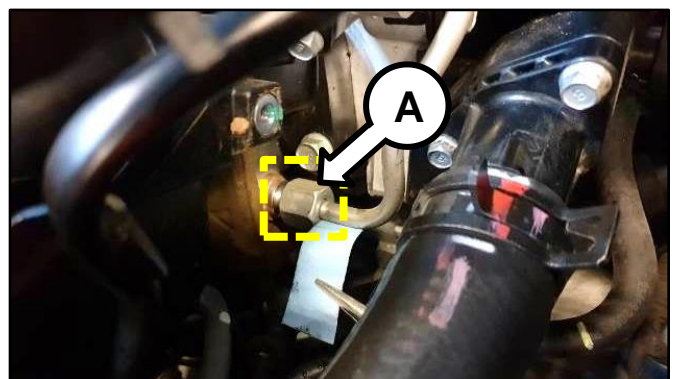
Fuel Leak	No Leak

- If the wiped section of the oil test paper becomes a darker shade, proceed to the 2.0T GDI High Pressure Fuel Pipe Replacement procedure on page 13.
- If the oil test paper color does not change, reinstall all removed components in the reverse order of removal, refill and bleed the cooling system, and then reprogram the customer's radio presets. No further action is required.

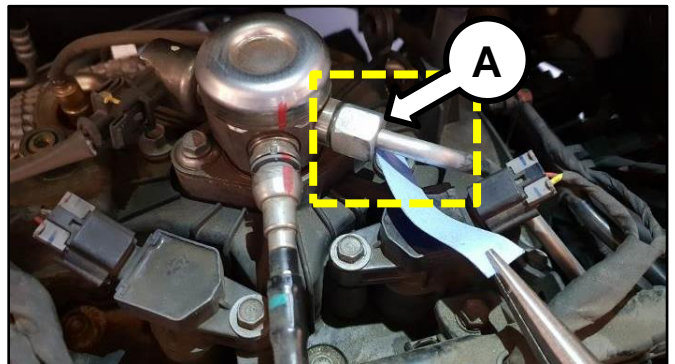
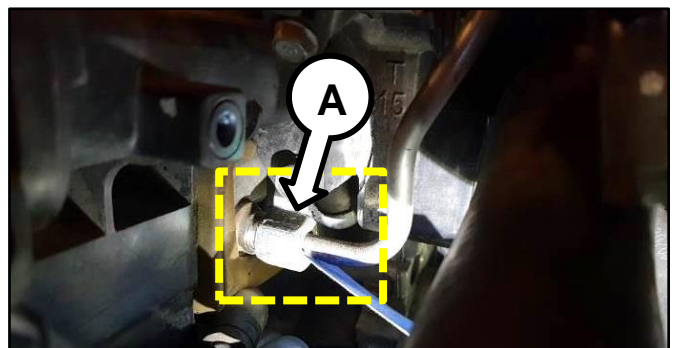
Fuel Leak	No Leak

- If the wiped section of the oil test paper becomes a darker shade, proceed to the “JFa/UMa/QL 2.0T GDI High Pressure Fuel Pipe Replacement Procedure” on page 19.
- If the oil test paper color does not change, reinstall all removed components in the reverse order of removal and reprogram the customer’s radio presets. No further action is required.
