GROUP Safety Recall Campaign	MODEL 2011-2014MY Optima (QF/TF) 2012-2014MY Sorento (XMa) 2011-2013MY Sportage (SL)
	NUMBER SC172	DATE January 2019
SAFETY RECALL CAMPAIGN		
SUBJECT: HIGH PRESSURE FUEL PUMP OUTLET INSPECTION (SC172)

This bulletin provides the procedure to inspect the connections of the High Pressure Fuel Pipe to the fuel pump outlet for fuel leaking and, if necessary, replace the fuel pipe with a new one on certain 2011-2014 MY Kia Optima, 2012-2014 MY Kia Sorento, and 2011-2013 MY Kia Sportage vehicles **that received an engine replacement under Recall No. 17v224 (SC147)**. The remedy for the previous recall may not have been properly performed, and in some cases, the high pressure fuel pipe may have been damaged, misaligned, or improperly torqued during the engine replacement procedure, allowing fuel to leak. Leaking fuel increases the risk of fire.

HIGH PRESSURE FUEL PUMP OUTLET INSPECTION (SC172)

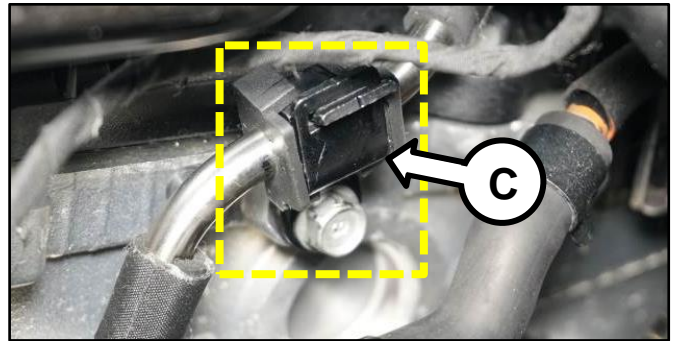
5. Ensure the high pressure fuel pipe retaining bracket (C) is torqued. If the bracket and bolt is missing, install a new bracket and bolt as necessary, prior to performing the next step.

Tightening torque (bracket):
5.8 – 8.7 lb.ft (7.8 –11.8 N.m,
0.8 – 1.2 kgf.m)

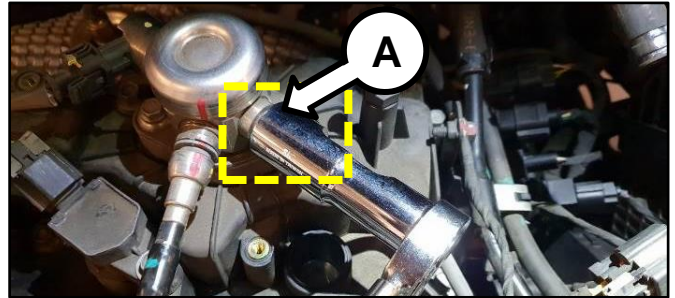
6. Using a click-type/electronic torque wrench and SST 09314-3Q100, verify and ensure the flare nuts (A) at both ends of the high pressure fuel pipe are torqued to specifications.

Tightening torque (flare nuts):
19.5 – 23.9 lb.ft (26.5 – 32.4 N.m,
2.7 – 3.3 kgf.m)

7. If the SST socket rotates, **DO NOT RE-TORQUE**. Proceed to the 2.4L GDI High Pressure Fuel Pipe Replacement procedure on page 5. If the SST socket did not rotate, proceed to the step 8.

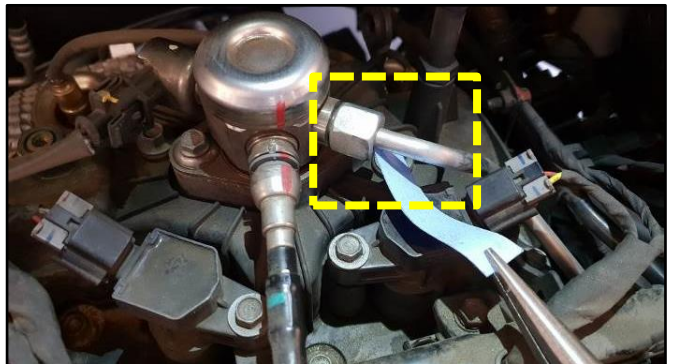
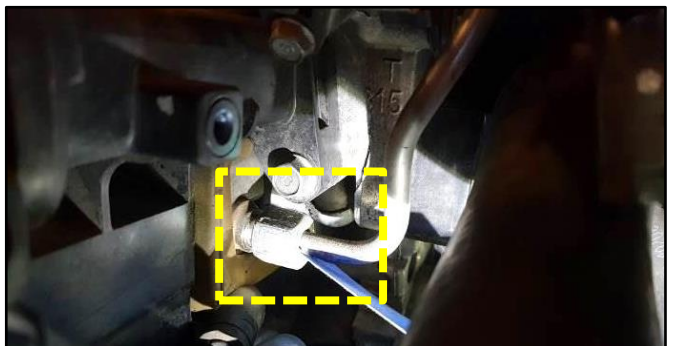
Fuel Leak	No Leak

- If the wiped section of the oil test paper becomes a darker shade, proceed to the 2.4L GDI High Pressure Fuel Pipe Replacement procedure.
- If the oil test paper color does not change, reinstall all removed components in the reverse order of removal and reprogram the customer's radio presets. No further action is required.
