GROUP  
Safety Recall Campaign

NUMBER  
SC172 (Rev 2, 03/08/2019)

SUBJECT: HIGH PRESSURE FUEL PUMP OUTLET  
INSPECTION (SC172)

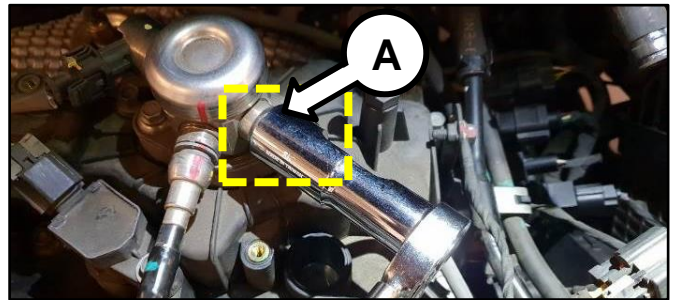
6. Using a click-type/electronic torque wrench and SST 09314-3Q100, verify and ensure the flare nuts (A) at both ends of the high pressure fuel pipe are torqued to specifications.

7. If the SST socket rotates, **DO NOT RE-TORQUE**. Proceed to the 2.4L GDI High Pressure Fuel Pipe Replacement procedure on page 5.

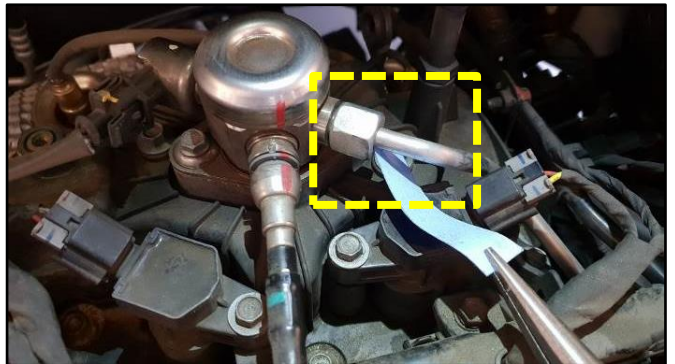
Fuel Leak	No Leak

- If the wiped section of the oil test paper becomes a darker shade, proceed to the 2.4L GDI High Pressure Fuel Pipe Replacement procedure.
- If the oil test paper color does not change, reinstall all removed components in the reverse order of removal and reprogram the customer's radio presets. No further action is required.

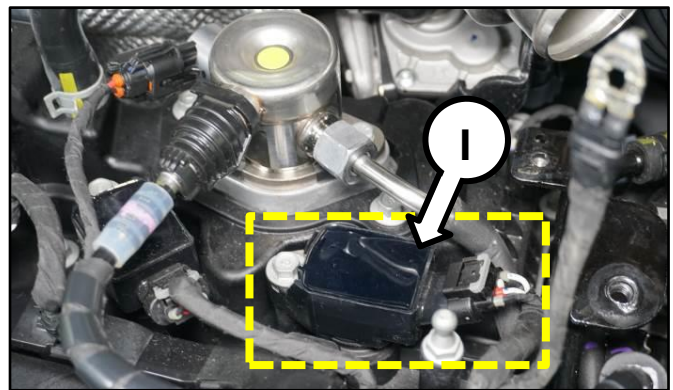
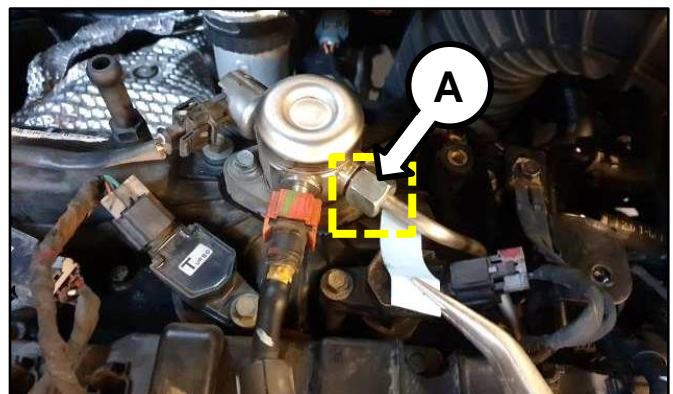
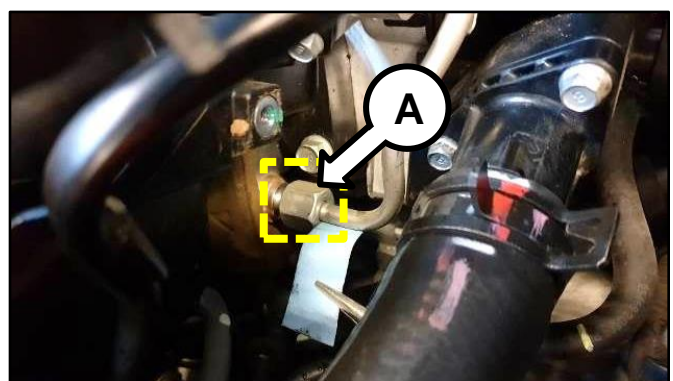
Fuel Leak	No Leak

- If the wiped section of the oil test paper becomes a darker shade, proceed to the 2.0T GDI High Pressure Fuel Pipe Replacement procedure on page 13.
- If the oil test paper color does not change, reinstall all removed components in the reverse order of removal, refill and bleed the cooling system, and then reprogram the customer's radio presets. No further action is required.

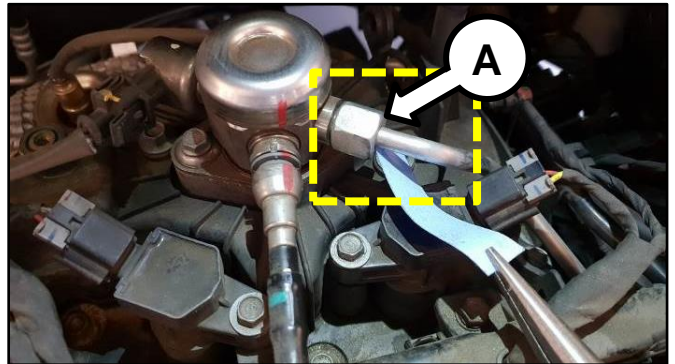
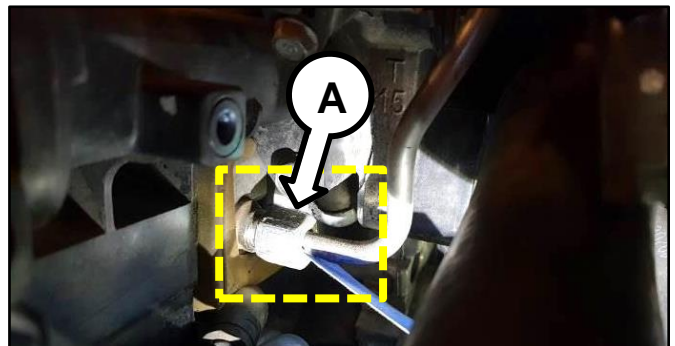
Fuel Leak	No Leak

- If the wiped section of the oil test paper becomes a darker shade, proceed to the “JFa/UMa/QL 2.0T GDI High Pressure Fuel Pipe Replacement Procedure” on page 19.
- If the oil test paper color does not change, reinstall all removed components in the reverse order of removal and reprogram the customer’s radio presets. No further action is required.
