RECALL CAMPAIGN BULLETIN

Classification: BT17-001a	Reference: NTB17-012a	Date: December 19, 2018
------------------------------	--------------------------	----------------------------

VOLUNTARY SAFETY RECALL CAMPAIGN 2015-2017 ALTIMA; REAR DOOR SEALING SCREEN/VAPOR BARRIER

CAMPAIGN ID #: PC675

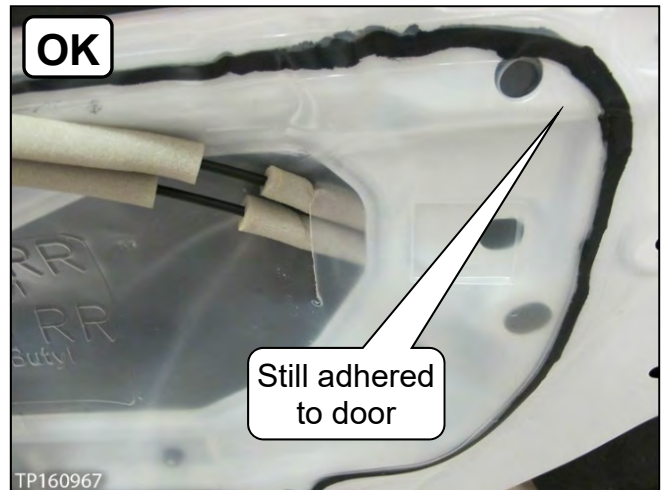
Figure 8

8. Inspect the upper right portion of the vapor barrier.

- If the barrier has already been adjusted from previous repair, (as shown in Figure 10 (on the next page) go to step 7 on page 9.
- If the vapor barrier's condition is similar to the one in Figure 8, go to page 7, **Vapor Barrier - Adjustment.**
- If the vapor barrier's condition is similar to the one in Figure 9, go to page 15, **Inspect Cables and Inside Handle, and Replace Vapor Barrier.**

Vapor Barrier – Adjustment

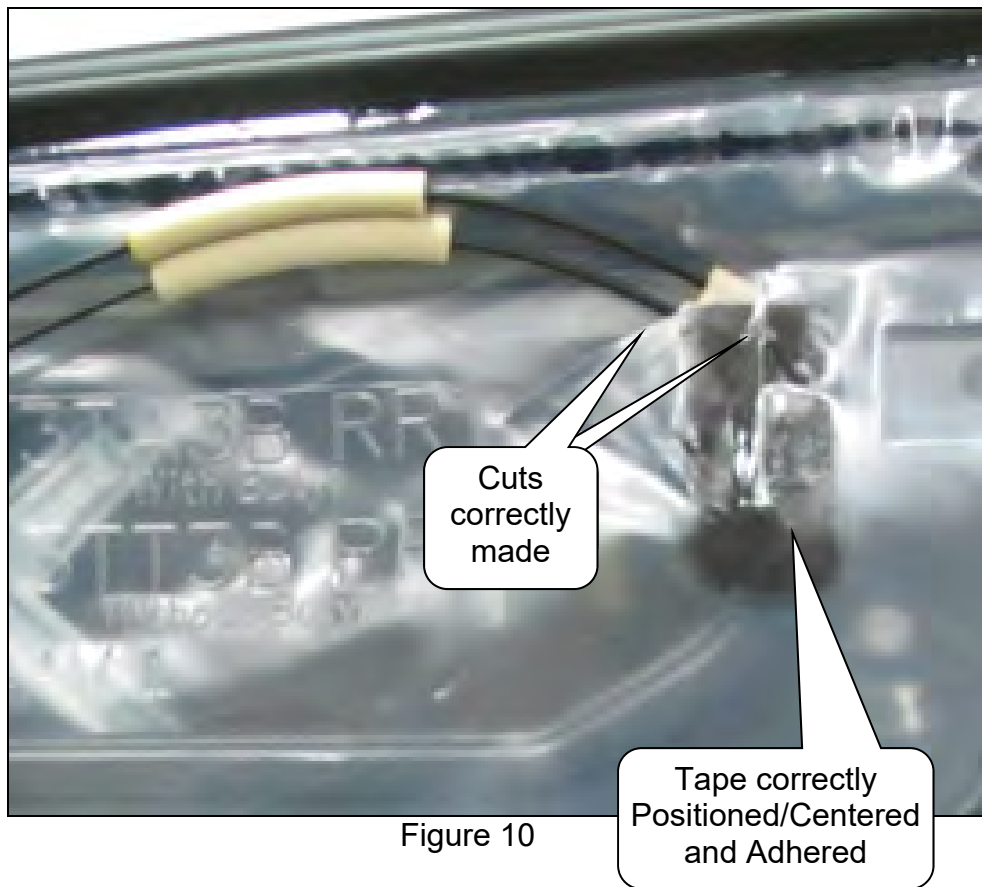
NOTE: The barrier shown in Figure 10 has already been adjusted from previous repair.

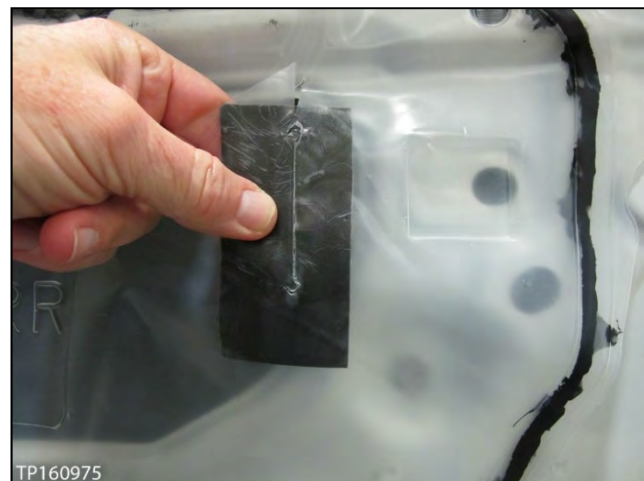
Figure 16

IMPORTANT: The tape MUST be properly adhered to the backside of the vapor barrier and flap.

- Protector P/N: 24271-0Z000 (see **PARTS INFORMATION**).
- a. Apply the tape's sticky side on the area prepped in step 5 (see Figure 15).
- b. Position the tape:
 - Upper edge: 3/8 – 1/2 inch (10 – 13 mm) above the vertical cut's upper molded circle (see Figure 15).
 - Horizontally **centered** on the vertical cut.
- c. Firmly **press** the tape to the vapor barrier to ensure adhesion.
- d. Raise the flap and press it to the tape.
 - Make sure the whole surface of the tape is adhered to the flap and vapor barrier with no gaps in the vertical cut (see Figure 16).

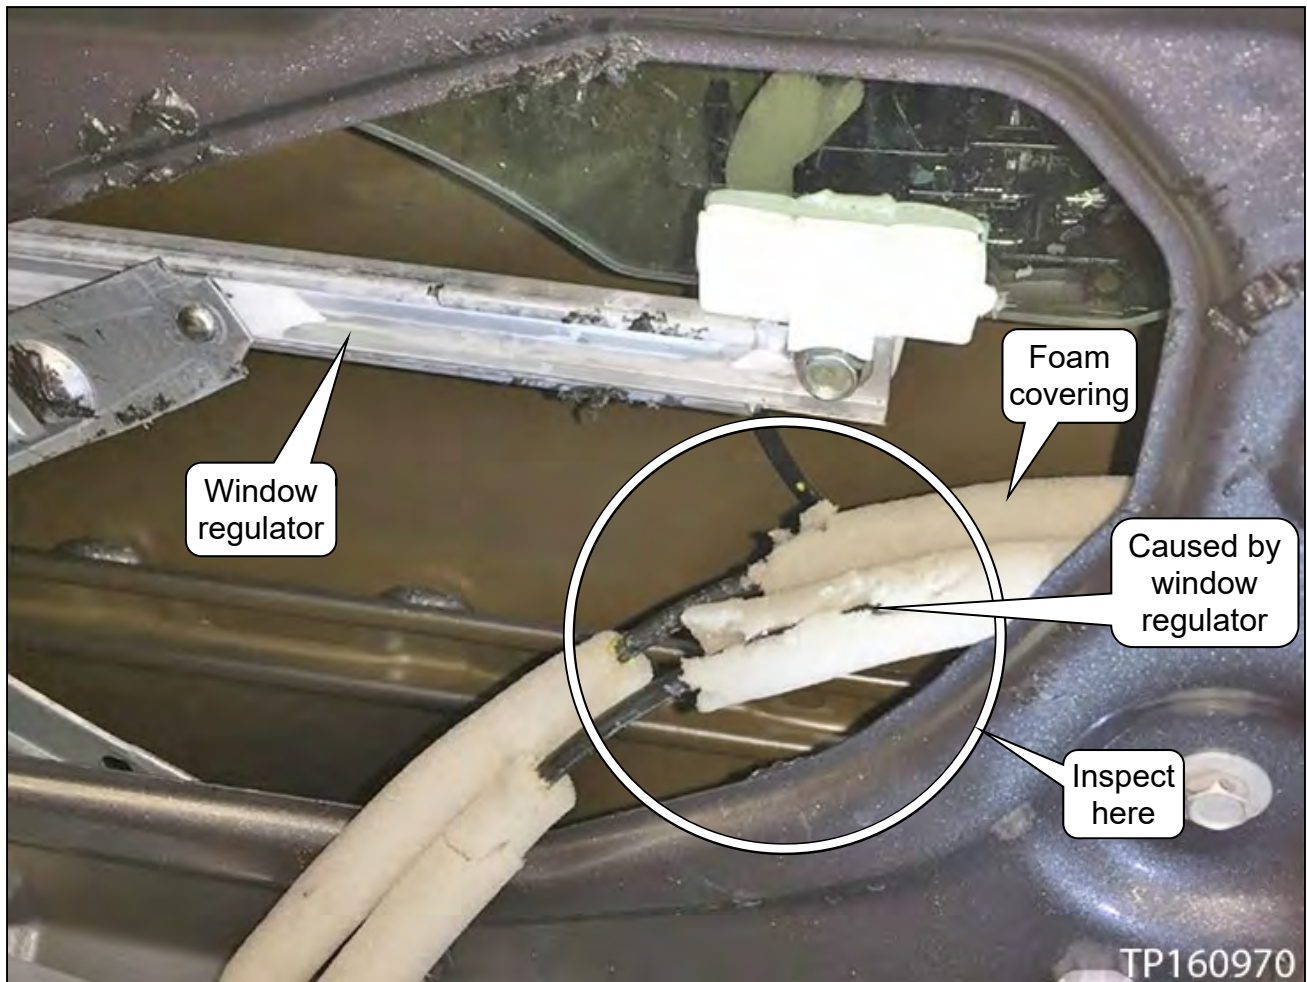
Figure 33

1. Inspect the foam covering on the cables for damage (see example in Figure 33).
2. Damage found: Replace the door lock assembly with cables.
 - Refer to the ESM, section **BODY EXTERIOR, DOORS, ROOF & VEHICLE SECURITY > DOOR & LOCK > REMOVAL AND INSTALLATION > DOOR LOCK > REAR DOOR LOCK > Removal and Installation.**
 - Skip to page 16, step 4.
3. No damage found: Do not replace the door lock assembly with cables.
 - Skip to page 16, step 7.

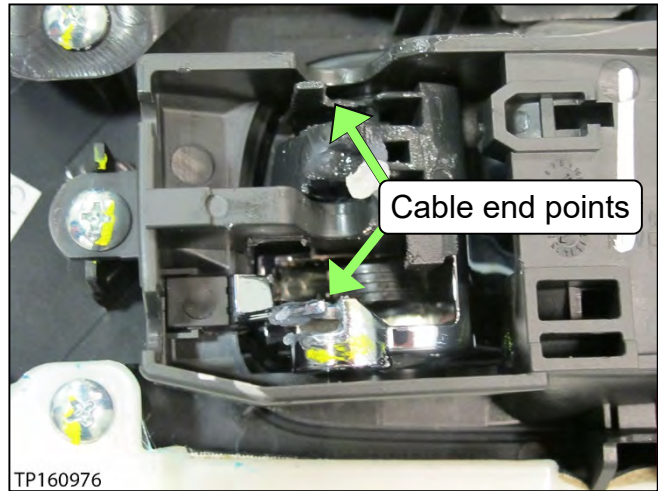
4. Inspect the inside door handle snap grooves and cable end points for damage (see Figure 34 and Figure 35).

5. Damage found: Replace the inside door handle.
