**SAFETY  
RECALL**

**SR19-04A**

DATE :	June 2019	SECTION : 14 STEERING
SUBJECT:	<b>DRAG LINK REPLACEMENT</b>

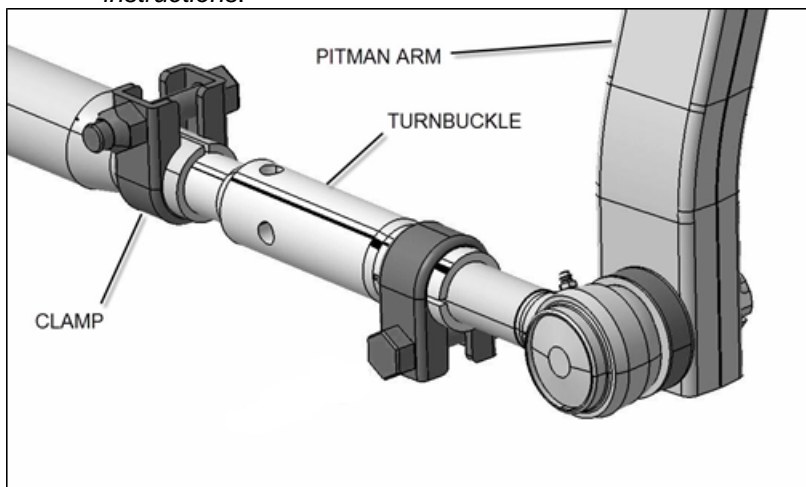
On the vehicles involved equipped with I-beam axles, cracks can occur and propagate in the steering draglink turnbuckle under certain conditions. If the cracks start to propagate, over time it may extend inward to a point where the turnbuckle may fracture.

If the turnbuckle fractures, a complete loss of steering would occur that can increase the risk of a vehicle crash or other risks associated with a disabled vehicle.

1. This recall involves a former draglink design with a turnbuckle near the pitman arm.(Figure 1)
2. Open the front service compartment and pull on the front bumper release. The pitman arm and steering draglink can be found on the driver's side.
3. The recalled draglink is identifiable by the presence of a *turnbuckle* and *two clamps* in the section nearest to the pitman arm. (Figure 1)
4. If it is confirmed your vehicle has the recalled draglink (Figure 1), you may proceed to the replacement.
5. If your vehicle does not have the recalled draglink design, please read further for *additional instructions*.

Figure 1: Recalled draglink with turnbuckle and two clamps.

Inspect the draglink and if required, replace the complete draglink by an improved part.

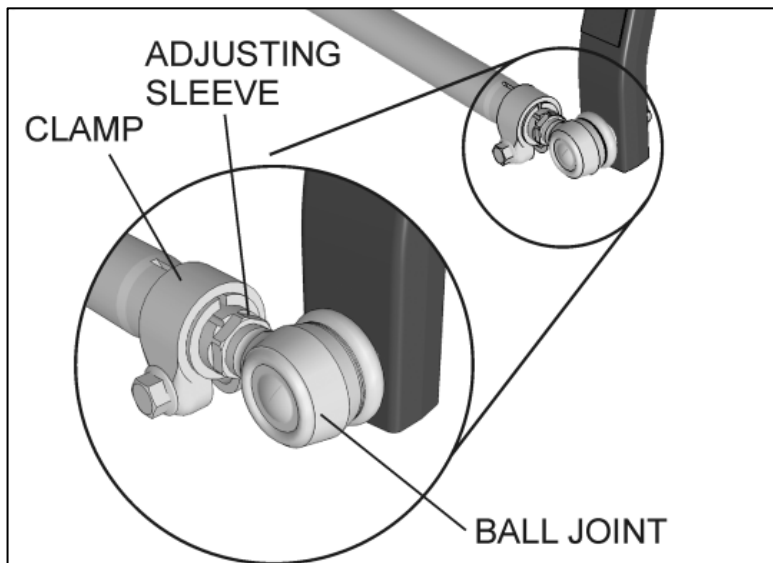
The improvement can be confirmed by the presence of an *adjusting sleeve* and a *single clamp* in the section nearest to the pitman arm. (Figure 2)

**Figure 2: Improved 660699 draglink**

If the vehicle already has this draglink, this is the improved part being installed in the recall. *You do not have to perform the replacement.*

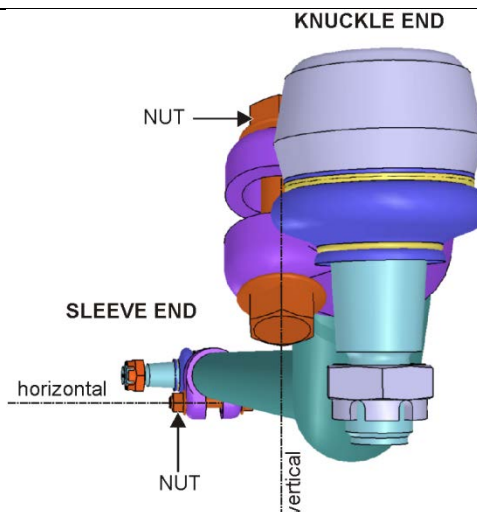
**FIGURE 7: NOTE THE VERTICAL ORIENTATION OF THE CLAMP BOLT AT THE KNUCKLE END AND ON WHICH SIDE THE NUT MUST BE POSITIONED**

10. To prevent interference between the ball joint clamp bolts and other components of the steering system, the clamp bolt must be positioned vertically as shown on FIGURE 7. **Tighten the clamp nut to 118-133 lbf-ft.**

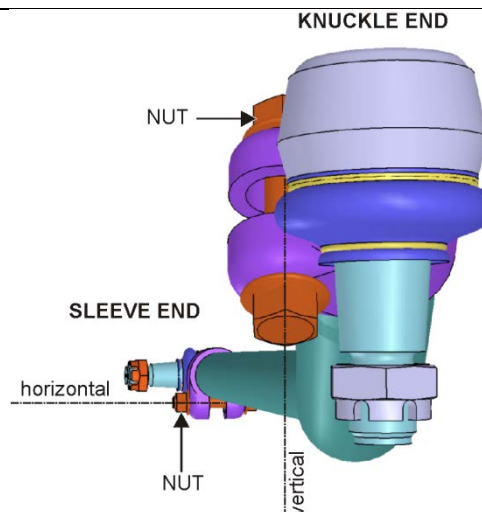
**FIGURE 12: NOTE THE HORIZONTAL ORIENTATION OF THE CLAMP BOLT AT THE SLEEVE END AND ON WHICH SIDE THE NUT MUST BE POSITIONED**

13. Adjust sleeve to the values of FIGURE 11.
14. Once the proper length adjustment is done, tighten the front end ball joint clamp. To prevent interference between the ball joint clamp bolts with other components of the steering system, the clamp bolt must be positioned horizontally as shown in FIGURE 12. **Tighten the clamp nut to 118-133 lbf-ft.**
15. Apply a torque seal mark
