GROUP	NUMBER
RECALL	19-01-001H
DATE	MODEL(S)
MARCH 2019	APPLICABLE VEHICLES BELOW

HIGH PRESSURE FUEL PIPE INSPECTION AND REPLACEMENT (RECALL CAMPAIGN 180)

Description: The high pressure fuel pipe may have been damaged, misaligned, or improperly torqued during prior engine replacement allowing fuel to leak, increasing the risk of a fire. This bulletin describes the procedure to confirm the high pressure fuel pipe is properly installed.

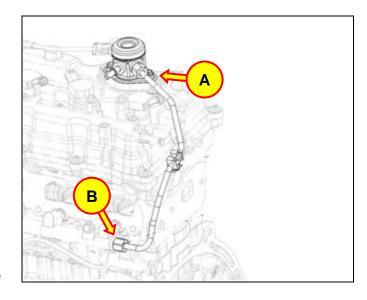
10. While the engine is idling, check the area where the fuel pipe connects to the high pressure fuel pump (A) and fuel rail (B) for any indication of fuel leakage or smell.

While the engine is idling, wipe the areas around the high pressure fuel pipe nuts and the gap between the pipe and nuts using the oil test paper.

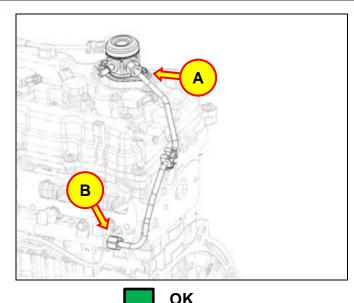
If the oil test paper appearance does not change:

NOT OK:

If the oil test paper becomes darker or if there is indication of fuel leakage/smell, follow the procedure to replace the high pressure fuel pipe.

- Reinstall all removed parts in the reverse order of removal.
- Reprogram the vehicle's audio presets.
- For 2.0L Turbo vehicles, refill and bleed the cooling system.
- Check for DTCs and perform the appropriate diagnostic service. Ensure no warning lights are present to complete the procedure.
