IMPORTANT SAFETY RECALL 18V-008 (SN663)

SN-663

Models Affected: XTPro56 & XTPro 60 Aerials

SUBJECT: Single Stick Control Adjustment

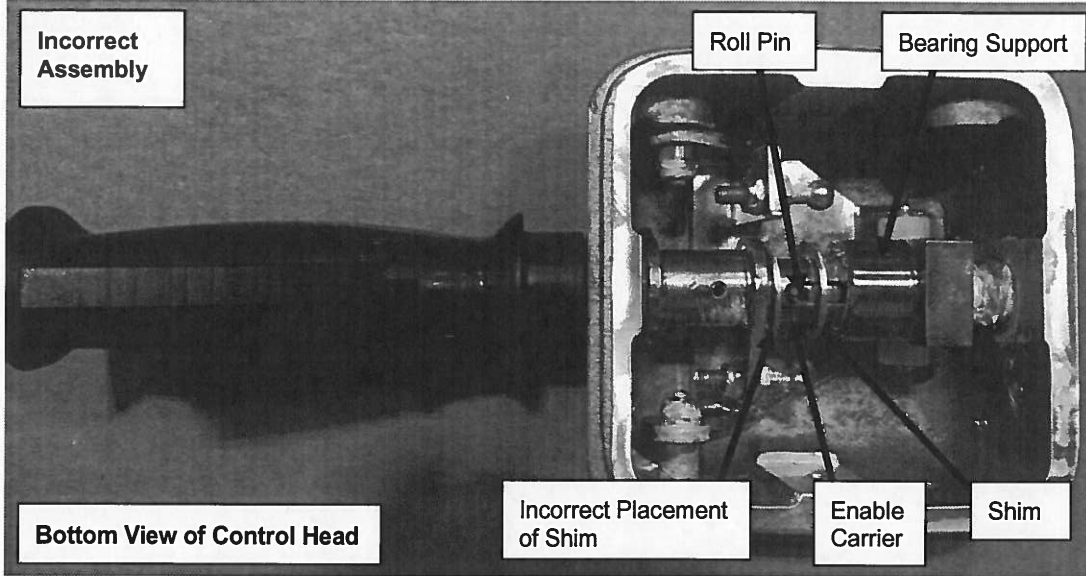
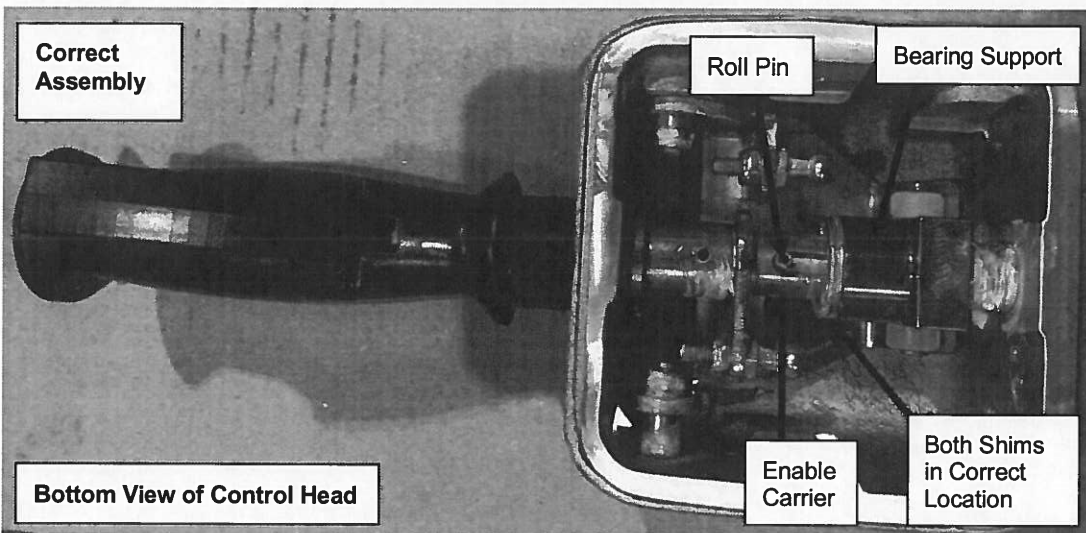
- a. Remove the plastic cap and lower the boot over the single stick mechanism.
 - b. Inspect the position of the two shims on the enable carrier.
 - c. If only one shim is between the roll pin and bearing support, the single stick is assembled incorrectly. Contact your local TEREX dealer to arrange repair. The control head must be assembled properly to provide allowance for wear to attain rated boom speeds.

- d. If both shims are between the roll pin and bearing support, the single stick is assembled properly. No further action is required for this bulletin. Continue to perform regular inspections and maintenance as stated in the manuals.
