BLUE BIRD

R18ZE

DATE: July 31, 2019
TO: Blue Bird Owners
Subject: Recall R18ZE, Intermittent Air Gauge Operation (Noncompliance)

Intermittent Air Gauge Operation

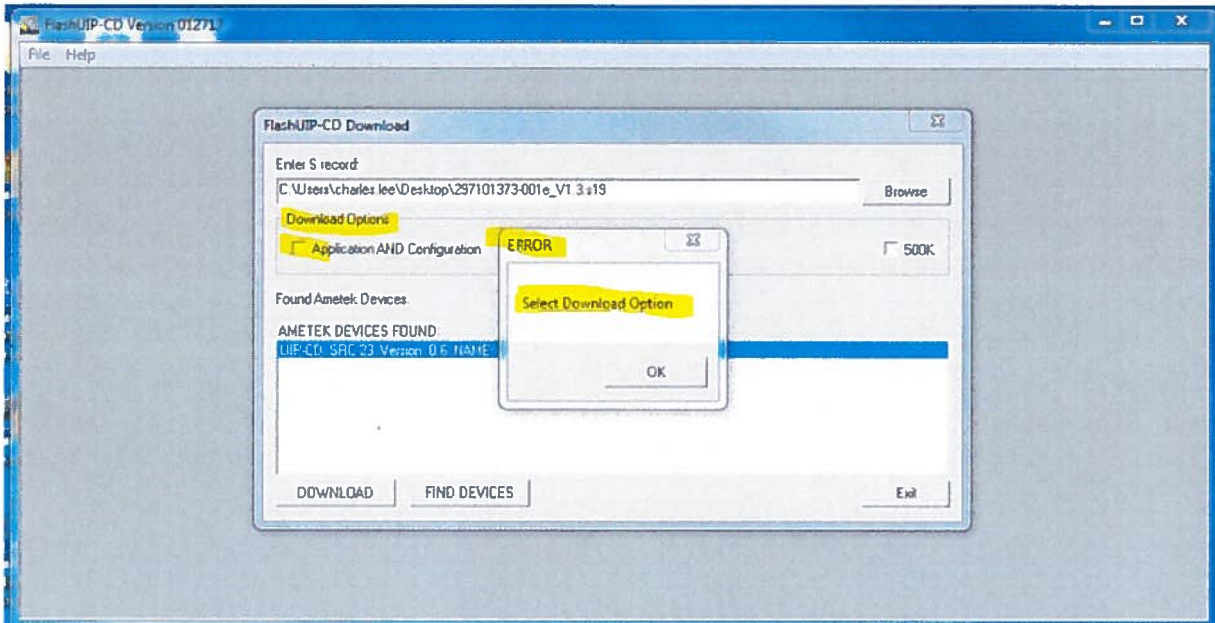
ERROR 'Select Download Option'

The 'Application AND Configuration' box was NOT checked before clicking the "DOWNLOAD" button.

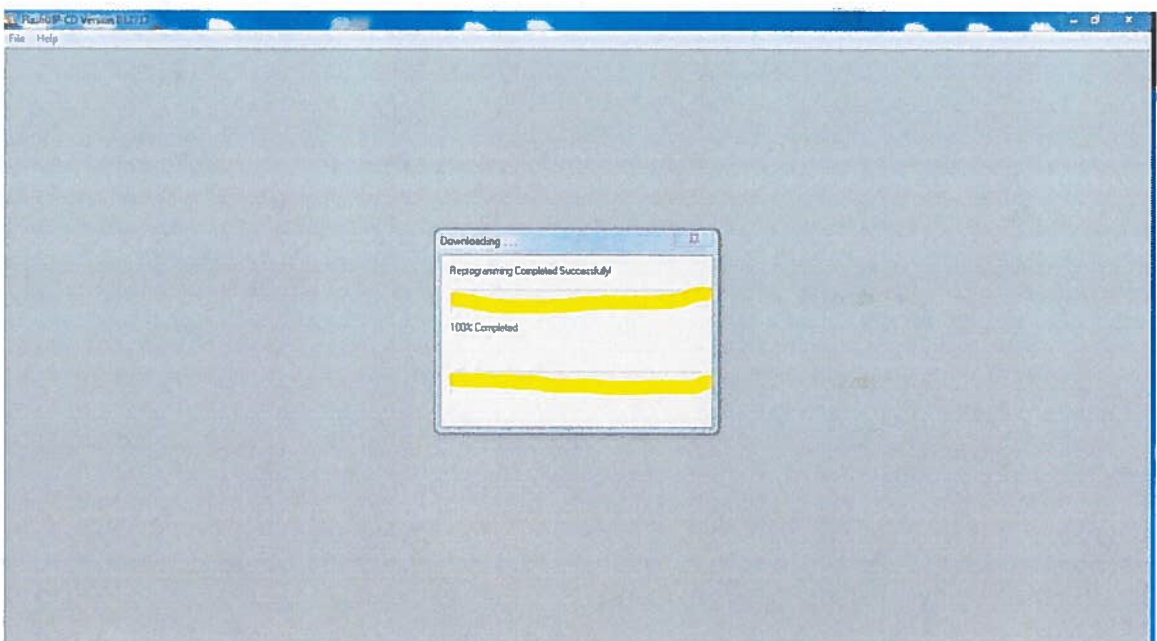
'Both status bars are blank'

The incorrect file type was selected. Insure the file type selected is '.s19'

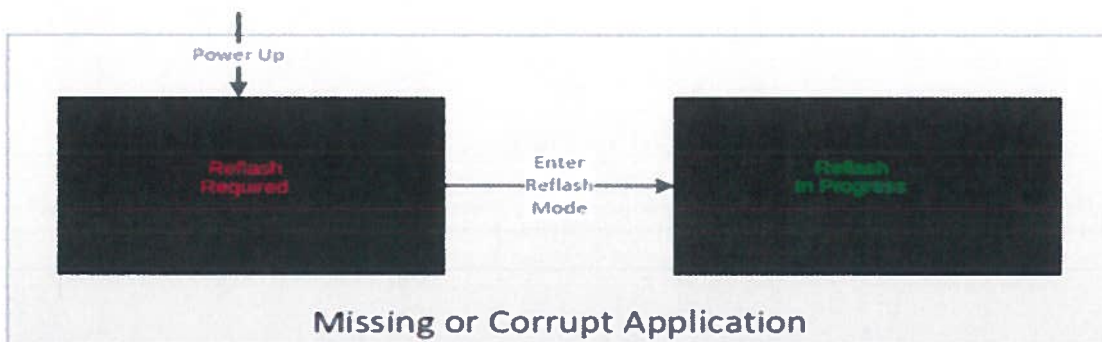
'Reflash Required'

Instrument cluster software files were erased and updated process was not successful. Possible causes include loss of power, ground, or J1939, during software update. Check J1939, battery, ignition, and ground connections at the cluster and the diagnostic port connector.
