BLUE BIRD

R18ZE

DATE: February 11, 2019
TO: Blue Bird Owners
Subject: Recall R18ZE, Intermittent Air Gauge Operation (Noncompliance)

Intermittent Air Gauge Operation

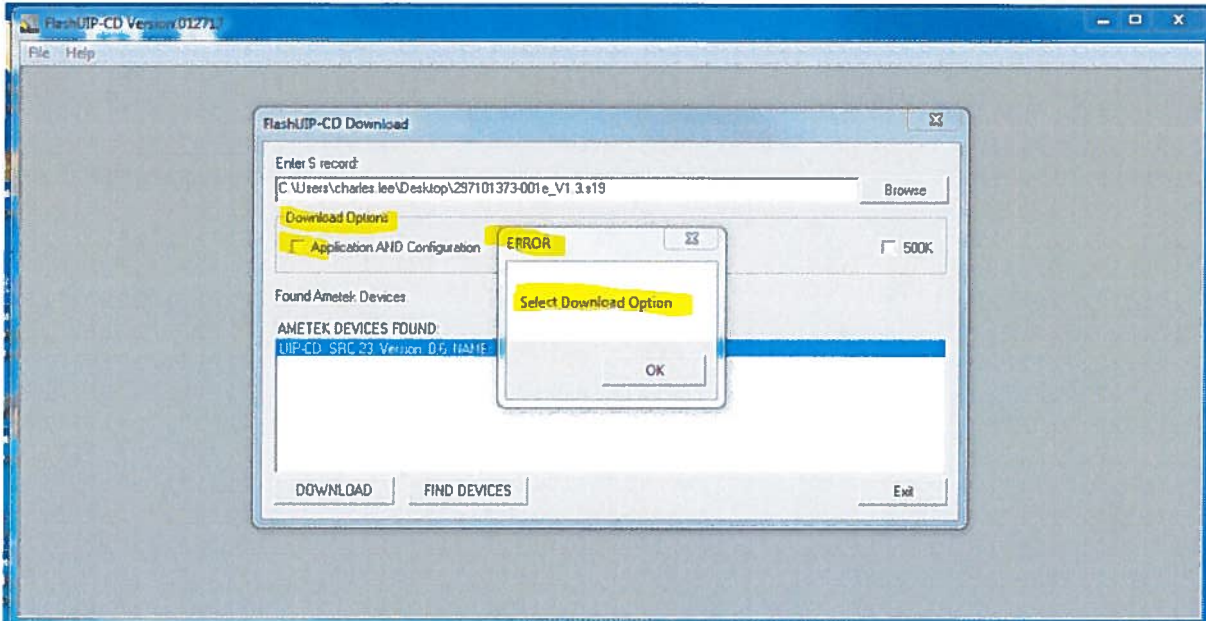
ERROR 'Select Download Option'

The 'Application AND Configuration' box was NOT checked before clicking the "DOWNLOAD" button.

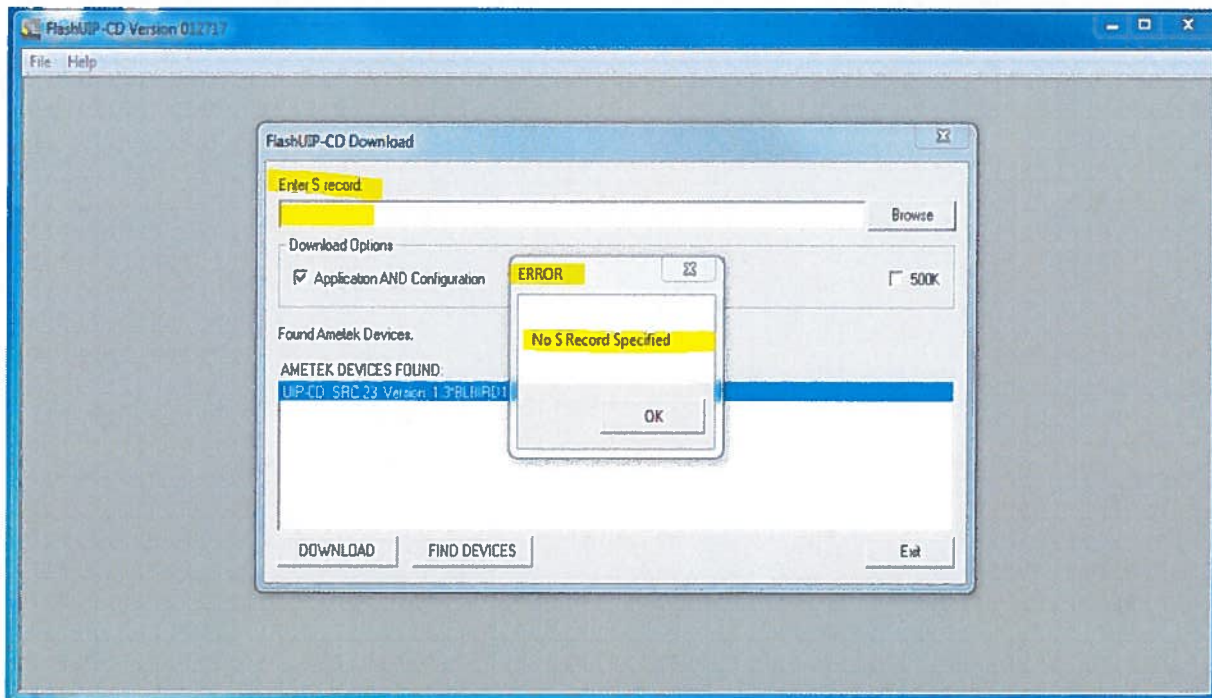
ERROR 'No S Record Specified'

.s19 software file MUST be selected. Click 'Browse' and select the .s19 software to be installed in cluster and click 'Open':

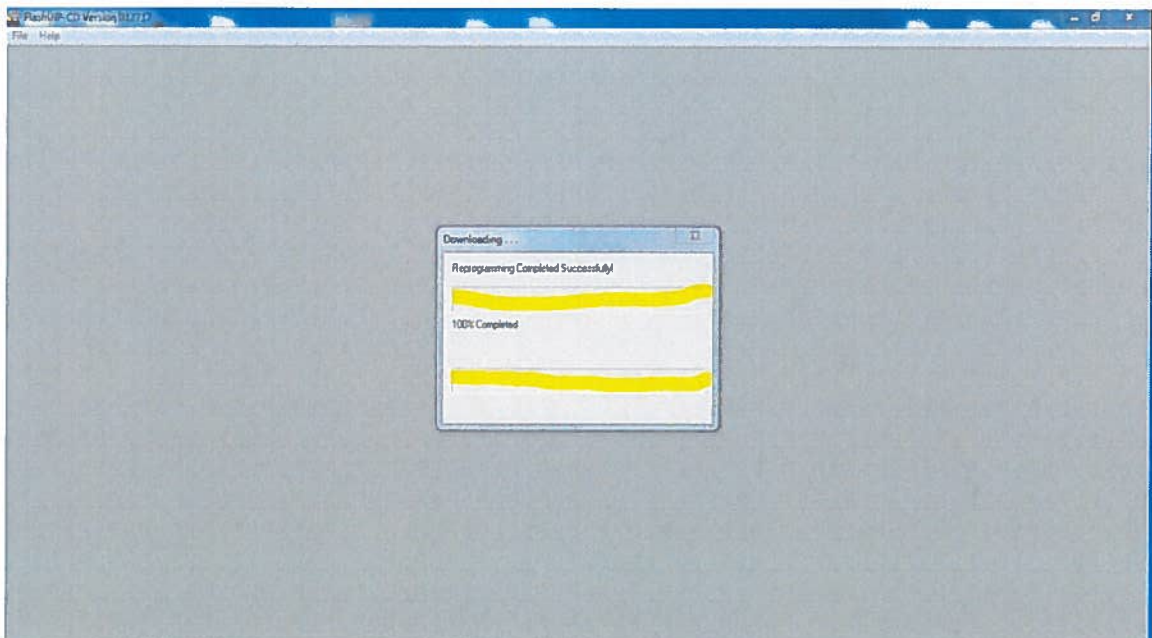
'Both status bars are blank'

The incorrect file type was selected. Insure the file type selected is '.s19'

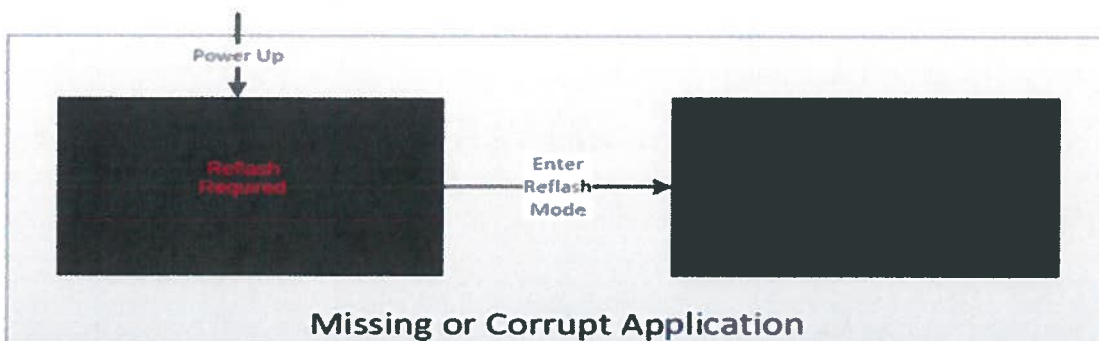
'Reflash Required'

Instrument cluster software files were erased and updated process was not successful. Possible causes include loss of power, ground, or J1939, during software update. Check J1939, battery, ignition, and ground connections at the cluster and the diagnostic port connector.
