TEREX®

Safety Recall Notice 18V-794

Terex Utilities	
SAFETY NOTICE	SN-669

SUBJECT: Pole Guide Bar 450543

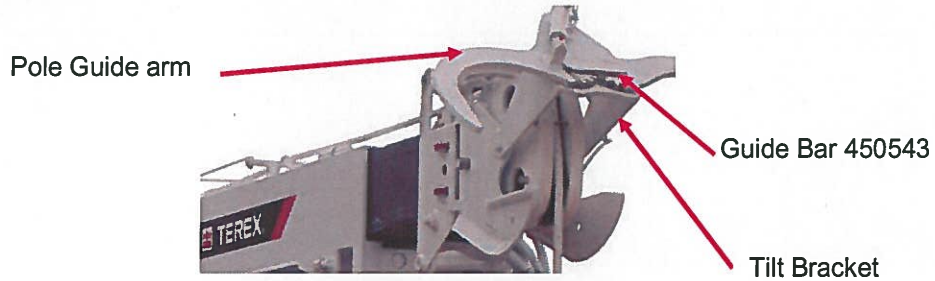
Identify Guide Bar:

Guide bar, 450543, may be on purchased machines which use these Pole Guide assemblies: 9143641, 618527, 608863, 494477, 491588, 488466, 483997, 481644, 479606, 479604, 469357, 464832, 463513, 458141, or 403186.

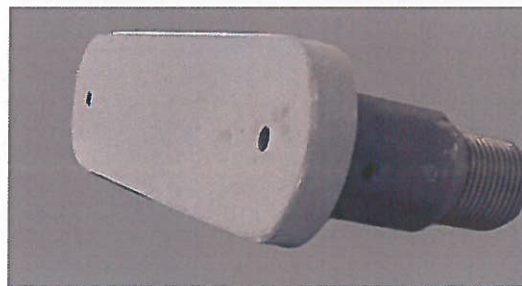
1. The grease zerk will be on the upper side above the pole guide arms and the surface is flat.
2. The top surface of the bar will be nearly flat with a milled counterbore (recessed area) for the grease zerk.

Zerk flush to top surface

Terex will provide a replacement guide bar (Z1523).

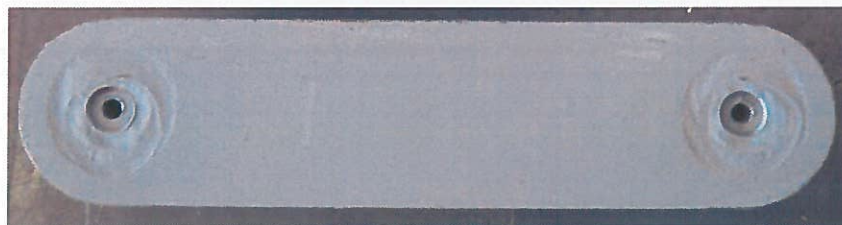
Zerk counterbored on bar side

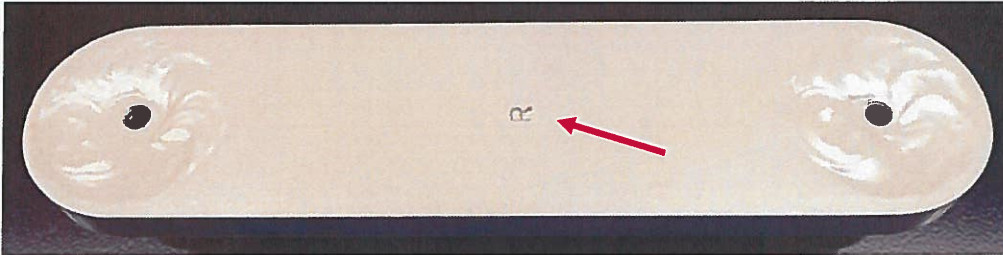
1. Weldments with one to four stamped marks on the top of the bar are older production or have been repaired.

Reworked stamped R, B, or four stamped letters

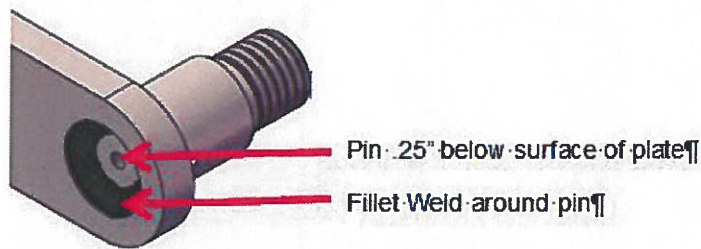
2. Weldments with a fillet weld around the pin and the top of the pin recessed below the surface of the bar.

Fillet weld around recessed pin

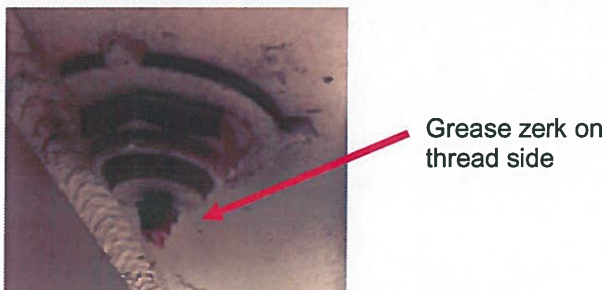
3. The zerk is on the threaded side next to the nut, or ther is no zerk on either end of both pins.

Grease zerk on thread side
