Safety Notice

SN-663

Models Affected: XTPro56 & XTPro 60 Aerials

SUBJECT: Single Stick Control Adjustment

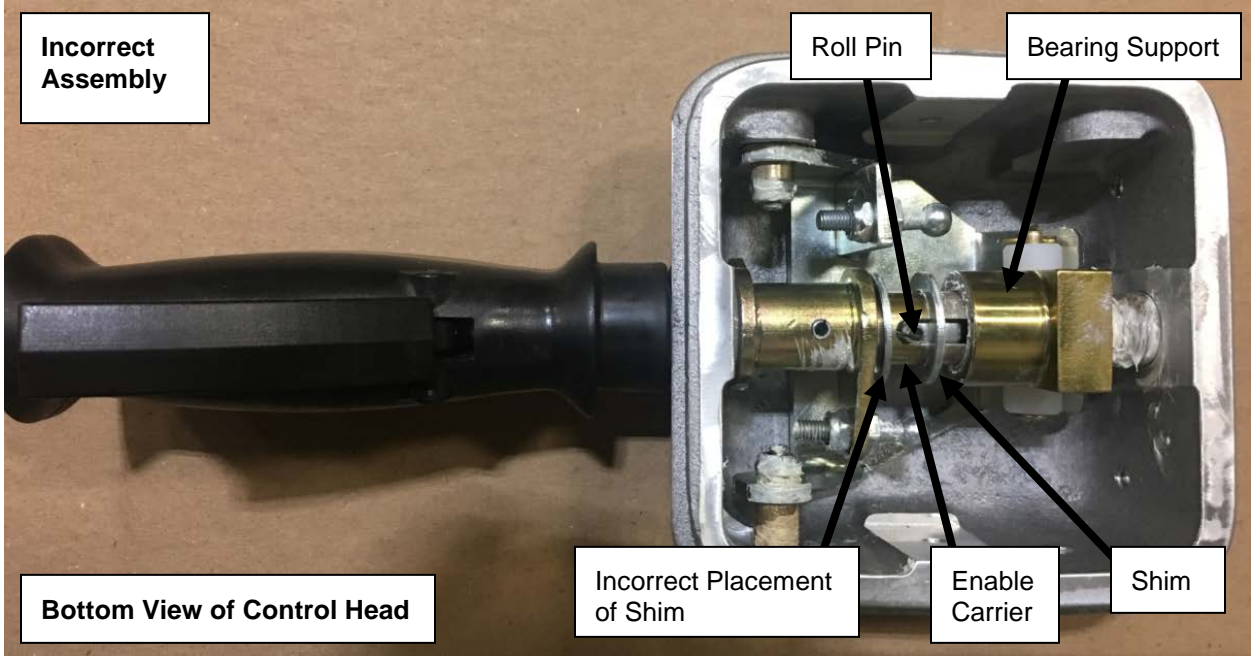
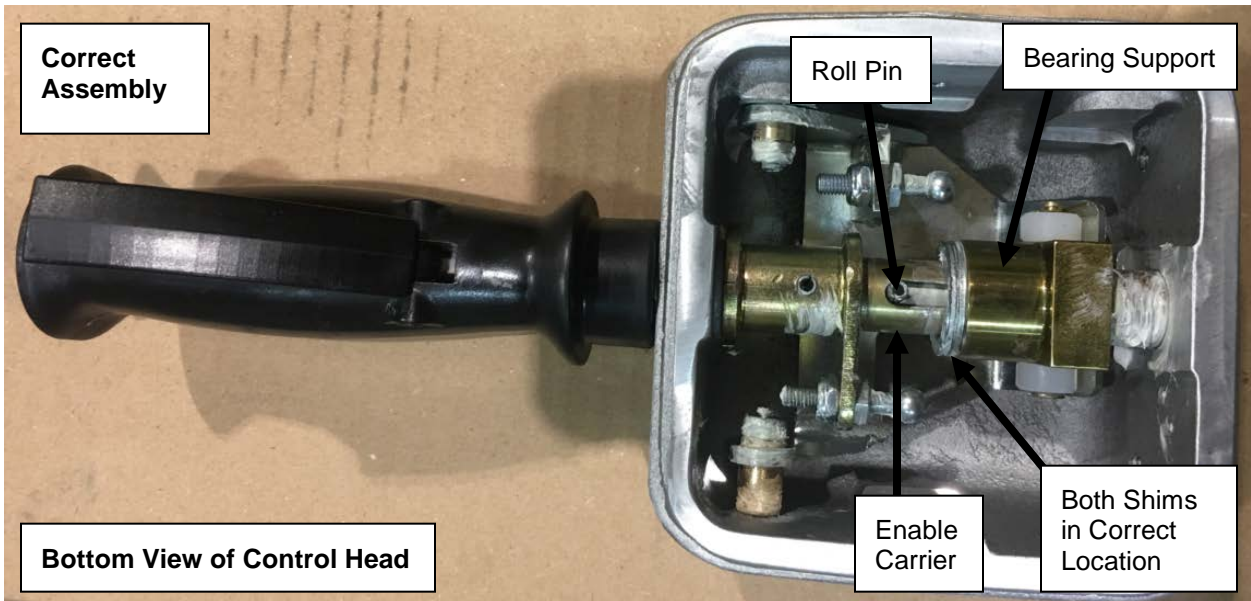
- a. Remove the plastic cap and lower the boot over the single stick mechanism.
 - b. Inspect the position of the two shims on the enable carrier.
 - c. If only one shim is between the roll pin and bearing support, the single stick is assembled incorrectly. Contact your local TEREX dealer to arrange repair. The control head must be assembled properly to provide allowance for wear to attain rated boom speeds.

- d. If both shims are between the roll pin and bearing support, the single stick is assembled properly. No further action is required for this bulletin. Continue to perform regular inspections and maintenance as stated in the manuals.

Proper adjustment of the single stick control is described in the manual. Terex will provide field service kit Z1496 for units that have the enable trigger adjusted or assembled incorrectly at no cost to the owner.
