Product Safety Recall

17477 Front Passenger Air Bag Inflator

Reference Number: N161644421

Release Date: March 2018

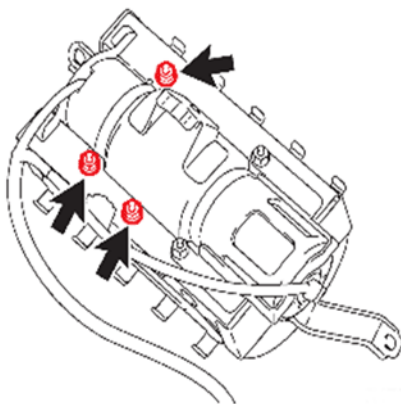
4751083

Important: If any gap exists, the aligned flats may move apart, resulting in failure in normal deployment of the airbag.

8. Remove the 3 remaining old self-locking nuts and install temporarily 3 **NEW** self-locking nuts by hand. Store the removed self-locking nuts in a replacement part box or the like.
9. Push the inflator and plate towards the position determining plate to eliminate any gap.
