# Product Safety Recall

## 17477 Front Passenger Air Bag Inflator

Reference Number: N161644421

Release Date: February 2018

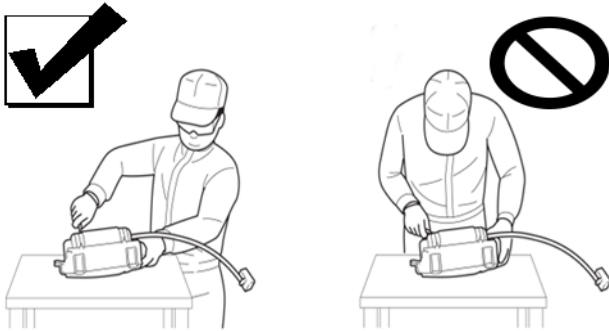
4751076

**Warning:** When working with the airbag module, avoid standing directly in front of the parts

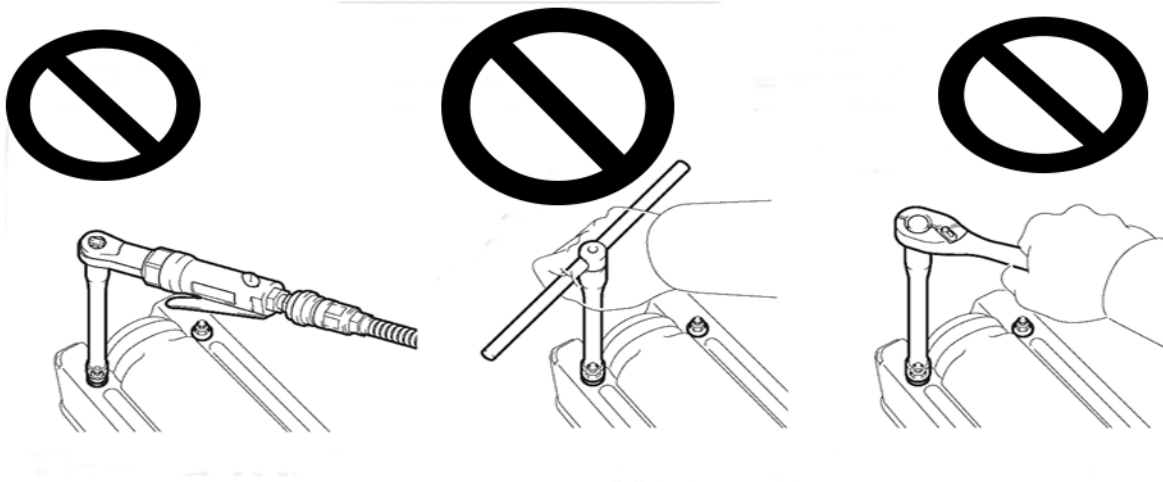
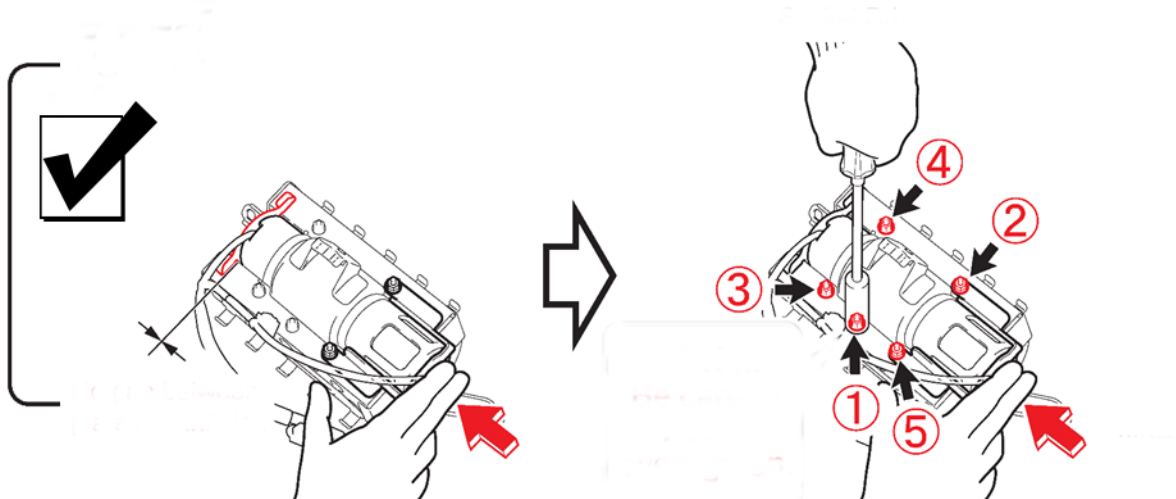
**Important:** The tightening torque is low (3.9 N·m). Use of an air ratchet wrench or tightening strongly with a T-handle wrench or a ratchet handle may cause deformation of the stud bolt.

10. Tighten 5 nuts evenly in several increments in the order shown above using a socket driver while pushing the inflator and plate. (You will encounter some resistance during tightening because these nuts are self-locking nuts.). Torque: 3.9 N·m (40 kgf·cm, 35 in.·lbf).
11. Install the harness clip to the center stud after all 5 nuts have been torqued.
