Product Safety Recall

18179 SDM Loss of Communication

Reference Number: N182155400

Release Date: June 2018
Revision: 01

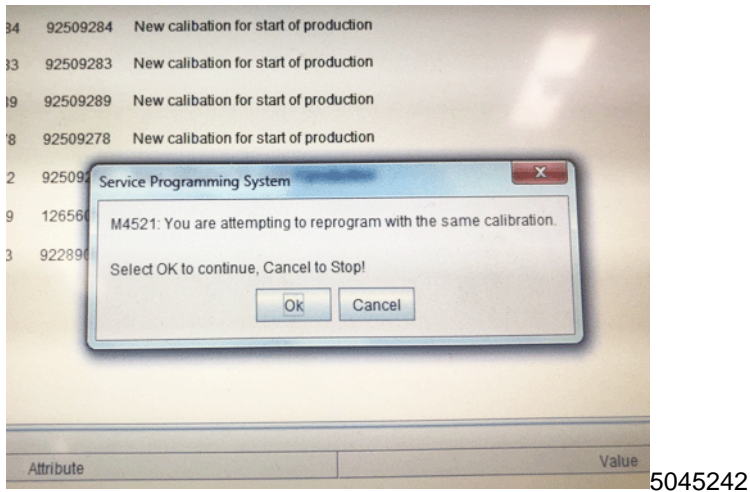
Note: If the Same Calibration/Software Warning is noted on the SPS controller screen, select “OK” and continue programming.

1. Reprogram the Inflatable Restraint Sensing and Diagnostic Module. Refer to *K36 Inflatable Restraint Sensing and Diagnostic Module: Programming and Setup* in SI.
2. Record SPS Warranty Claim Code on job card for warranty transaction submission.
