RC-18-78-01

MODEL: 2018 Model Year (MY18) Karma Revero

TITLE: Exterior Rearview Mirror Inspection

Safety Recall Notice (Remedy)

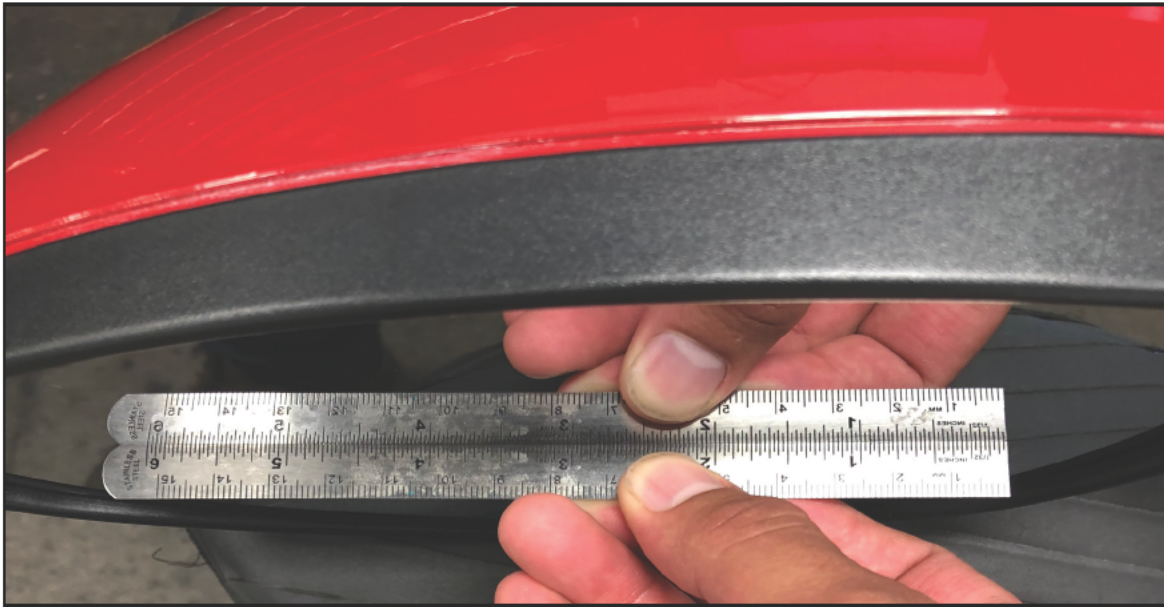
fig. 1a

A flat surface is correct as shown (fig. 1a and 1b). If no fault is found, complete the TSS case and file the warranty claim for the inspection.

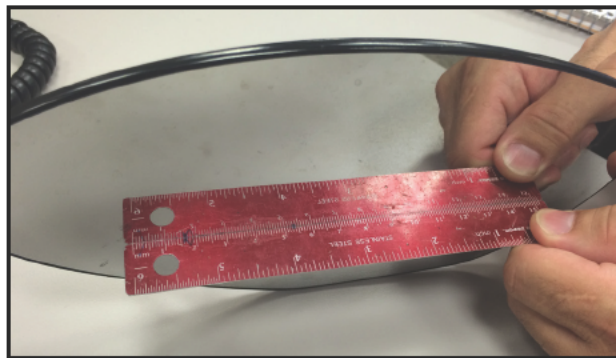
fig. 1b

The Correct flat Exterior Rearview Mirror Glass,
part number C131166001500 - LH Glass Case Sub-Assembly (fig. 1b).

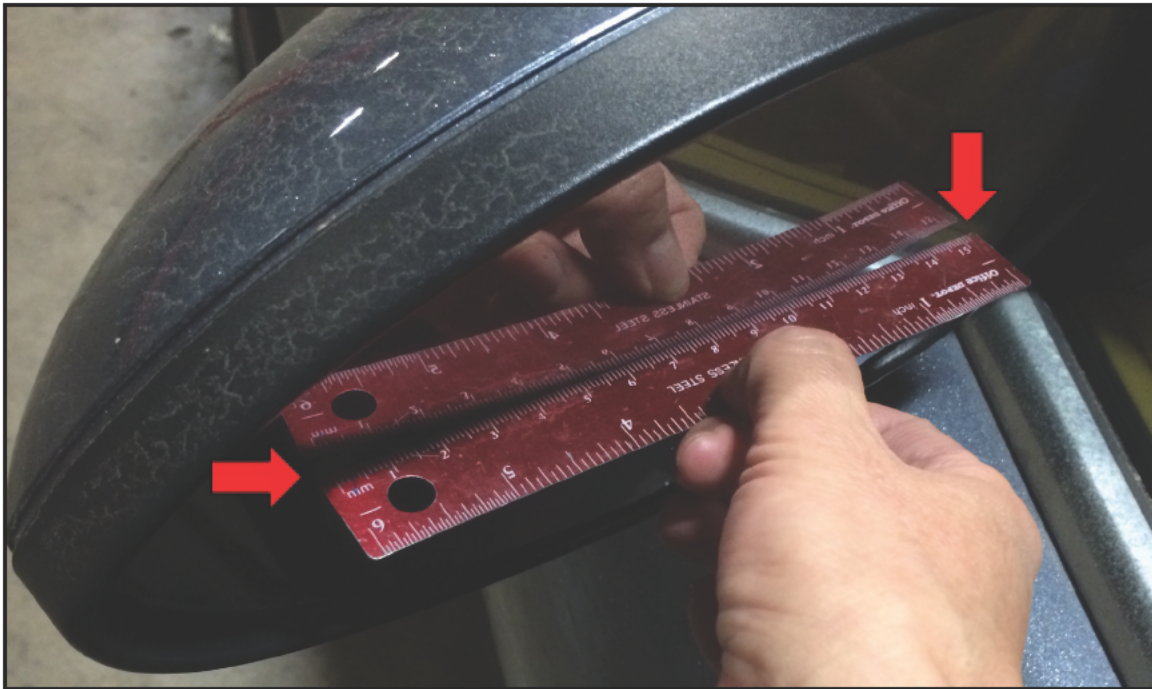
fig.2a

If the Left-hand side Exterior Rearview Mirror Glass is found to be a convex mirror, notice the straight edge ruler reflection has distortion (fig.2).

Again: a convex mirror surface is incorrect for the U.S.A and Canada markets - notice the image distortion and requires replacement. Replace this with C131166001500 - LH Glass Case Sub-Assembly.

Replace this driver's side Exterior Rear View Mirror Glass with the correct Flat Exterior Rearview Mirror Glass, part number C131166001500- LH Glass Case Sub-Assembly as shown above (fig. 1b).

The incorrect (convex) Exterior Rearview Mirror Glass should be removed by “snapping” it off and the new correct Exterior Rearview Mirror Glass needs to will be snapped into place.

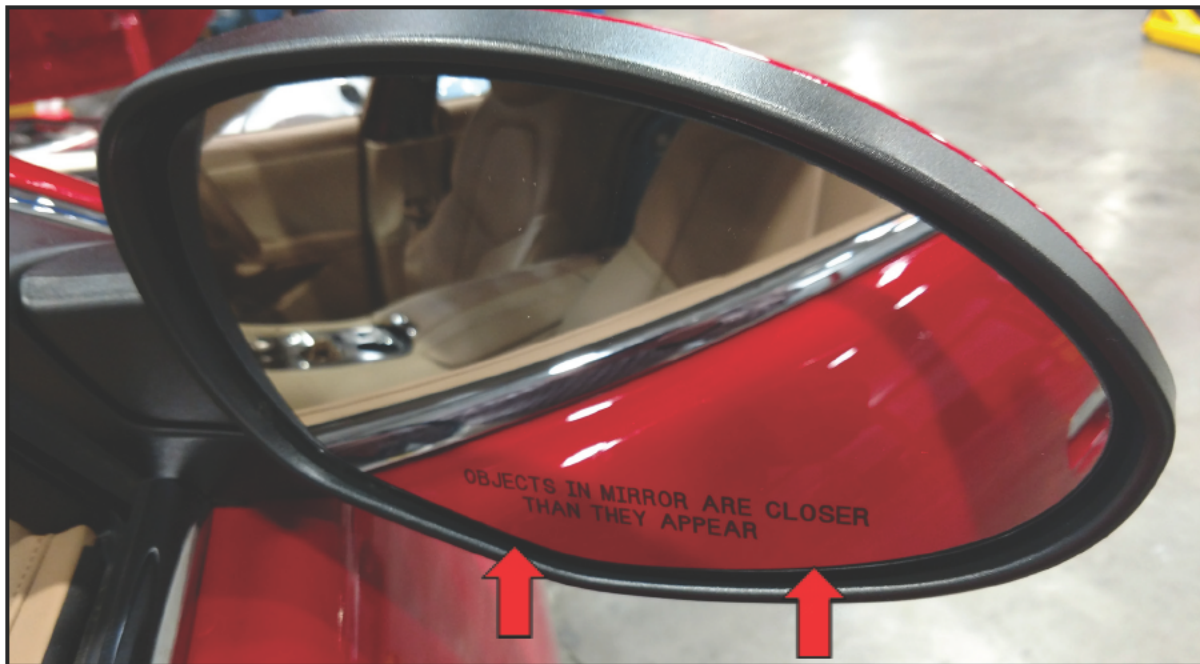
fig.4

Inspect the right-hand side Exterior Rearview Mirror Glass, this should display the appropriate text as “**Objects in Mirror Are Closer Than They Appear**” (fig.4). Capture an image of this finding for warranty and the TSS case.

If this is found to be incorrect, replace with C131166001600- RH Glass Case Sub-Assembly. This is done in the same manner as the left-hand side Exterior Rearview Mirror Glass, by snapping it out, and snapping the correct part in place. Removal and replacement if necessary is the same procedure as the left-hand side.
