Product Safety Recall

18278 Brake Pedal Pivot Bolt

Reference Number: N182165530

Release Date: September 2018
Revision: 00

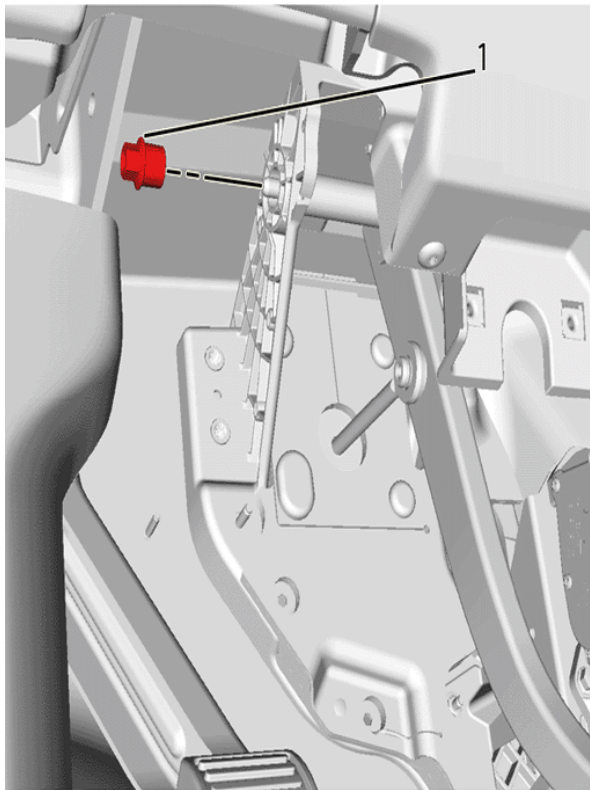
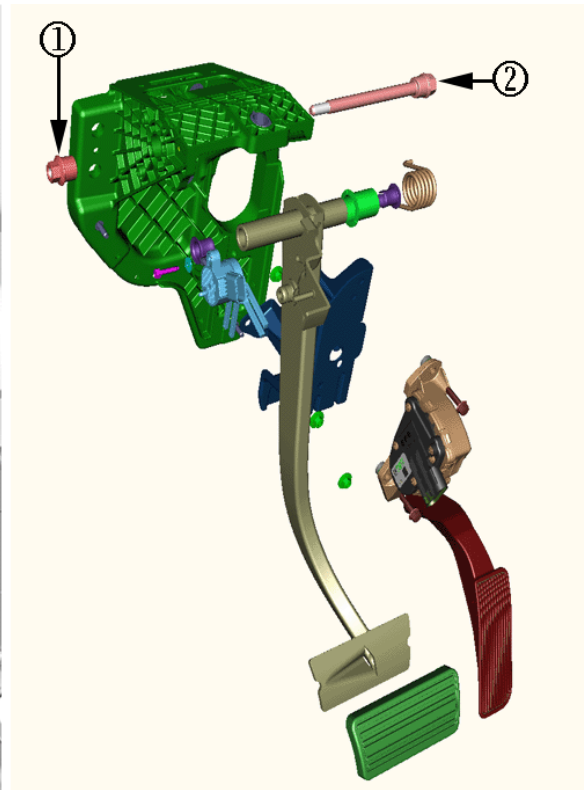
4404322

Caution: Apply pressure to the brake pedal pivot bolt while removing the nut to ensure the bolt does not back out of the housing. Part damage could occur if the bolt backs out of the housing.

Note: The bolt may be facing either direction, not necessarily the direction shown above. Do NOT attempt to reorient the bolt and nut if they are not facing the direction shown in the photo – only apply Loctite to the nut and torque to specification as described below.

4. Holding the brake pedal pivot bolt (2) with a box end wrench, remove the brake pedal pivot nut (1).

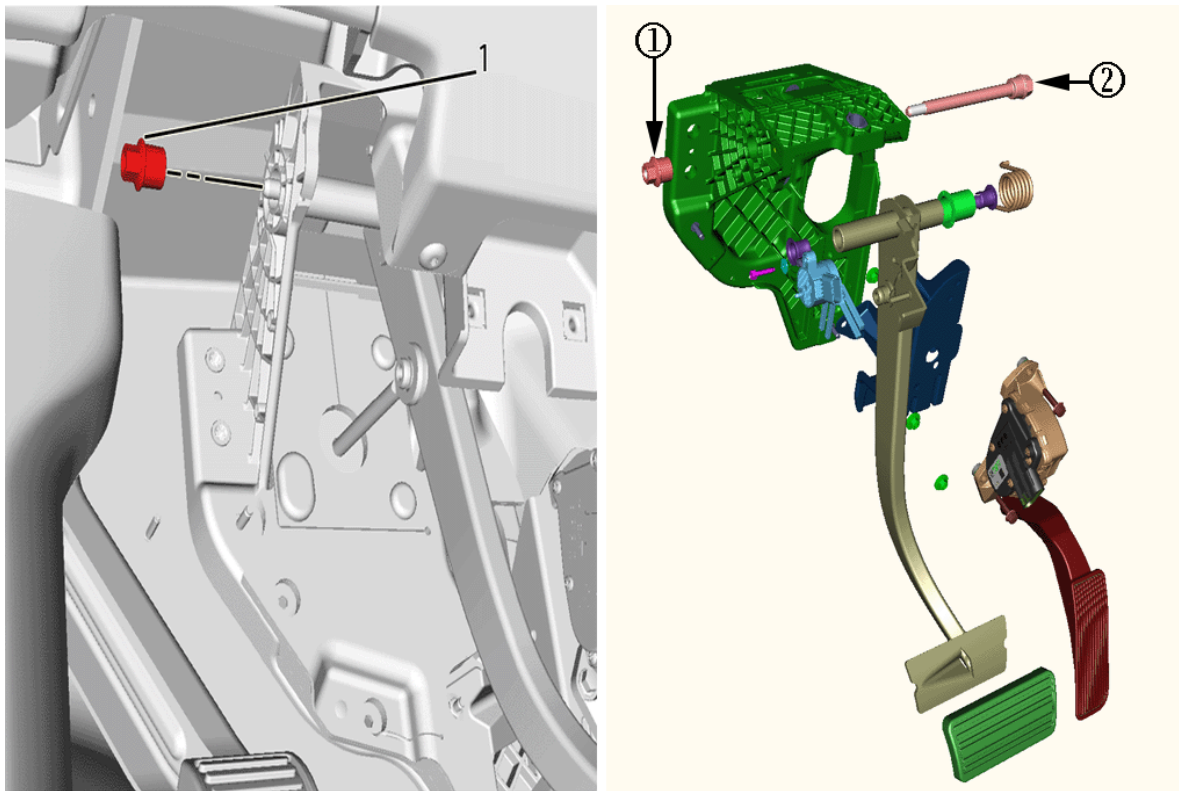
4404322

Caution: Apply pressure to the brake pedal pivot bolt while installing the nut to ensure the bolt does not back out of the housing. Part damage could occur if the bolt backs out of the housing.

6. Holding the brake pedal pivot bolt (2) with a box end wrench, install the brake pedal pivot nut (1).
7. Holding the brake pedal pivot bolt with a box end wrench, torque the brake pedal pivot nut to 26 Nm (19 lb ft).
