# Product Safety Recall

## 18278 Brake Pedal Pivot Bolt

**Reference Number:** N182165530

**Release Date:** September 2018  
**Revision:** 01

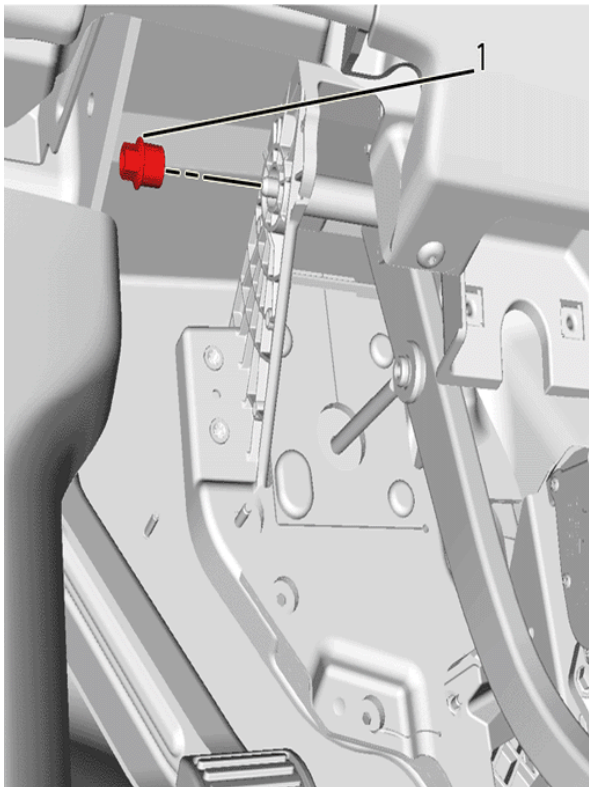
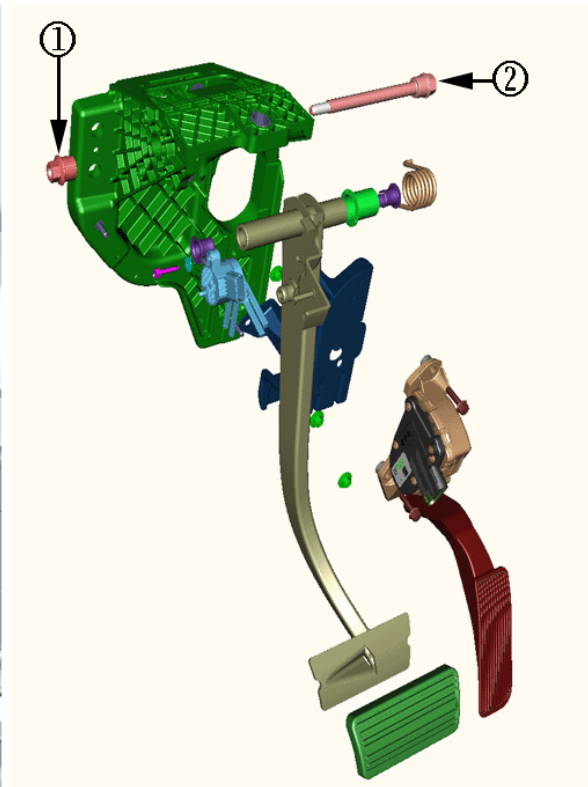
4404322

**Caution:** Apply pressure to the brake pedal pivot bolt while removing the nut to ensure the bolt does not back out of the housing. Part damage could occur if the bolt backs out of the housing.

**Note:** The bolt may be facing either direction, not necessarily the direction shown above. Do NOT attempt to reorient the bolt and nut if they are not facing the direction shown in the photo – only apply Loctite to the nut and torque to specification as described below.

4. Holding the brake pedal pivot bolt (2) with a box end wrench, remove the brake pedal pivot nut (1).

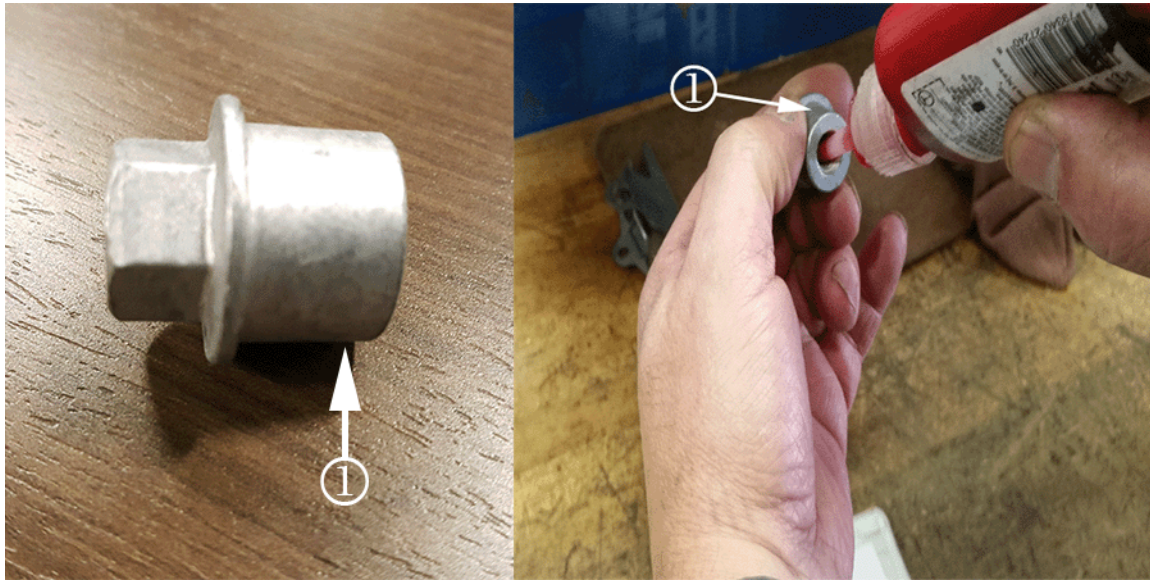
5141084

**Note:** Do NOT get threadlocker on the exterior of the brake pedal pivot nut. The exterior of the brake pedal pivot nut must be kept clean of threadlocker.

5. Holding the nut horizontally, apply two drops of red threadlocker to the threads in the collar portion (1, opposite the hex end) of the nut.

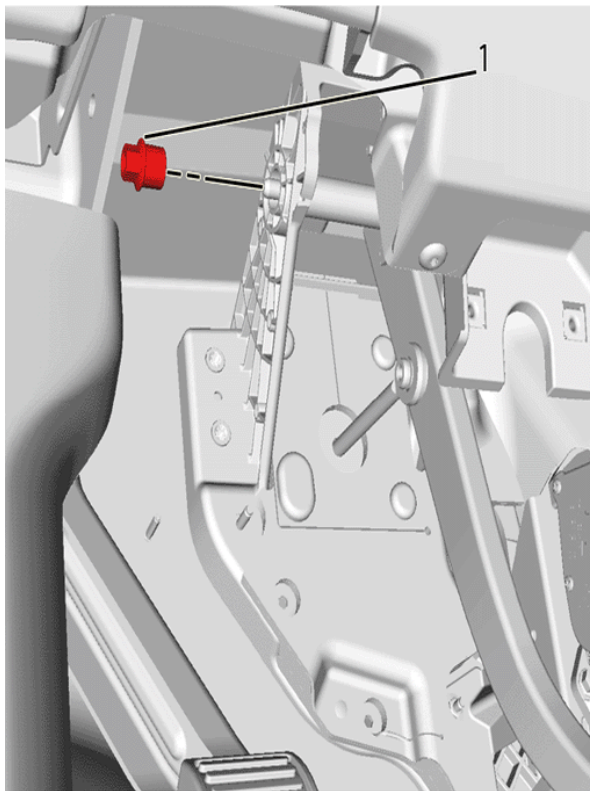
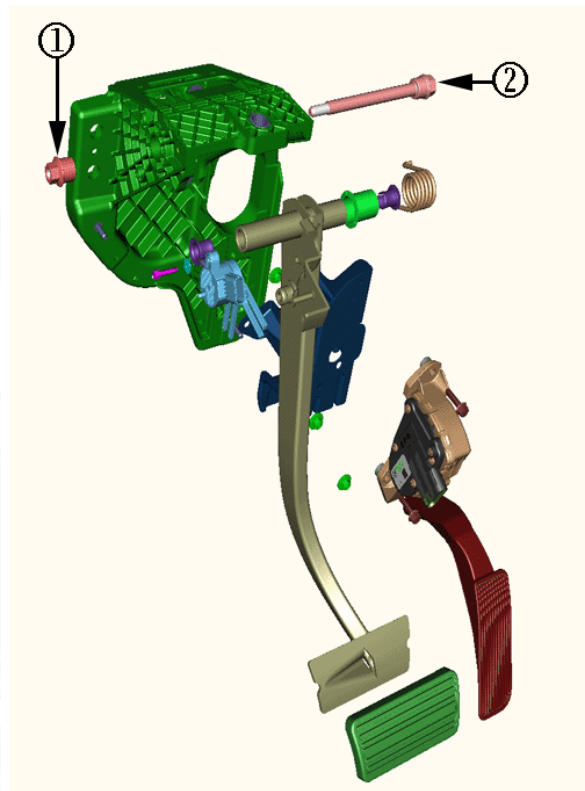
4404322

**Caution:** Apply pressure to the brake pedal pivot bolt while installing the nut to ensure the bolt does not back out of the housing. Part damage could occur if the bolt backs out of the housing.

6. Holding the brake pedal pivot bolt (2) with a box end wrench, install the brake pedal pivot nut (1).
7. Holding the brake pedal pivot bolt with a box end wrench, torque the brake pedal pivot nut to 26 Nm (19 lb ft).
