Terex Utilities	
SAFETY NOTICE	SN-669

Models Affected: Digger Derricks

SUBJECT: Pole Guide Bar 450543

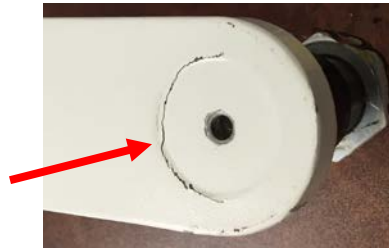
Figure 1 - Example of a crack

The 450543 Guide Bar attaching the pole guide arms to the pole guide tilt bracket may have an issue with weld quality on units built from May 18, 2017 to August 30, 2018. If the weld is not sufficient the stud holding the pole guide arm can detach. **If the weld fails, the guide arm can fall and may cause injury to ground personnel.**

1. Inspect for cracked welds as shown in figure 1 below. If cracks are found, remove the part from service. Contact Terex Utilities as noted below.
2. Inspect the digger derrick pole guide bar 450543 by comparing to the pictures below. If the bar has a grease zerk on the bar side and flush with the surface it is subject to this bulletin.

Contact Terex Utilities through your nearest TEREX Utilities dealer as shown on the web site, terexutilities.com, call Terex Utilities at 844-837-3948 or by email at utilities.warranty@terex.com to arrange for replacement of affect guide bars within 30 days of receiving this bulletin.

Terex will provide a replacement guide bar.

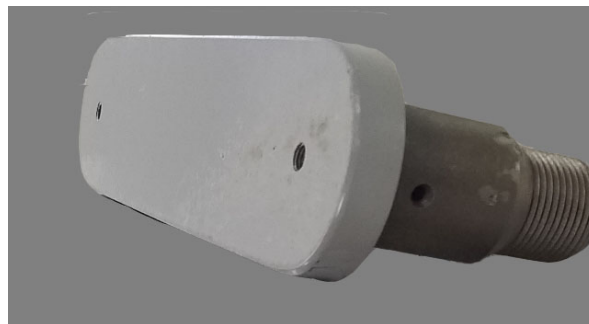
1. The grease zerk will be on the upper side above the pole guide arms and the surface is flat.
2. The top surface of the bar will be nearly flat with a milled counterbore (recessed area) for the grease zerk.

Zerk flush to top surface

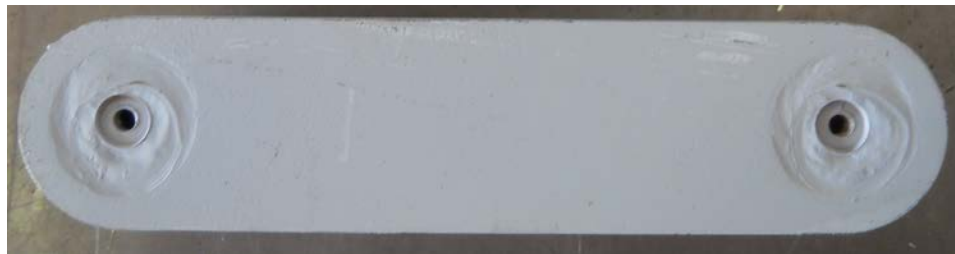
Zerk counterbored on bar side

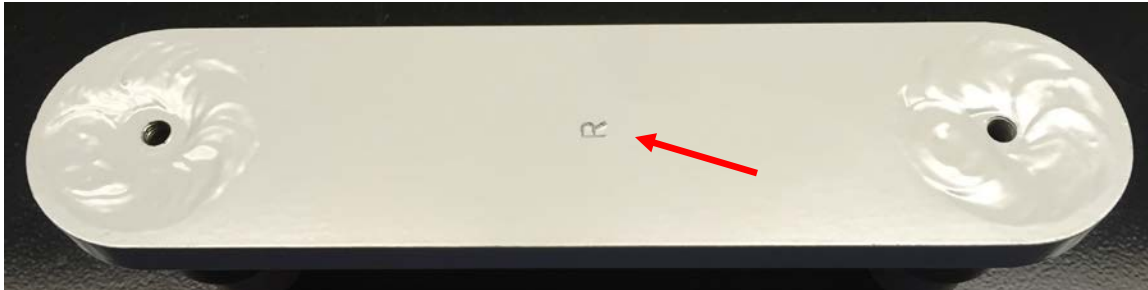
- 1. Weldments with one to four stamped marks on the top of the bar are older production or have been repaired.

Reworked stamped R, B, or four stamped letters

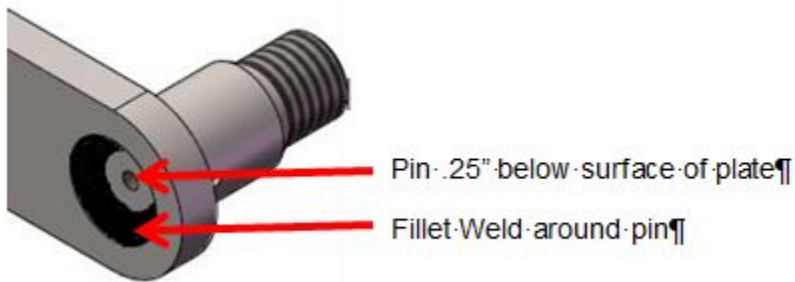
- 2. Weldments with a fillet weld around the pin and the top of the pin recessed below the surface of the bar.

Fillet weld around recessed pin

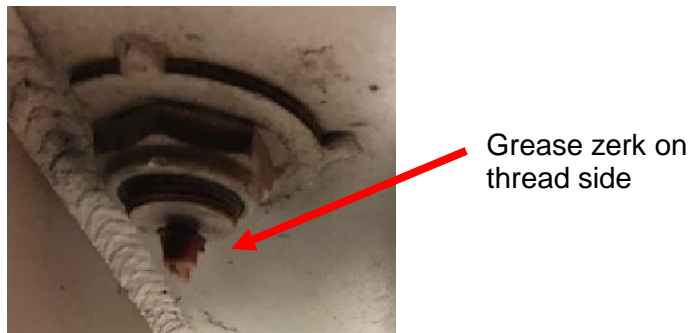
- 3. The zerk is on the threaded side next to the nut, or there is no zerk on either end of both pins.

Grease zerk on thread side
