# Product Safety Recall

## N182198820 Passenger Airbag Underinflated

Release Date: December 2018

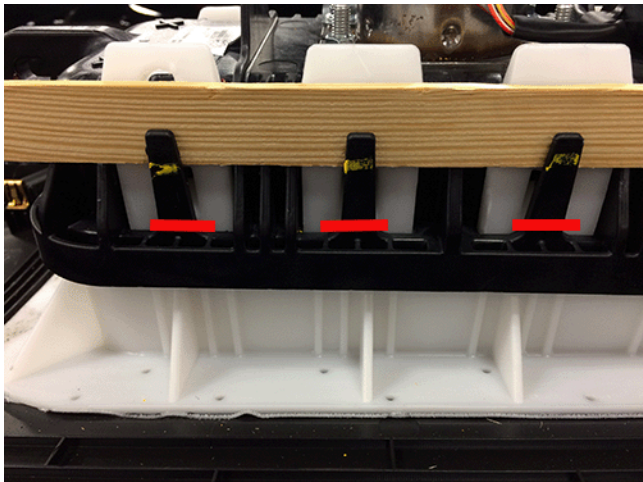
5185382

**Cut slots in all eight black tabs, cut area indicated in red.**

When removing the airbag from the instrument panel, it may be difficult to release the black tabs from the bracket. Use a small cut off wheel such as a Dremel tool to cut a slot in the black tab near the base, this will relieve the tension on the tab. **Use extreme care to not cut into the white bracket on the instrument panel.**
