Reference Number: N161644422

Front Passenger Air Bag Module Replacement

Product Safety Recall 17478 Front Passenger Air Bag Inflator

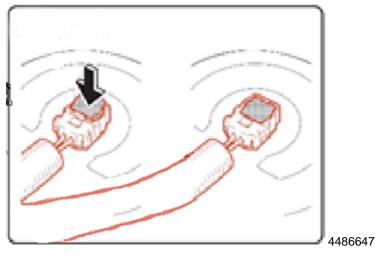
4.2. Reengage the tangs of the module into the door using the screwdriver with the shaft wrapped in tape.

- 4.3. Connect the new harness to the new module.
- 4.4. Press the lock tab down.
