Product Safety Recall

17478 Front Passenger Air Bag Inflator

Reference Number: N161644422

Release Date: December 2018
Revision: 00

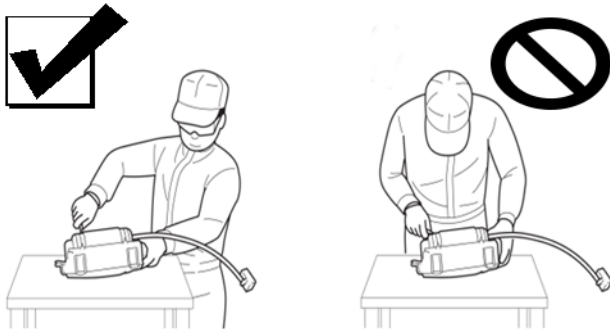
4751076

Warning: Confirm the stopper plate to inflator fitment is correct. *DO NOT* pinch the harness between the inflator and the stopper plate.

Warning: When working with the air bag module, avoid standing directly in front of the parts.

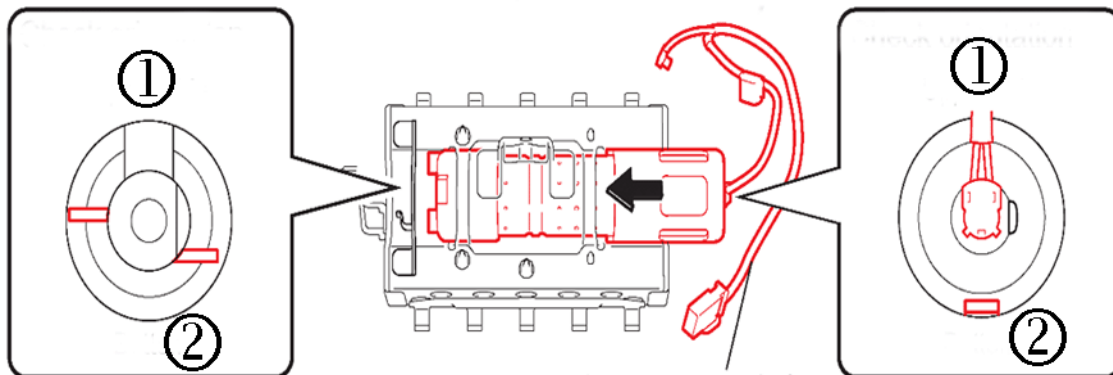
4751078

Important: DO NOT insert the inflator fully.

4. Insert a NEW inflator to the center of the air bag case with the correct orientation as shown (1) Upper side (2) Bottom.
 - If the passenger air bag inflator is upside down, it will not be able to be fully inserted.
