SB190-18

Diego External Backup Warning Device Isolation Switch Removal (Ref. FSI 1240)

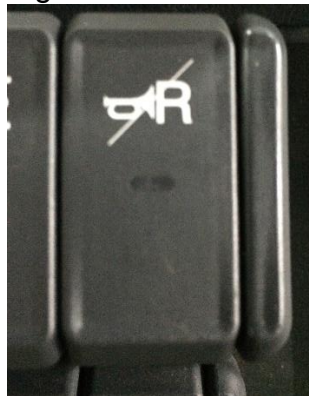
Fig.1

Diego vehicles have been fitted with an external backup warning device isolation switch (see fig.1) which is required to be removed in order to comply with regulations.

AS A TEMPORARY MEASURE THE SWITCH MUST NOT BE USED

Dennis Eagle Inc. will be contacting customers to arrange carrying out the re-work on affected vehicles which is to simply remove the switch to prevent the external backup warning device from being isolated and replace it with a blanking cover.
