Please read before repairing and submitting a 2718F Curtain Air Bag Claim

CONDITION OF CONCERN

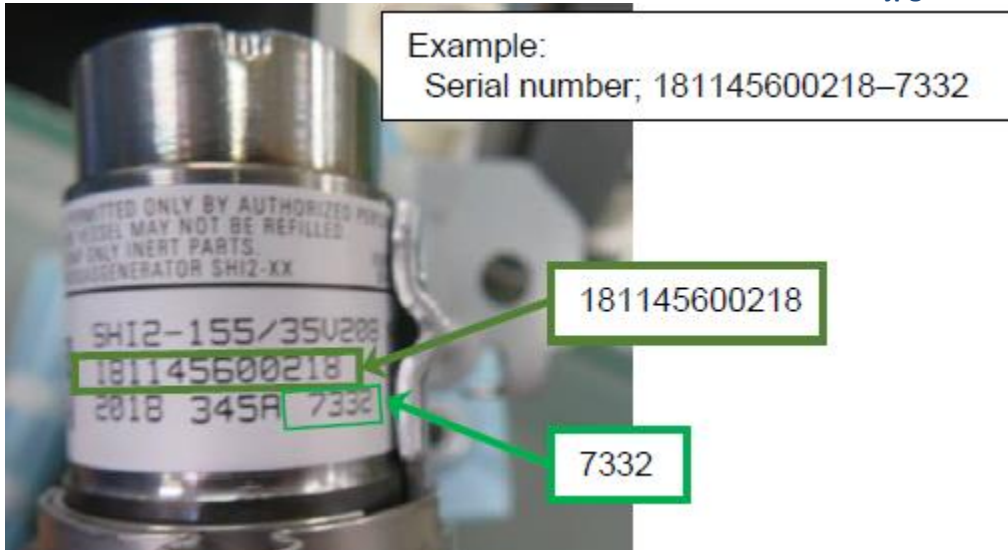
1. A clear photo of the **ORIGINAL** inflator(s) (right, left, or both) where the complete serial number is viewable. Save the photo as Claim_xxxxx – Original Inflator Left and/or Claim_xxxxx – Original Inflator Right. Attach one or both photos to the claim using Attachment ID D40. **IF THE PHOTO IS BLURRY OR THE ENTIRE SERIAL NUMBER CANNOT BE READ, RETAKE THE PHOTO AND ATTACH TO THE CLAIM. DO NOT USE LONG FILE NAMES USE RO45221L.jpg AS EXAMPLE**

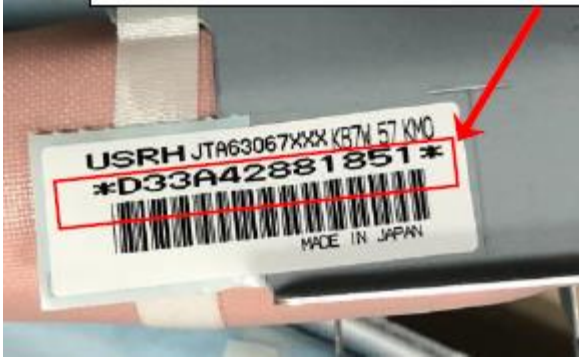
2. Clear photos of the new inflator (right, left, or both) showing the complete serial number. Save the photo as Claim_xxxxx – New Inflator Left and/or Claim_xxxxx – New Inflator Right. Attach one or both photos to the claim using Attachment ID D40. **IF THE PHOTO IS BLURRY OR THE ENTIRE SERIAL NUMBER CANNOT BE READ, RETAKE THE PHOTO AND ATTACH TO THE CLAIM. TECHNICIAN – CHECK YOUR PHOTO BEFORE REINSTALLING THE HEADLINER. MAKE SURE THE SERIAL NUMBER IS FULLY VISIBLE AND EASY TO READ**
