A. INTERIM VEHICLE INSPECTION PROCEDURE UNTIL PARTS ARE AVAILABLE

2009 Mazda6 (HP) and 2010 Mazda6 (HZ) vehicles, which were originally sold in, or currently or previously registered in Salt Belt States listed below.

B. CROSS MEMBER INSPECTION PROCEDURE 2009-2010 MAZDA6

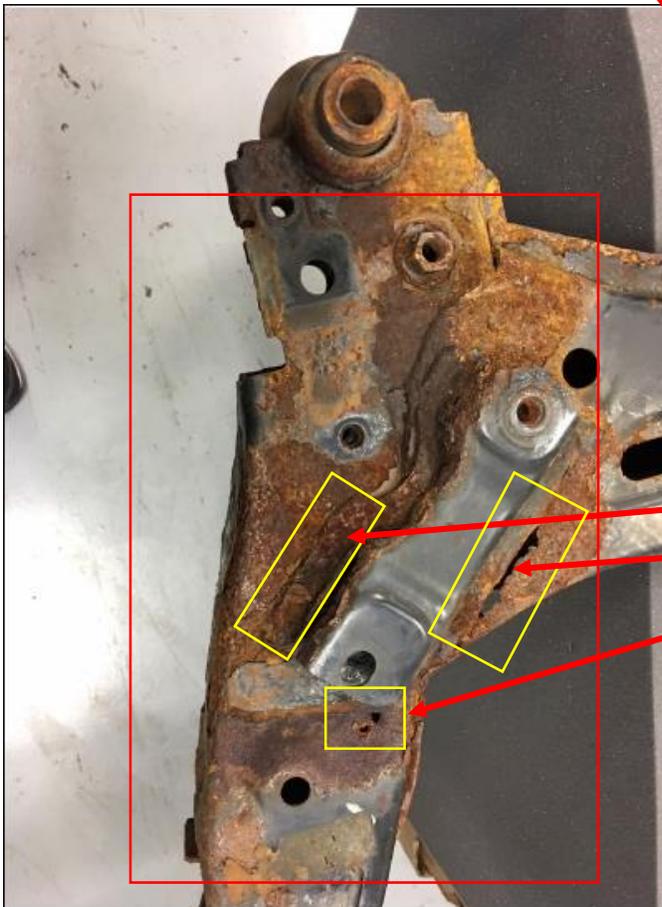
Zone 1 inspection Area: Top Surface

Look for holes or cracks along the top surface in these areas. If a hole or crack is present, the cross member needs to be replaced. This cross member fails inspection as there is perforation

If the cross member fails inspection in this Zone, take a clear photo showing the failure. You will need it for later.

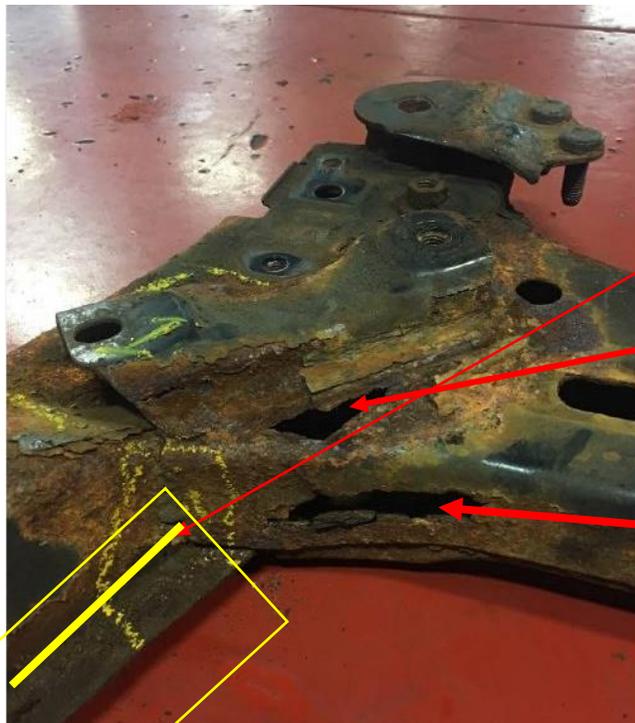
Zone 2 inspection Area:

Look for perforation or crack along the flange in this area. If a crack or perforation is present, replace the cross member.

Top side Zone 1 Failure due to perforation. Replace

Corrosion or a hole in this area does not compromise the structural integrity of the cross member, however this cross member will fail a state safety inspection due to perforation so we need to replace the cross member

If the cross member fails inspection in this Zone, take a clear photo showing the failure. You will need it for later.

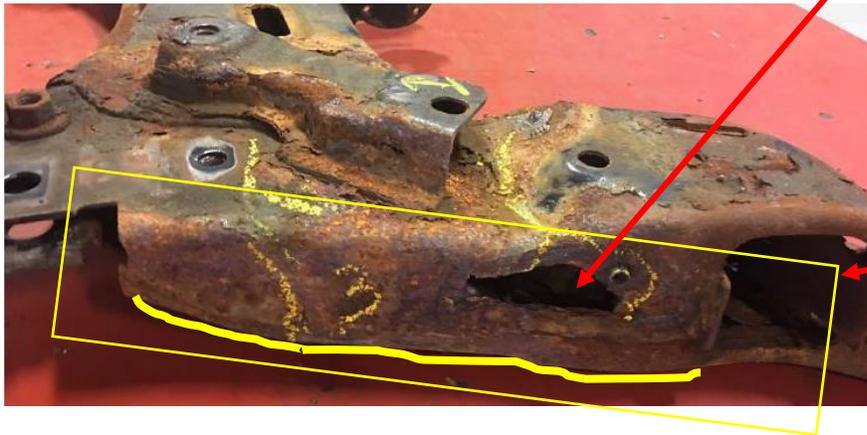
This cross member passes inspection even with the perforation as the bracket supports and covers the hole. If perforation is visible beyond what the bracket covers, the cross member must be replaced as it will fail a state safety inspection for perforation.

If the cross member fails inspection in this Zone, take a clear photo showing the failure. You will need it for later.

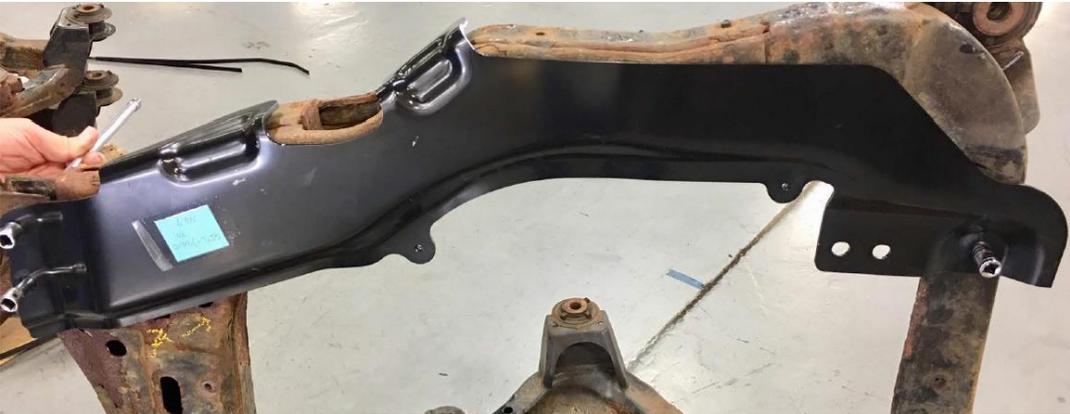
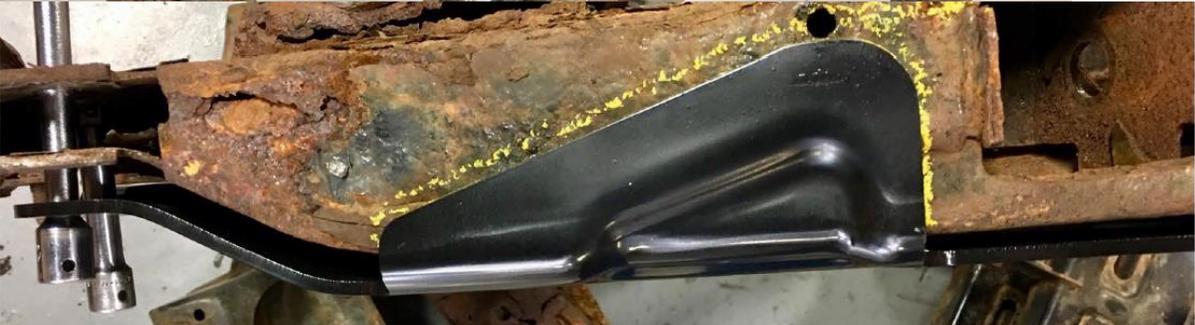
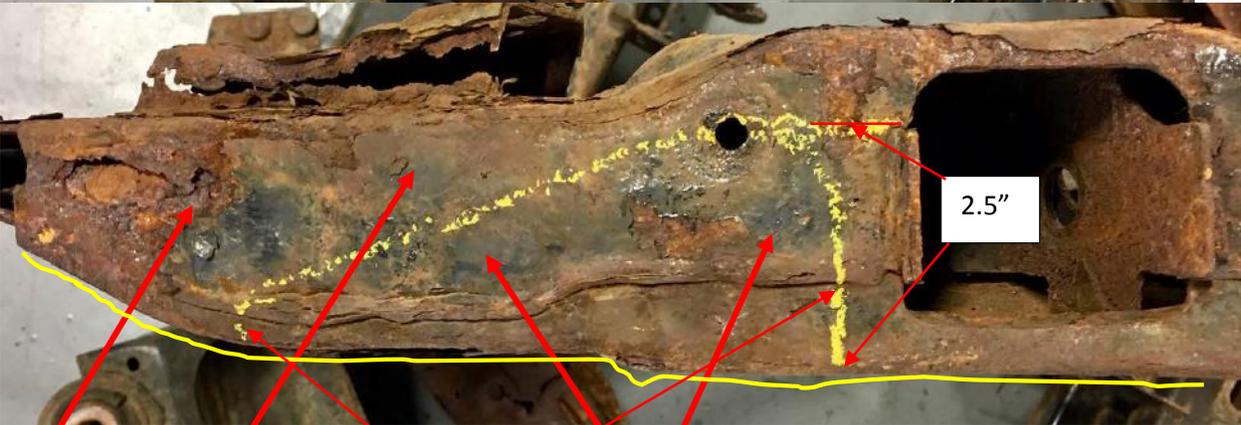
Photos of the bracket installation

Perforation in this area is not covered by the bracket and will fail State Inspection.

6.5 " Perforation in this area is covered by the bracket and is ok to use the cross member.
