A. VEHICLE INSPECTION PROCEDURE

2009 Mazda6 (HP) and 2010 Mazda6 (HZ) vehicles, which were originally sold in, or currently or previously registered in Salt Belt States listed below.

B. CROSS MEMBER INSPECTION PROCEDURE 2009-2010 MAZDA6

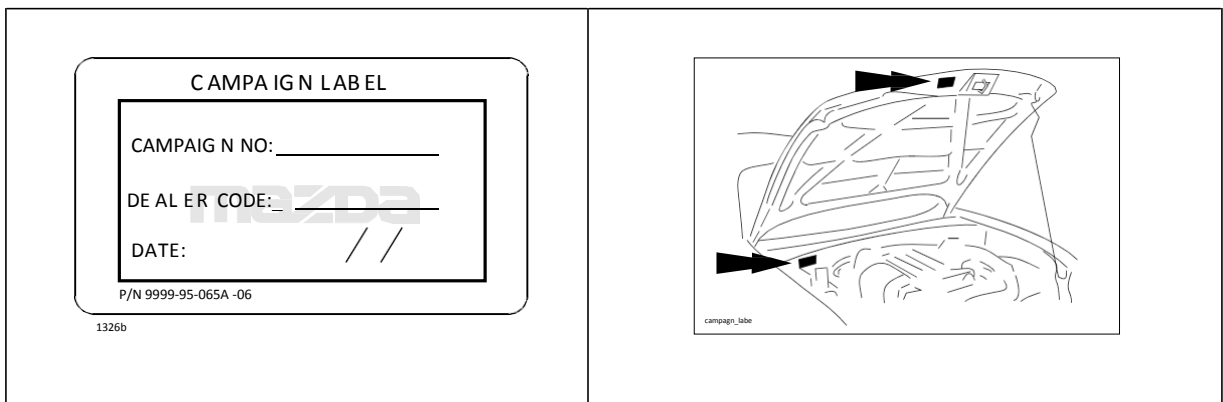
Perform a Warranty Vehicle Inquiry using your eMDCS System and inspect vehicle for Campaign Labels **Recalls 2818I** attached to the vehicle’s hood or bulkhead. Refer to eMDCS System - Warranty Vehicle Inquiry Results table below.

NOTE: Be sure to verify Recall number as the vehicle may have multiple Recall labels.

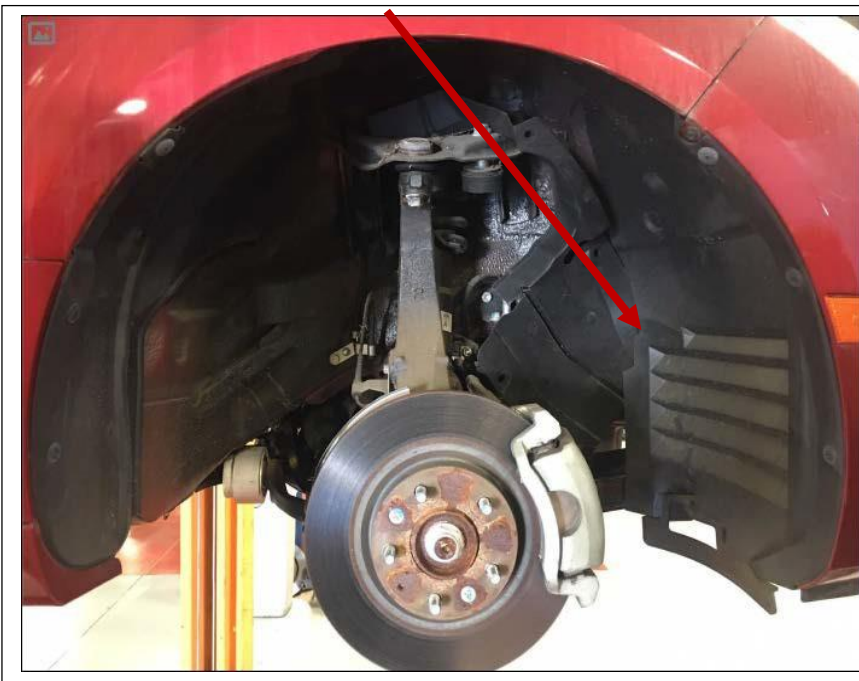
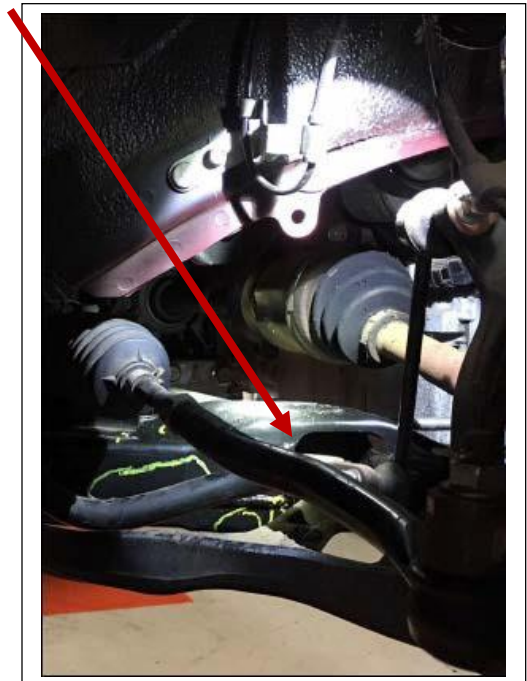
- A. Remove the right front tire.
- B. Remove **visible** clips of side cover of right front tire house.
Then bend the side cover so that Inspection point Zone No.1: Upper surface of the cross member can be seen

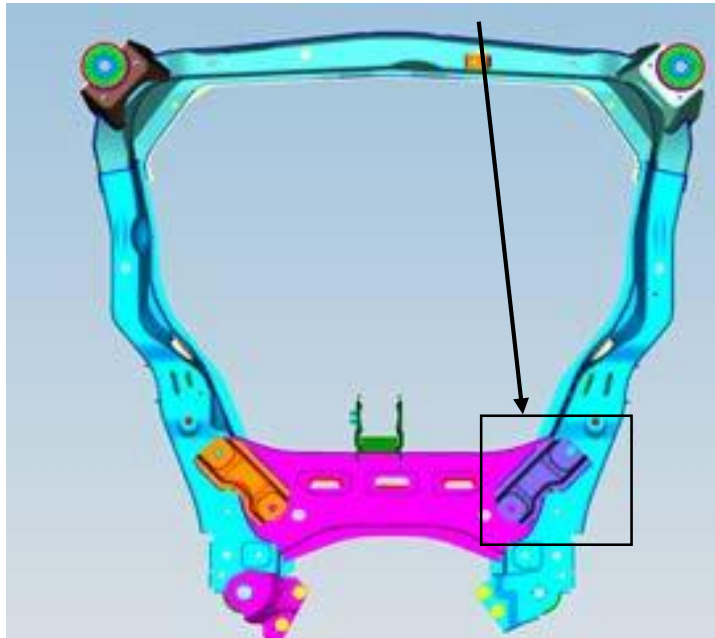
Top View – Area affected (Right Top Side)

On certain subject vehicles in salt belt states, it is possible that the front cross member may be corroded due to possible insufficient paint coating. Corrosion may be more severe on the portion just under the air conditioner drain, causing a perforation.

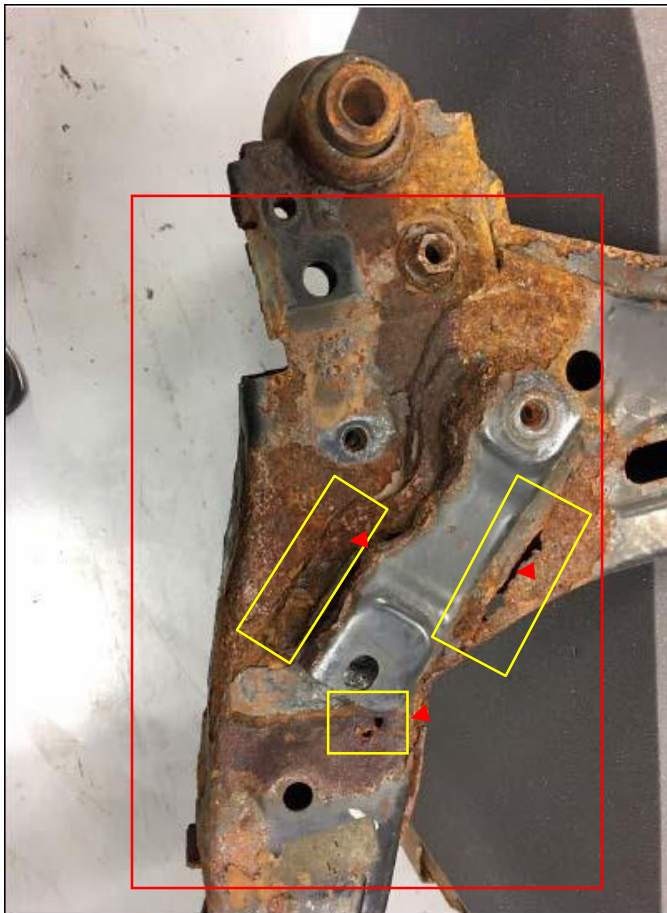
Top View: Used Cross member

Zone 1 inspection Area: Top Surface

Look for holes or cracks along the top surface in these areas. If a hole or crack is present, the cross member needs to be replaced. This cross member fails inspection as there is perforation

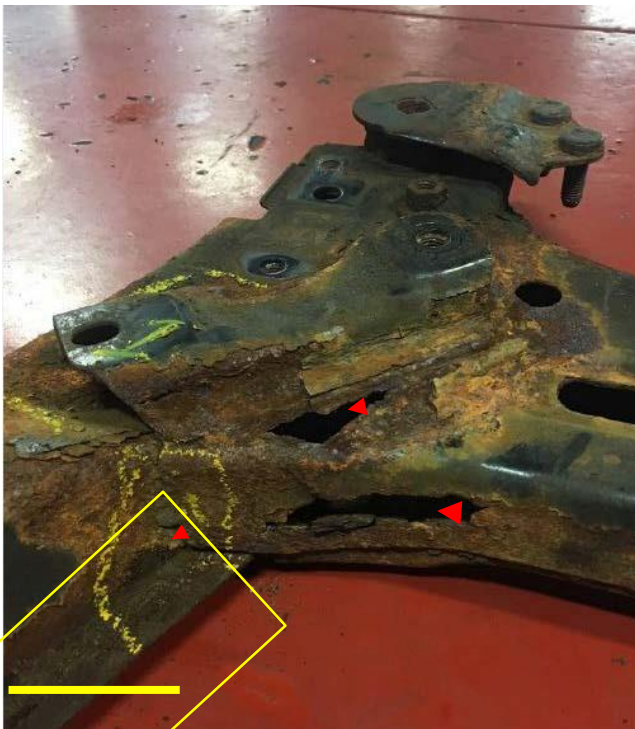
Inside Top View: Damaged Cross member

Zone 2 inspection Area:

Look for perforation or crack along the flange in this area. If a crack or perforation is present, replace the cross member.

Top side Zone 1 Failure due to perforation. Replace

Corrosion or a hole in this area does not compromise the structural integrity of the cross member, however this cross member will fail a state safety inspection due to perforation so we need to replace the cross member

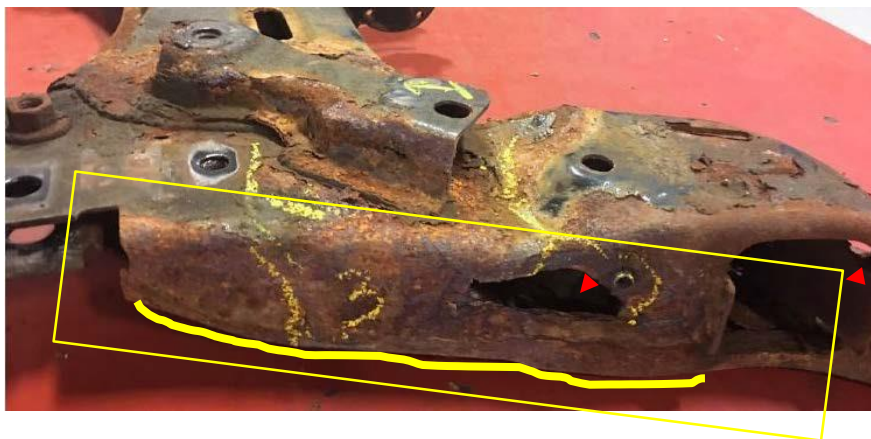
Top Side View: Damaged Cross member

Zone 3 inspection Area:
Look for perforation especially along the bottom corner ridge line (this area). If perforation or a crack is present the cross member needs to be replaced.

This cross member passes inspection even with the perforation as the bracket supports and covers the hole. If perforation is visible beyond what the bracket covers, the cross member must be replaced as it will fail a state safety inspection for perforation.

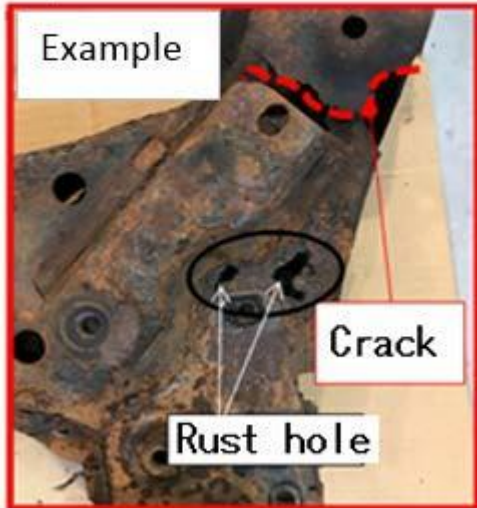
Zone No 1: Upper

If even one hole exists at these points Zone No.1 to Zone No.3, the vehicle needs replacement of the cross member.

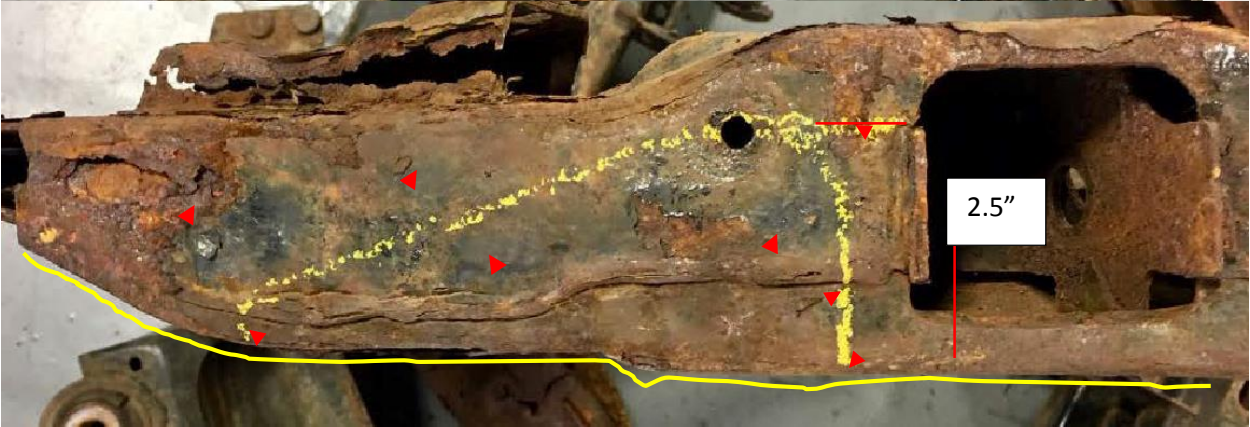
Photos of the bracket installation

Perforation in this area is not covered by the bracket and will fail State Inspection.

6.5 " Perforation in this area is covered by the bracket and is ok to use the cross member.

Meanwhile, even if there are holes at other places, except holes at Zone No.1 to Zone No. 3 points, the vehicle doesn't need replacement of the cross member. Instead, the subject vehicle will require the installation of the reinforcement side member and the A/C drain hose and wax application.
