**From:** Speir, Randall  
**Sent:** Tuesday, April 16, 2019 9:40 AM  
**To:** 'ceatherly@pedistributors.com' <[ceatherly@pedistributors.com](mailto:ceatherly@pedistributors.com)>  
**Cc:** [rsosnoff@scottlewisinc.com](mailto:rsosnoff@scottlewisinc.com)  
**Subject:** Subject: IMPORTANT SAFETY RECALL NOTICE: ACTION REQUIRED (NHTSA Recall # 19E012)  
**Importance:** High

## Ultimate Dana 44™ Front Axle Pinion Lube Check Procedure

## IMPORTANT SAFETY RECALL

*Re: NHTSA Recall # 19E012*

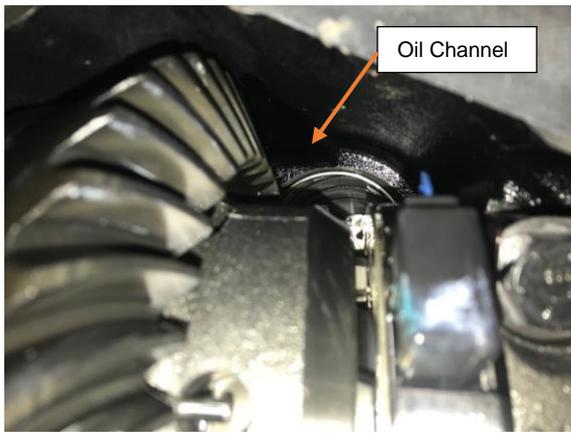
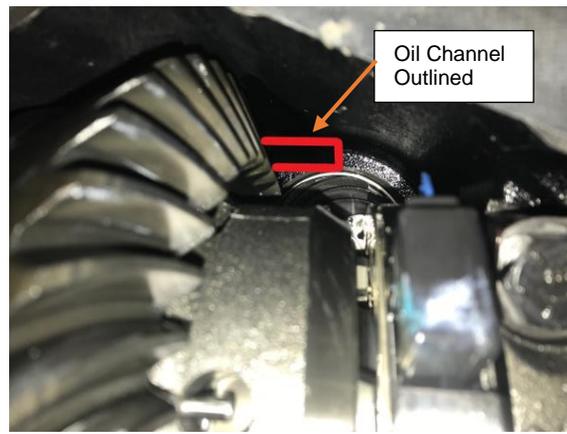
4. Remove the cover and gasket, and set them aside. Both will be reused.
5. Reinstall the drain plug in the axle housing.
6. Use a light and identify the pinion oil feed channel behind the differential, above the pinion. A reference picture appears below:

Axles subject to this notice can experience a pinion tail bearing seizure. In that event, the axle may not be able to rotate, which could affect a vehicle operator's control. This increases the risk of a crash without prior warning.

7. Use 8-12 inches of rubber tubing on the end of a standard gear oil bottle with a tapered spout. Feed the tube into the pinion oil feed channel identified above, and add oil to this channel. It should require .25 quarts of oil before the oil begins to drain back into the sump. Once the oil starts draining out, stop filling with oil.
