Bentley
Bulletin

19-008

Subject: RECALL CAMPAIGN – Bentley Mulsanne Rear Seat Belt Anchorage Plate (RE19/01)

Topic	Mulsanne - Rear seat belt anchor plate installation (RE19/01)
Market area	Bentley: worldwide (2WBE),Hongkong-Macau (5HK)
Brand	Bentley
Transaction No.	2052868/1
Campaign number	RB15
Note	
Type	
US code

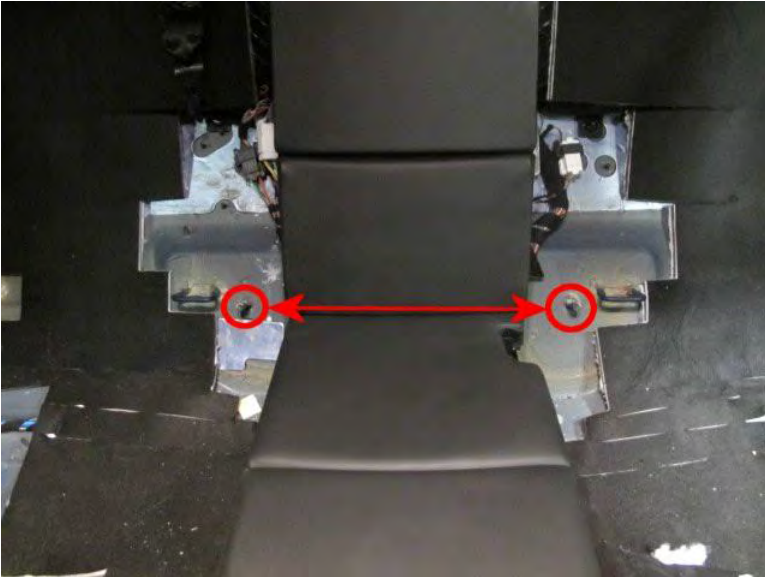
The right and left hand inner rear seat frame studs as shown in Figure 1 are located on opposing sides of the propshaft tunnel, the studs are used to locate and secure the rear seat frames, centre seat belt buckle and the seat belt anchor to the rear floor panel

Both studs require removal, once removed the installation of pre-assembled plates is required to the left and right hand side

The installation of left and right hand plates is required for remedy, the replacement seat frame studs are an integral part of the plates

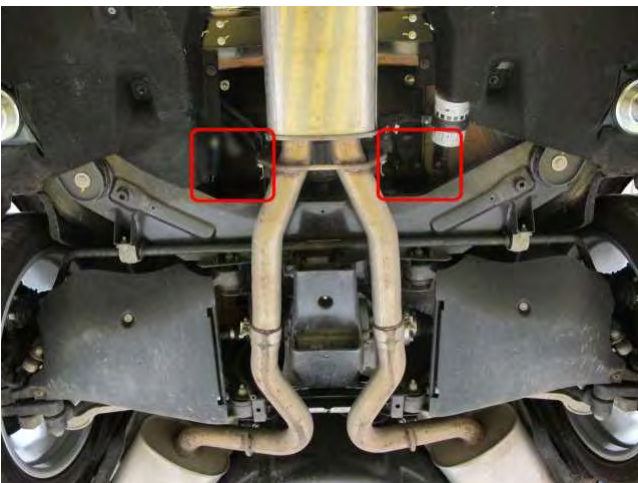
Figure 2

Referring to Figure 2, conduct a visual inspection of the rear floor panel using the left and right hand access points shown, the operative should look directly above the front section of the rear subframe, the rework status can be easily identified by the colour of the underseal which is applied

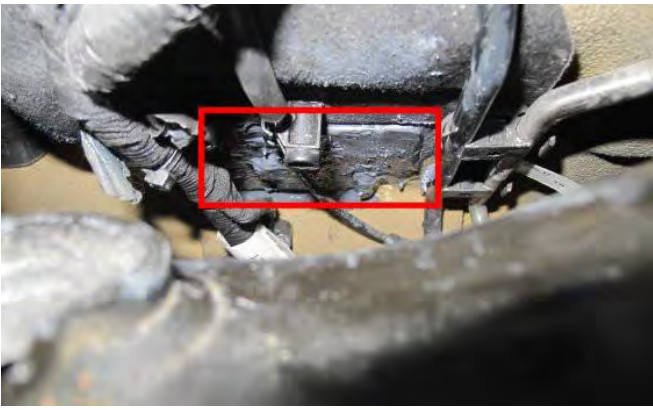
- Referring to Figure 3 - Should light grey underseal be found to be applied to the floor panel on the left and right hand sides, the plates have already been fitted, no further action is required (For clarity Figure 3 shows the left hand side), *please submit a Warranty claim via SAGA for a total of 10 Time units, this will ensure the VIN is removed from the applicability list*

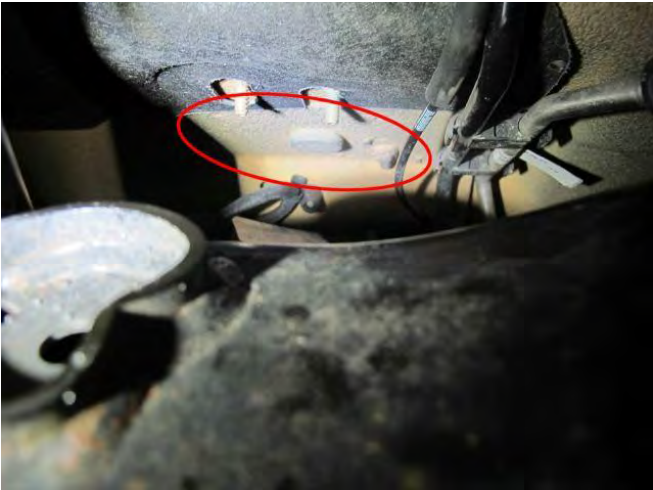
- Referring to Figure 4 - Should the rear floor panel **NOT** have any light grey underseal evident and has the standard beige underseal applied the rework **HAS NOT** been conducted therefore carry out the rework procedure as detailed within this document

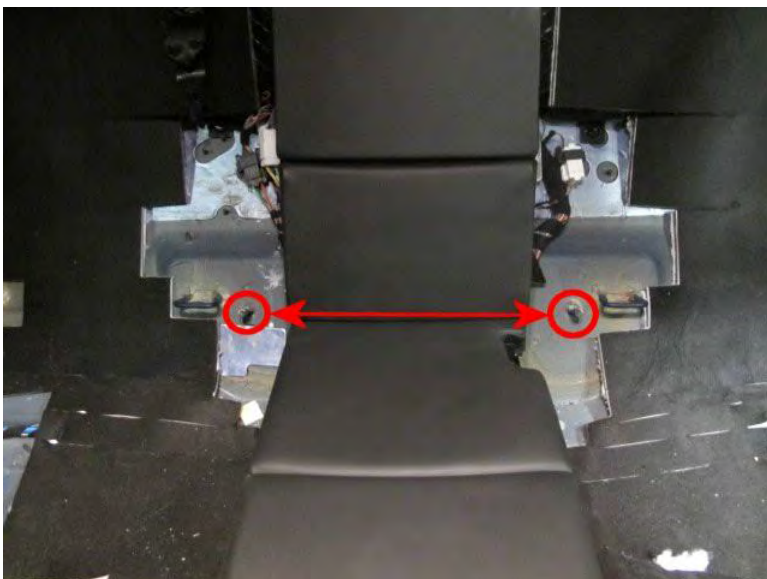
The right and left hand inner rear seat frame studs as shown in Figure 1 are located on opposing sides of the propshaft tunnel, the studs are used to locate and secure the rear seat frames, centre seat belt buckle and the seat belt anchor to the rear floor panel

Both studs require removal, once removed the installation of pre-assembled plates is required to the left and right hand side

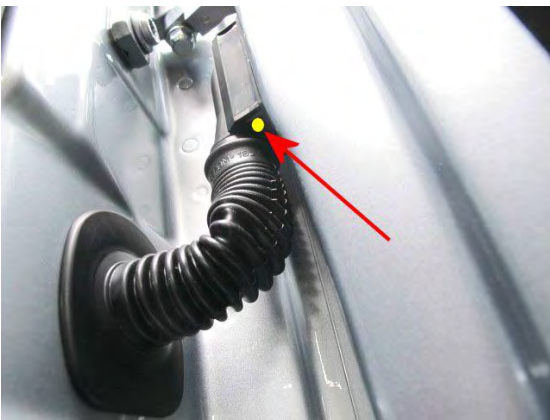
Figure 36

Yellow paint mark on the underside of the left hand rear door harness connector (Figure 36)

16) Apply a Yellow paint mark on the underside of the left hand rear door harness connector (Figure 36)
