January 18, 2019
Subject: Recall R89910
TO: All U.S. and Canadian Volvo Retailers

**R89910: Tailgate Lift Arms (Drive Units)
Model Year 2018 – 2019 XC60**

Title	Inspection and replacement of "drive units", tailgate lift arms	Page:	1 (5)
Action

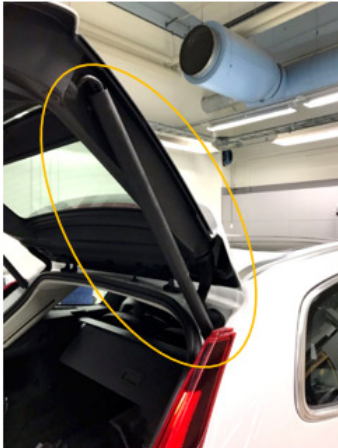
Condition 1, OK

-Condition 1, replace the lifting arms according to VIDA VCC-370949-5.
