TO: Mercedes-Benz Dealer Principals, General Managers, Sales Managers, Service Managers, Parts Managers	FROM: Heike Scheuble, General Manager, Aftersales
RE: Recall Campaign Notification MY19 907 (Sprinter) Bolt Connection between Steering Shaft and Steering Gear	DATE: January 28, 2019

Campaign No. 2019010006, January 2019

SUBJECT: **Model 907 (Sprinter), Model Years 2019**
Bolt connection between steering shaft and steering gear

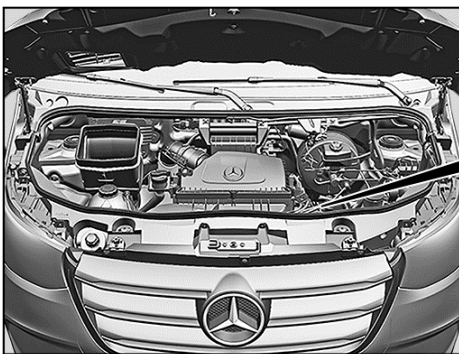
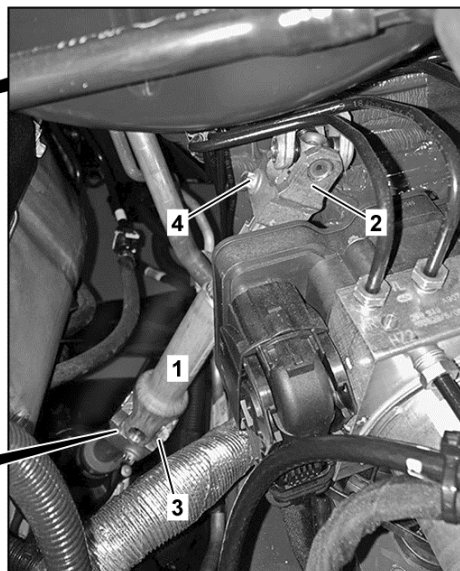
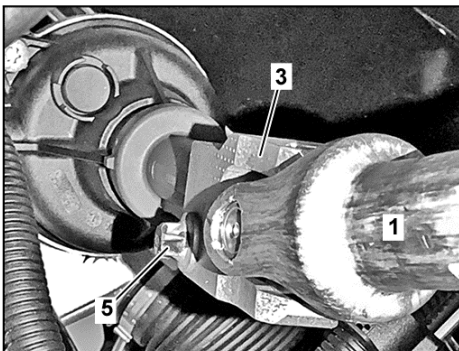
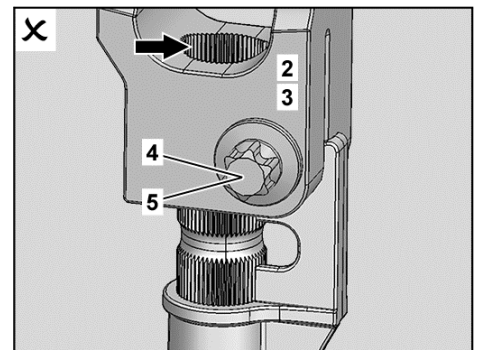
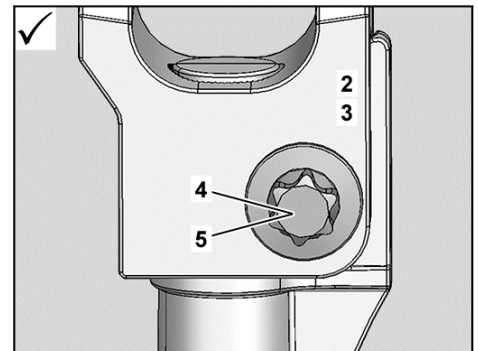
- 1 Steering shaft
- 2 Universal joint
- 3 Universal joint

- 4 Screw
- 5 Screw

2	Check threaded connection at universal joints (2, 3)	<p>Check, whether screws (4, 5) installed. To do this, turn in the steering until the respective screw (4, 5) is visible and accessible. Then check both universal joints (2, 3) for correct seating (see picture). The gearing (arrow) must not be visible.</p> <p>Screw steering shaft at bottom of steering gear</p> <p>Screw steering shaft to steering shaft bearings</p> <p>If one or both screws (4, 5) are installed and the respective universal joint (2, 3) is correctly aligned,</p> <p style="text-align: center;">↓</p> <p>tighten the respective screw (4, 5). If the universal joint (2) or universal joint (3) is not aligned correctly,</p> <p style="text-align: center;">↓</p> <p>align affected universal joint (2, 3) correctly, fasten and replace corresponding screw (4, 5). Remove and install lower steering shaft</p> <p>If one or both screws (4, 5) are not installed,</p> <p style="text-align: center;">↓</p> <p>correctly align respective universal joint (2, 3), fasten and subsequently screw in missing screw (4, 5) and tighten. Remove and install lower steering shaft</p>

3	Mark renewed or retightened screws on the screw head with green colour.

Number	Designation	Model 907, 910
BA46.10-N-1001-05TS	Screw steering shaft at bottom of steering gear Nm	28

Number	Designation	Model 907, 910
BA46.10-N-1004-05TS	Screw steering shaft to steering shaft bearings Nm	28
