February 4, 2019

**SUBJECT: NEW VEHICLE DEMONSTRATION / DELIVERY HOLD -  
Compliance Recall 19C02**  
Certain 2019 Model Year Ranger Vehicles  
Brake Transmission Shift Interlock Override – Wire Routing

## CERTAIN 2019 MODEL YEAR RANGER VEHICLES — BRAKE TRANSMISSION SHIFT INTERLOCK OVERRIDE – WIRE ROUTING

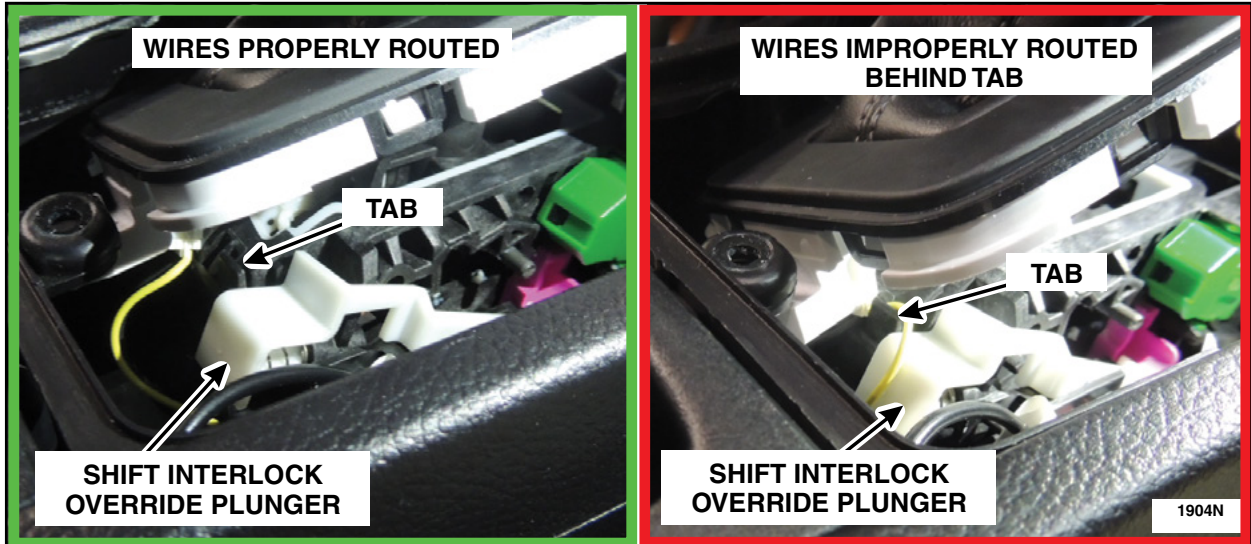
FIGURE 8

Some of the affected vehicles may not conform to the requirements specified by Federal Motor Vehicle Safety Standard (FMVSS) 114, theft protection and rollaway prevention. On some vehicles, improperly routed transmission floor shift selector wiring may interfere with the brake transmission shift interlock override plunger. This may prevent the shifter from locking in the park position, allowing the shifter to move without the key in the starting system and without depressing the brake pedal. If the park brake is not applied on the vehicle, this can result in unintended vehicle movement, increasing the risk of injury or crash.

8. Relocate the improperly routed yellow and/or black wires, that were holding down the shift interlock override plunger, to the correct position. See Figure 8.
