TO: Mercedes-Benz Dealer Principals, General Managers, Sales Managers, Service Managers, Parts Managers	FROM: Gregory Gunther, Department Manager, Vehicle Compliance and Analysis, Engineering Services
RE: Recall Campaign Launch Notification Replace Rear Seat Back MY18-19 156 (GLA-Class)	DATE: March 22, 2019

Campaign No. 2019030003, March 2019

SUBJECT: **Model GLA-class (156 platform)**
Model Year 2018-2019
Top Tether Rear Backrest Cover

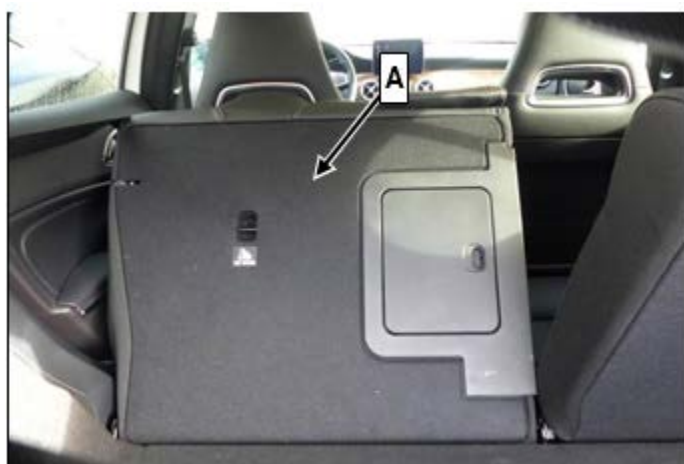
Figure 1

Daimler AG ("DAG"), the manufacturer of Mercedes-Benz vehicles, has determined that on certain Model Year ("MY") 2018-2019 GLA-class (156 platform) vehicles, an incorrect rear seat back covering (carpet) could have been installed on the split- rear seat back. As a result, the child seat anchorage point (top tether) on the center position of the rear seat would be covered and inaccessible for use. The customer might not be able to attach a child restraint system with the top tether anchorage point on the center position of the rear seat as described in the Operator's manuals. An authorized Mercedes-Benz dealer will check the rear seat back covers on the affected vehicles and replace them, if necessary.

3. Install new left rear seat backrest panel (**A, Figure 1**).

i To do this, pull cover of rear seat backrest around the backrest frame from the guide using an extraction hook and remove rear seat backrest panel.
