**Ditch  
Witch**<sup>®</sup>

Publication Number: ID0555609

## Safety Notice

<b>Affected Models</b>	<b>HX30, HX50, HX75 on VT24 trailers (see attached list for affected VINs)</b>
<b>Attention</b>	Dealership Owners, Managers, Parts and Service Managers
<b>What Dealer Should Do</b>	<ol style="list-style-type: none"><li>1. Read the attached customer notice.</li><li>2. Check safety notification search tool on Dealer Central to see a list of units in your area.</li><li>3. Order 2 kits for each affected trailer in your area.</li><li>4. Check axles using procedure on following page to see if they are from affected lots.</li><li>5. Repair both hubs on each affected axle using instructions provided by Dexter and attached to this safety notification.</li><li>6. Submit warranty claim. Reference the lot number on the claim.</li></ol>
<b>Parts Required</b>	1 kit per axle: 500-3425 12K axle bearing kit
<b>Estimated Repair Time</b>	inspection: 30 minutes per machine repair: 2 hr per axle

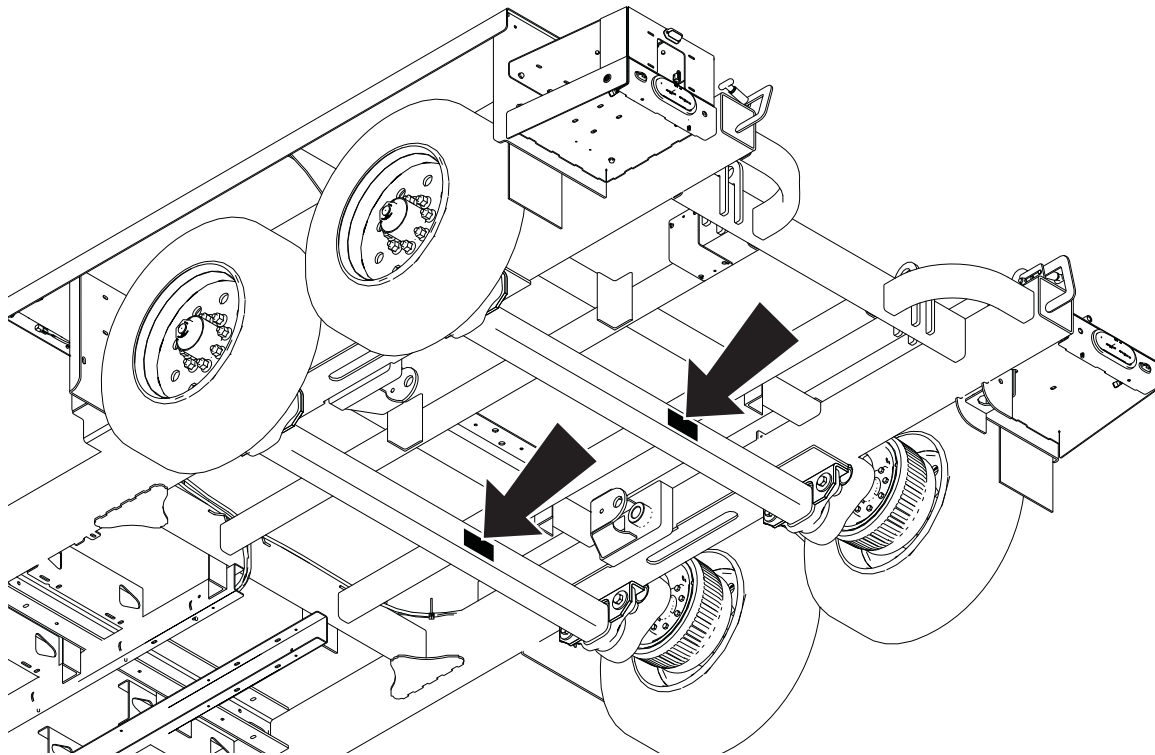
## Find Lot Number

1. Block trailer tires.
2. From rear of trailer, inspect axle lot number etching on both axles.

**IMPORTANT:** Front axle requires inspection from under trailer.

3. If the lot is one of the following numbers, replace both hubs using kit 500-3425.
