Quality Bulletin

**Recall R19931: Front Seat Rail Flange Nuts
Model Year 2018 - 2019 XC60 & S90**

CAT/NO:
R19931

QB Instruction VCC-516729-1

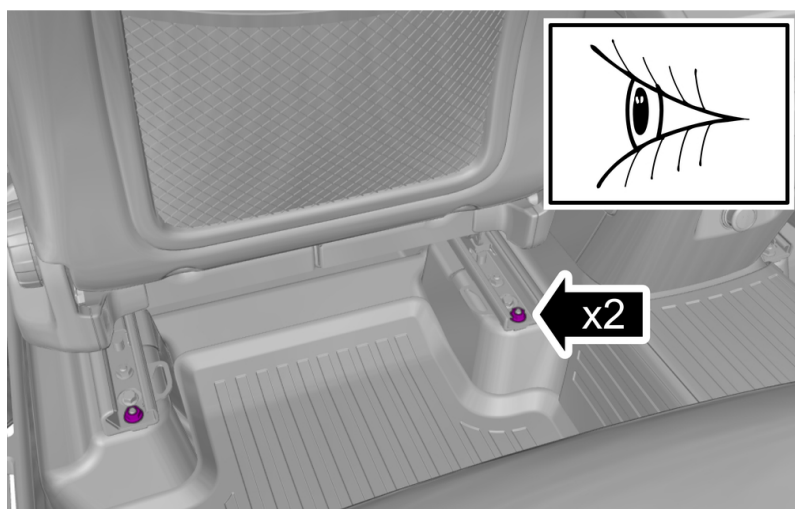
Check

Make sure that the rear flange nuts are installed on both front seats.
