## **IMPORTANT SAFETY RECALL**

This notice applies to certain 2018-2019 Load Trail Tandem and Triple Axle Dump Trailers with 621-scissor hoist option

NHTSA Recall Number: 19V-279

### **Load Trail 621-Scissor Hoist Repair Procedure**

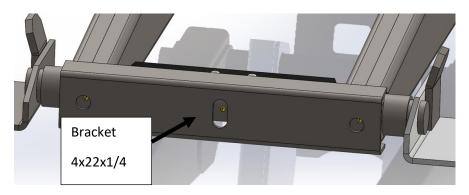
Diagram N-1.0

In the Covered Trailers, the bolts that attach the hydraulic cylinder clevis to the scissor hoist can break off under heavy load. This breaking may create an increased risk of injury as it could cause the hydraulic cylinder to disengage from the scissor hoist and cause the dump box to lower back down onto the trailer frame at a rapid rate.

- 1. Lift the dump body following the instructions in <u>Section 5.6 (Body Prop)</u> of your Load Trail owner's manual.
  - \* DO NOT enter the area under a raised dump body without first supporting the empty dump body up with the body prop. \*
- 2. Lower dump body onto the body prop.
- 3. Begin the installation of the 621-Scissor Hoist repair kit by first welding the (4 X 22 X ¼ Bracket) to the outer scissor arms of the 621-Scissor Hoist. There should be a weld on the top and the bottom of both outer scissor arms. (See diagrams N-1.0 and N-1.1)
