TO: Mercedes-Benz Dealer Principals, General Managers, Sales Managers, Service Managers, Parts Managers	FROM: Anthony Washington, Department Manager, Regulations and Certifications
RE: <b>Recall Campaign Notification</b> <b>Model 907 Sprinter, Model Year 2019</b> <b>Headlamp Range Adjustment Sensor</b>	DATE: June 3, 2019

Campaign No. 2019050017, June 2019

SUBJECT: **Model 907 (Sprinter), Model Year 2019  
Headlamp Range Adjustment Sensor**

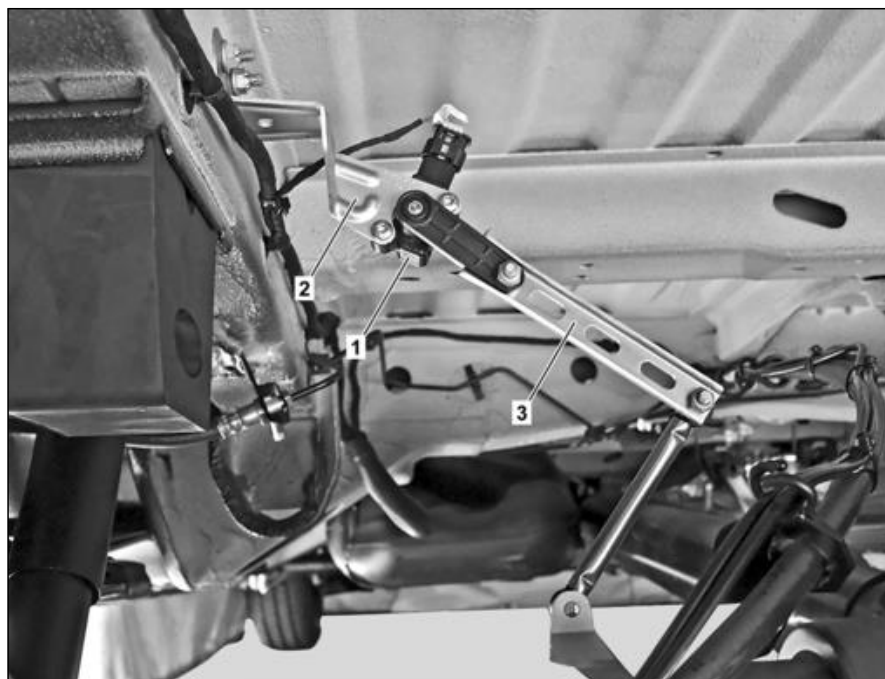
Daimler AG (DAG), the manufacturer of Mercedes-Benz vans, has determined that on certain Mercedes-Benz and Freightliner Sprinter vehicles (platform 907) with LED high performance headlights, the sensor for the headlamp range adjustment may not have been mounted or calibrated correctly. Incorrectly adjusted LED headlights could result in increased glare to oncoming traffic. In addition, sufficient illumination of the road could also be impaired. This could increase the risk of a crash. We ask you to check the level sensor on the rear axle for the headlamp range adjustment and to retrofit and calibrate the level sensor in case it is missing.

| 1 | Level sensor |
| 2 | Bracket |
| 3 | Linkage rod |

<p><b>⚠ Danger</b></p> <p>2</p>	<p>Risk of death caused by vehicle slipping or toppling off of the lifting platform.</p>	<p>Align vehicle between vehicle lift columns and position the four support plates at the vehicle lift support points specified by the vehicle manufacturer.</p>	<p>AS00.00-Z-0010-01A</p>
<p><b>Topical note</b></p>	<p>Raise vehicle. Special instructions for lifting and supporting vehicle</p>		<p>AH00.60-N-0100-01TS AR00.60-D-1000-04TS</p>
<p>3</p>	<p>Check level sensor (1) at rear axle for headlamp range adjustment.</p>	<p>To do this, check whether level sensor (1), holder (2) and the linkage (3) with its bolts/nuts are present. If component parts are missing, ↓ retrofit corresponding component parts or level sensor (1) and continue with operation step 4.  If all component parts are present, ↓ continue with operation step 4.</p>	<p>AR82.10-D-0005TS</p>
<p><b>Check</b></p>

7	Calibrate level sensor (1) at rear axle for headlamp range adjustment.	To do this, select the following menu items: Control unit view → E1/2n9 Left headlamp (SG- LEDSW-L) (CODE: LG7) → Adaptations → Calibration processes → Zero adjustment  It is absolutely essential to precisely follow the operation steps as described in the vehicle diagnosis system.	
8	Disconnect diagnostic system.		AD00.00-D-2000-06TS
