# SERVICE ADVISORY

**Communication #:** ISA-19-02-A / B

## SUBJECT: 2014 INDIAN MOTORCYCLE (111 C.I.) FORWARD LIGHTING

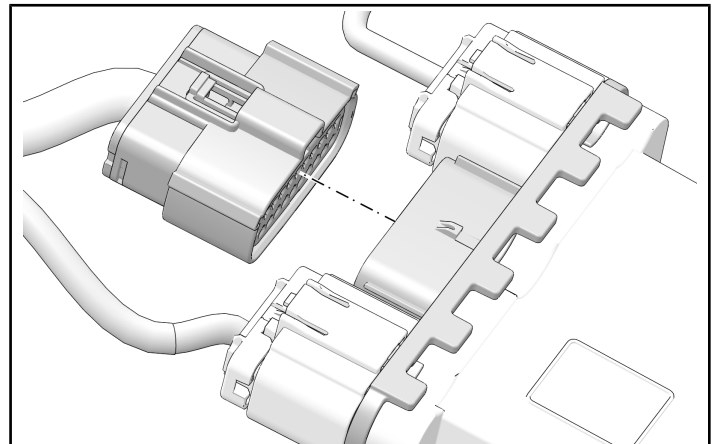
10. Disconnect the center connector on the VCM. Locate Pin 11 of the VCM1 (center) connector and check for any discoloration.

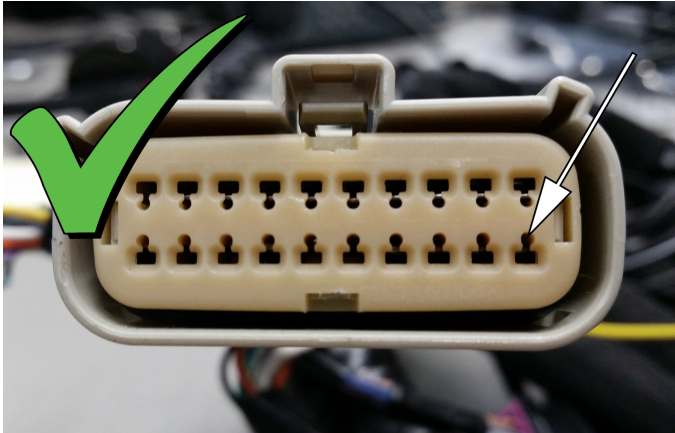
DAMAGE <u>IS NOT</u> PRESENT	DAMAGE <u>IS</u> PRESENT
<p>VCM connector, pin 11</p>

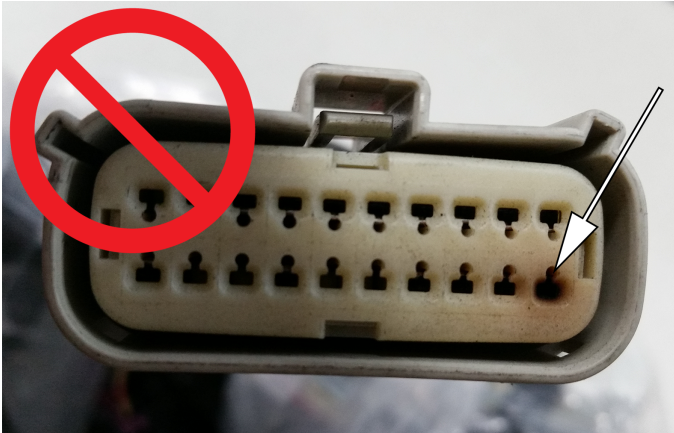
<p>VCM connector, pin 11</p>

Pay special attention to the white terminal lock plate during inspection. If damage is present, a dark halo will be present around pin 11 of the VCM connector. Refer to the pictures below for examples.

Damage = Any sign of heat or thermal damage in or around pin 11 of the center VCM connector (e.g. the dark halo shown in the right image above).

- If damage **IS** present, take pictures of the damage and proceed to ISA-19-02-B.  
US/CAN: Submit an Ask Polaris Service & Warranty Question> All Vehicle Diagnostic case.  
INT'L: Contact your Country Service Department.
- If damage is **NOT** present, proceed to step 11 to complete ISA-19-02-A.
