SUBJECT: NEW VEHICLE DEMONSTRATION / DELIVERY HOLD

Safety Recall 19S16 - Supplement #1

Certain 2013-2016 Fusion Equipped with a 2.5L Engine and 6F35 Transmission

Shift Cable Bushing Replacement and Protective Cap

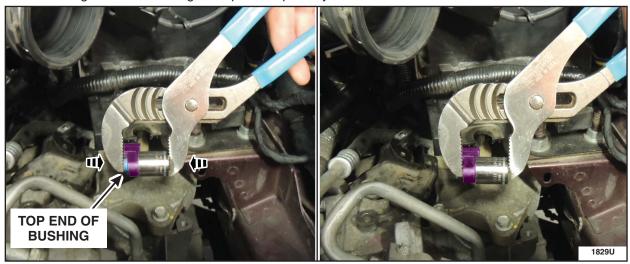
FIGURE 3

NOTE: For all 2013 Fusion vehicles equipped with original shift cable, the bushing is taller than the replacement bushing.

- 6. Using a pair of Straight Jaw Adjustable pliers and a 15mm shallow socket push the bushing partially out of the selector lever cable end. See Figure 3.
 - Use caution not to damage the shifter cable during this procedure.
 - Inspect for damage before installing the new shifter cable bushing.
