**CONDITION OF CONCERN**

**SUBJECT VEHICLES**

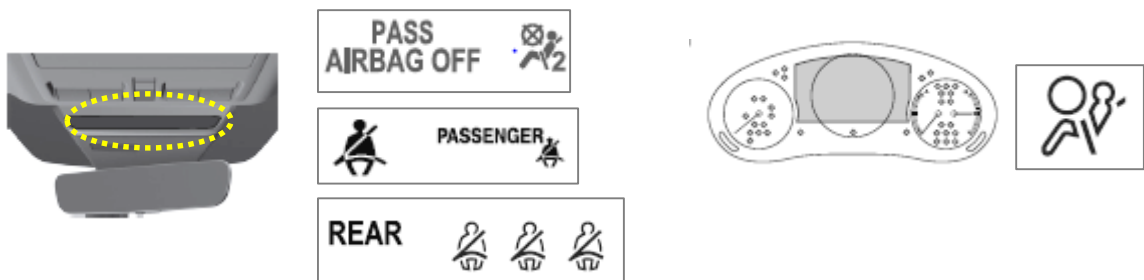
Certain vehicles may exhibit any one or all of the following concerns, (please reference the following illustrations):

- Passenger air bag deactivation indicator light may turn off, even though the passenger air bag is deactivated.
- Seat belt status indicator of the front passenger seat may turn off, even though the front passenger seat belt is unfastened.
- Seat belt status indicators of rear passenger seats may turn green, even though the rear seat belt(s) are unfastened.

These false indicator concerns can be detected by illumination of the air bag system malfunction warning light in the instrument cluster and an audible warning.

Incorrect indicator warning lights may lead the driver and/or passengers to be unaware of deactivated air bags or unfastened seat belts, increasing the risk of injury.

Dealers are instructed to replace the Indicator Assembly with a modified one. The repair must be performed on all subject vehicles at no charge to the vehicle owners.
