IMPORTANT SAFETY RECALL – 19E-009

Subject: Part 573 Defect Information Report for ASA Electronics, LLC Company Recall Number 19E-009 – Certain 2017-2018 Voyager brand VOM74MM Mirror Monitors.

49 CFR Part 573 – DEFECT INFORMATION REPORT 19E009 –
CERTAIN 2017-2018 VOYAGER BRAND VOM74MM MIRROR MONITORS HAVE THE
IMAGE INVERT – REVERSE IMAGE DISPLAYED ON MONITOR

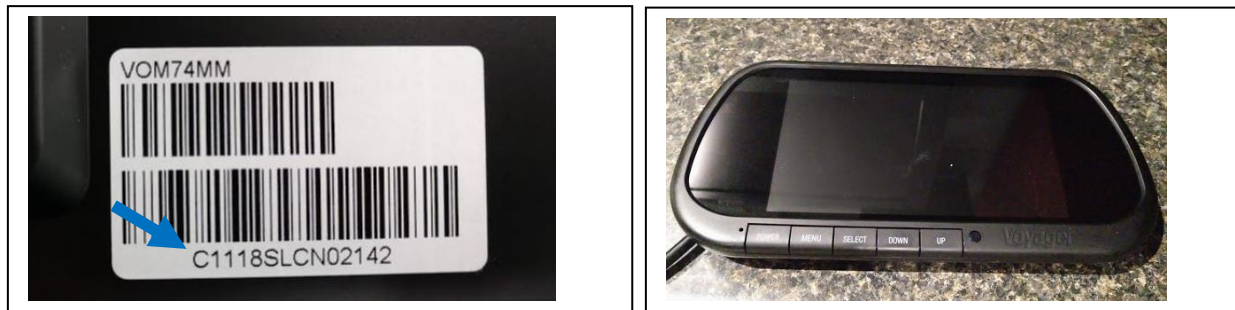
The serial numbers associated with the mirror monitors start with an “A”, “B”, or “C”.
