David J. Johnson
 Director
 Service Engineering Operations
 Ford Customer Service Division

October 30, 2020

SUBJECT: **NEW VEHICLE DEMONSTRATION / DELIVERY HOLD - Safety Recall 19S17 – Supplement #2**
 Certain 2011-2017 Model Year Explorer Vehicles
 Rear Suspension Toe Link Replacement

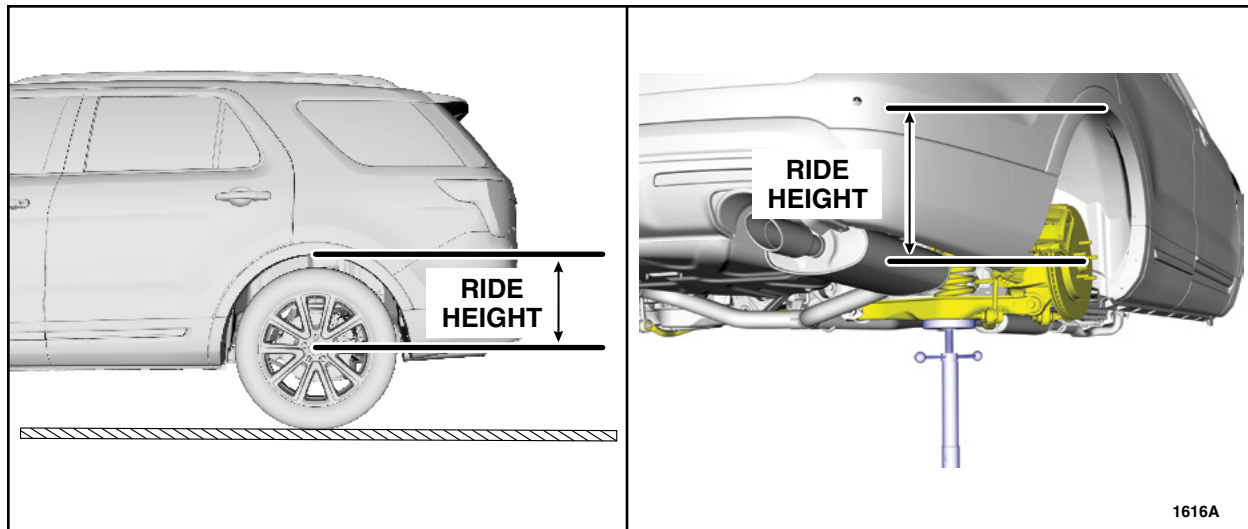
FIGURE 1

2. Measure the distance from the center of the wheel hub to the lip of the fender with the vehicle in a level, static ground position (ride height) before disassembly. See Figure 1.

NOTE: The toe links must be secured at ride height during replacement. See Figure 1.

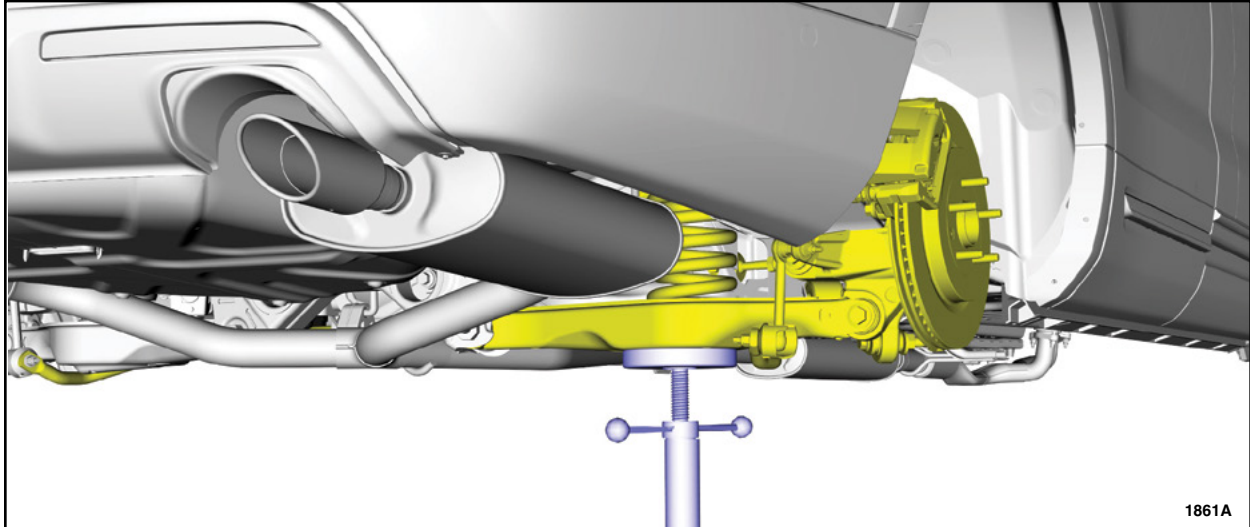
FIGURE 2

5. Using a jack stand, support the rear suspension to ride height. See Figure 2.

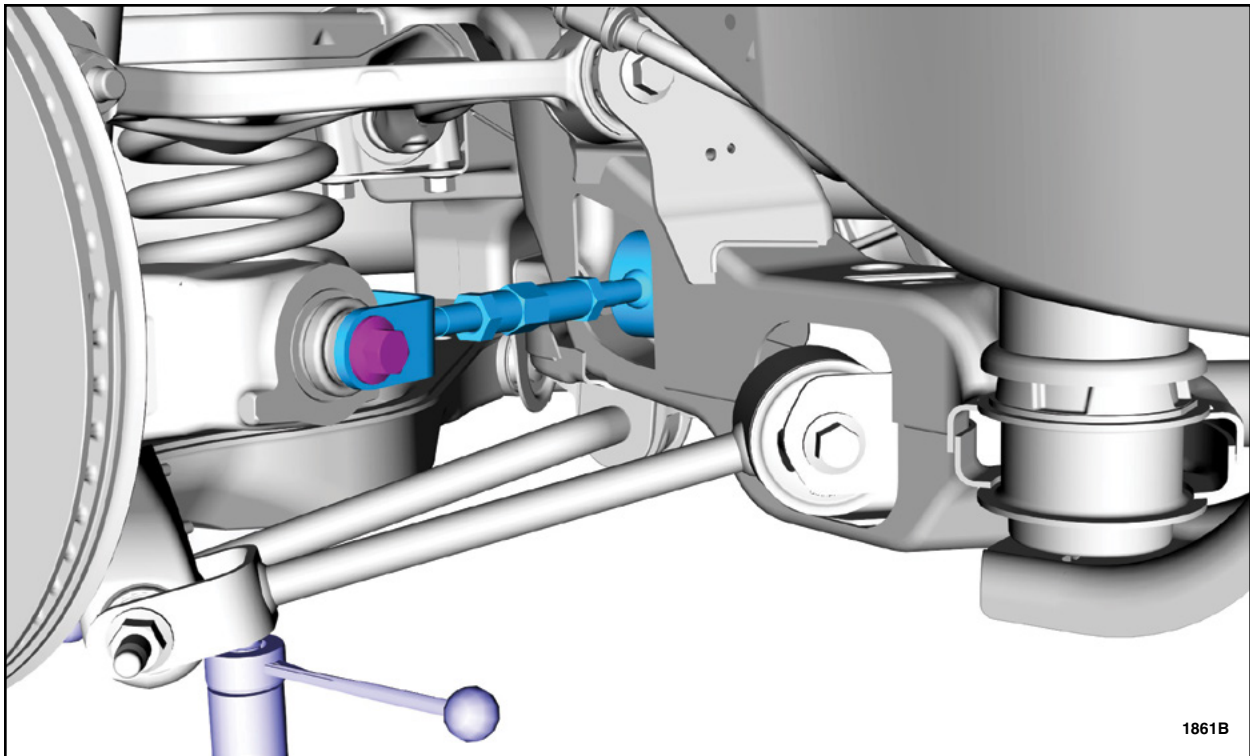
FIGURE 3

6. Remove the toe link-to-wheel knuckle bolt and nut. See Figure 3.

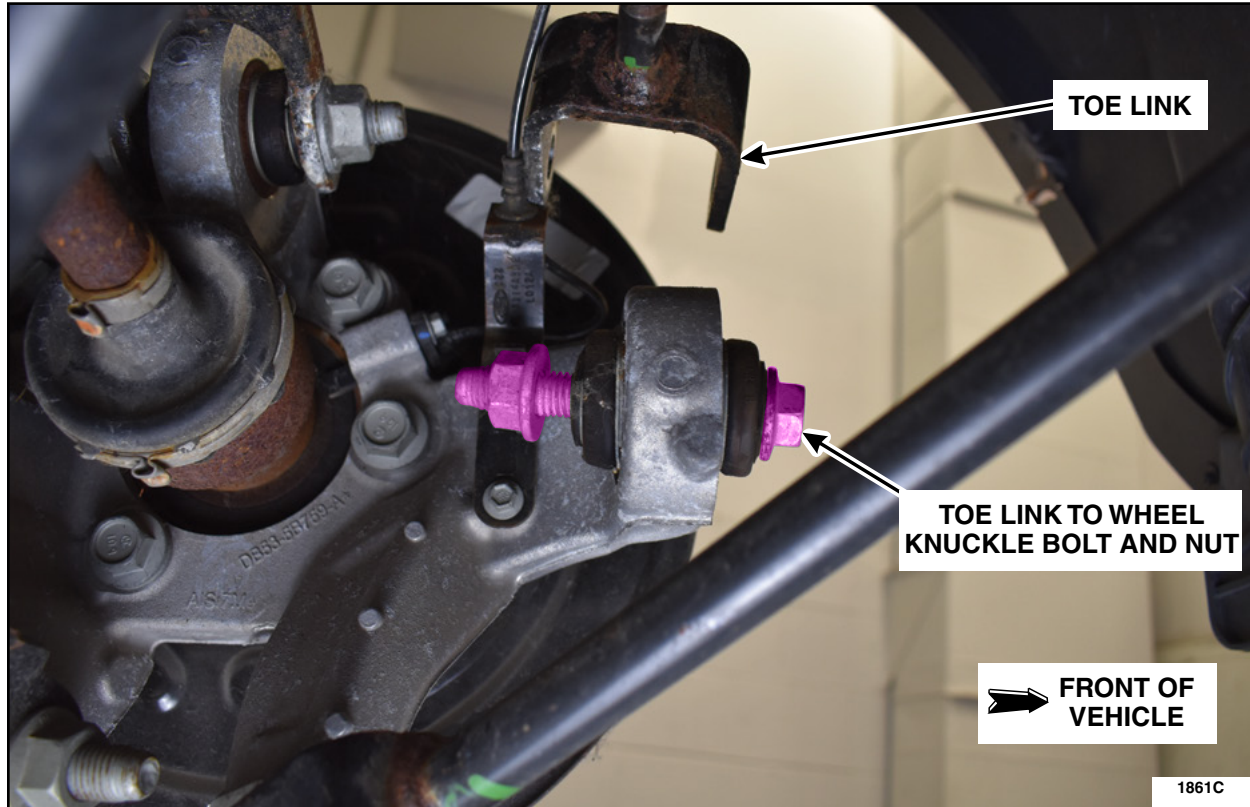
FIGURE 4

7. Install the toe link to knuckle bolt and nut. Tighten the nut while holding the bolt still with a wrench.
See Figure 4.

- Torque: 111 lb.ft (150 Nm).

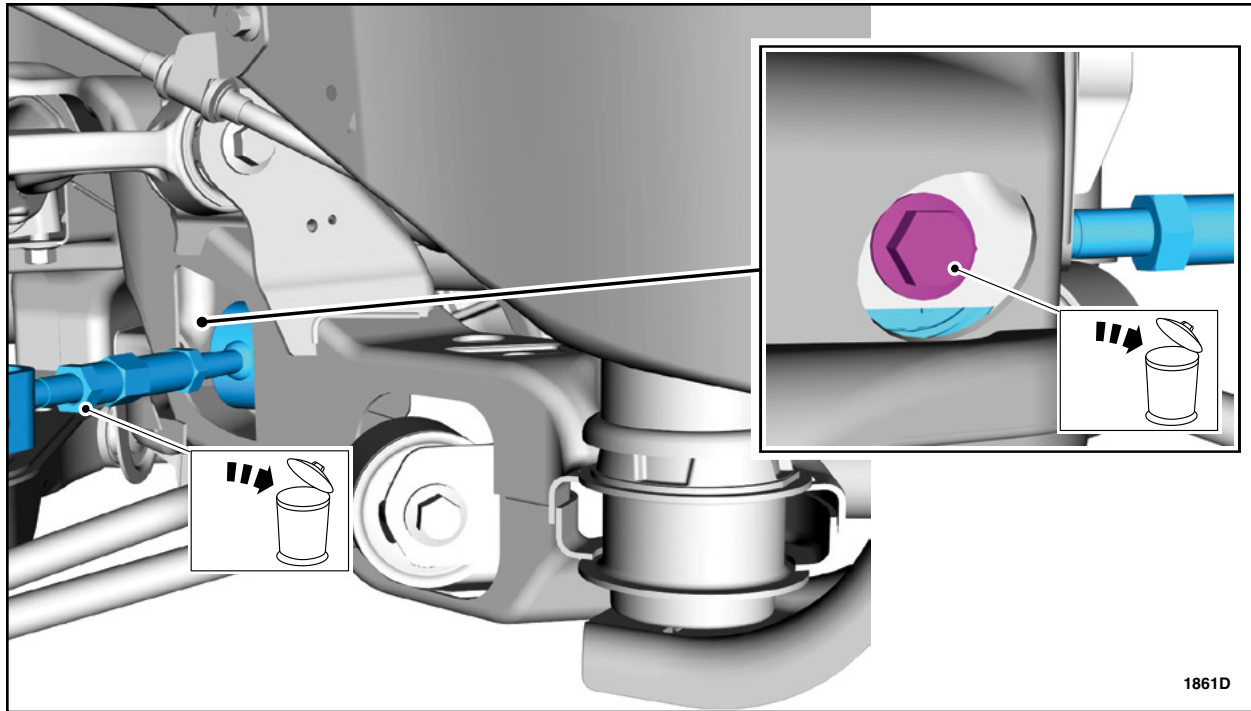
FIGURE 5

8. Remove and discard the toe link to subframe bolt and the toe link. See Figure 5.

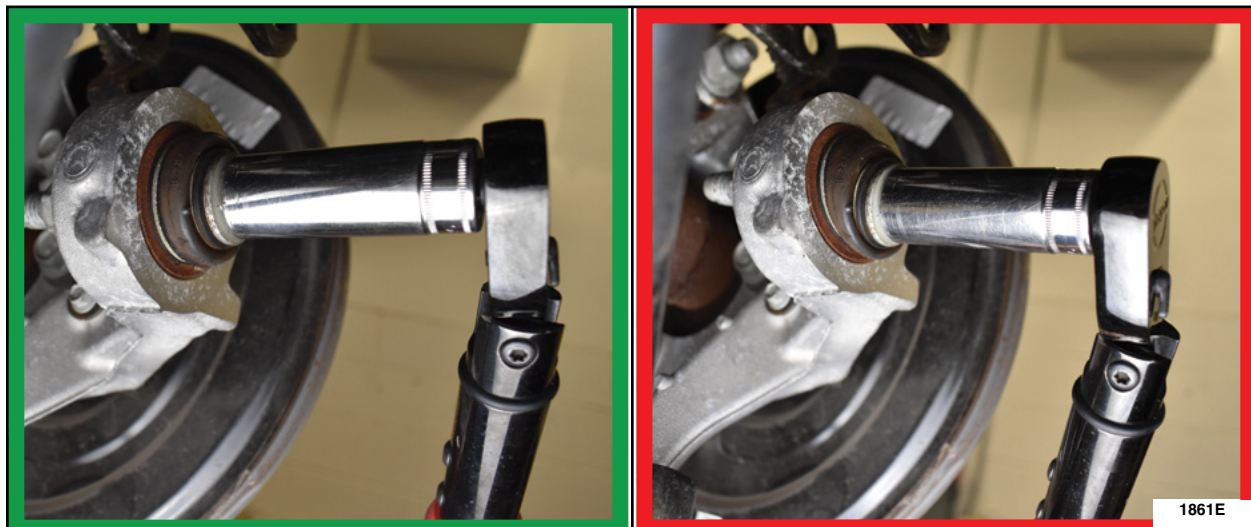
FIGURE 6

9. Set a torque wrench to 11 lb.ft (15 Nm). Apply torque to the toe link to wheel knuckle bolt while keeping the ball joint straight. See Figure 6. Did the ball joint rotate before the torque wrench actuated?

- If **YES** - Remove and discard the toe link to wheel knuckle bolt and nut. Proceed to Step 11.
- If **NO** - Remove and discard the toe link to wheel knuckle bolt and nut. Proceed to Step 10.

10. Replace the wheel knuckle. Please follow the WSM procedures in Section 204-02.

11. Install the new toe link. Please follow the WSM procedures in Section 204-02.

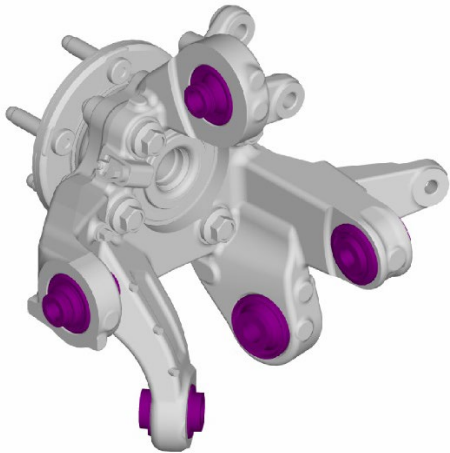
KNUCKLE BALL JOINT/BUSHING LOCATIONS

Ford has received reports of toe link failures on customer vehicles after the installation of non-OEM cross-axial ball joints (aka bushings) in the rear wheel knuckle. Installation of aftermarket bushings rather than replacement of the rear wheel knuckle assembly is not recommended, as this may limit the movement of the joint and cause stress on the toe link. In the reports that Ford received, the toe links failed shortly after installation of an aftermarket bushing installed by the dealership.

If 2011-2019 Ford Explorers or PIU vehicles require service of the rear wheel knuckle and/or rear wheel knuckle bushings, the recommended repair is to replace the affected rear wheel knuckle (5B758/9) as an assembly only. Refer to WSM, Section 204-02, and the Ford Service Parts Catalog as needed.
