STOP SALE AND DELIVERY – SAFETY RECALL

Subject: Stop Sale and Delivery for Upcoming Safety Recall

Affected Models: 2018-2020MY Isuzu FTR Vehicles

STOP SALE SERVICE PROCEDURE FTR STEERING STOP JAM NUT REPLACEMENT

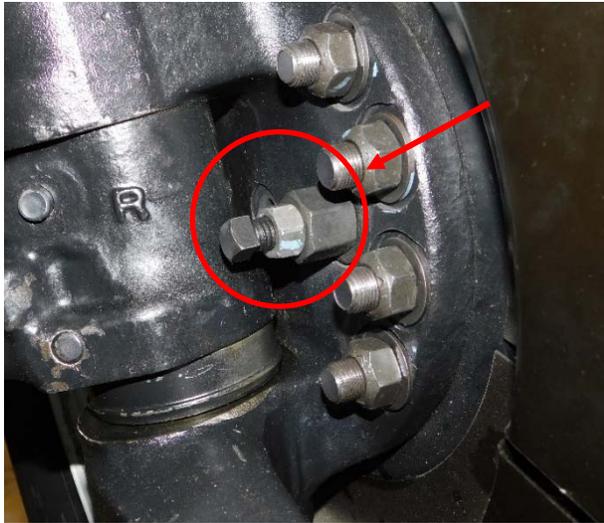
Figure 1 - Right Front Stop Screw

1. Apply the parking brake and block the rear wheels.
2. Start the engine and turn the steering wheel all the way to the left in order to access the right (passenger side) stop screw. (See Figures 1 and 2.) Shut the engine off after turning the steering wheel.

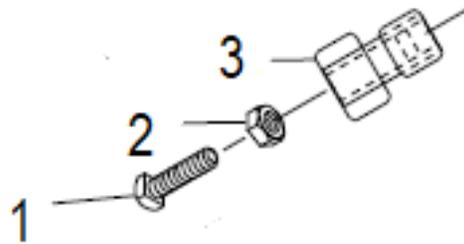
Figure 2

1. Stop Screw
2. Jam Nut
3. Adapter Base
