STEERING SHAFT BOLT TORQUE - Dealer Prenotification

Bulletin Type:	RECALL
Bulletin #:	Yet to be assigned
Job Code:	9901434 Please hold claims until Recall numbers are assigned by NHTSA
Flat Rate:	RC024Inspect only NO repair required .25hr RC025 Inspect and repair .5hr

Publication Date:	Prenotification 8-26-19
Make:	Jayco Motorized Entegra
Models:	Embark Insignia, Aspire, Anthem, Cornerstone, Reatta
Model Year:	2019-2020

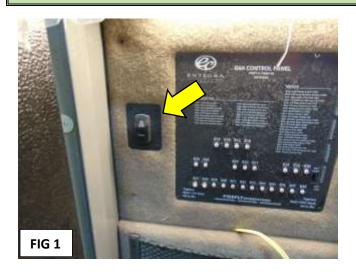
FIG 1: Open the generator compartment using the switch (arrow) inside the driver side front electrical compartment.

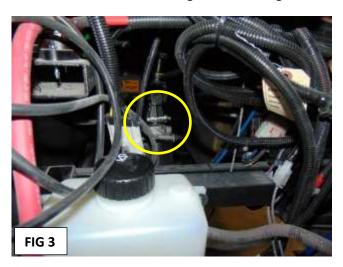
FIG 3: Bolt location is circled in this photo.

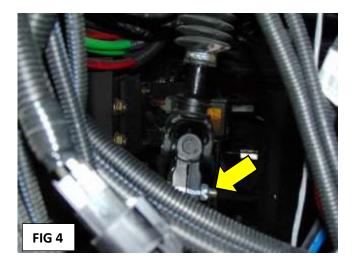
FIG 4: Arrow is pointing to the Steering Slip Shaft bolt.

- Move wiring out of the way to see it.
- IF WHITE LINE RUNNING FROM BOLT HEAD TO THE NUT NO REPAIR IS REQUIRED BOLT WAS TORQUED TO 45FT LBS PRIOR TO SHIPPING.

FIG 5: IF WHITE LINE IS NOT VISIBLE - TORQUE PER SPECIFICATIONS

Bolt head size takes a 5/8" socket or wrench.

- Nut size takes an 11/16" socket
- Use a torque wrench and torque the nut to 45 ft./lbs.
- Mark the bolt with a white line as shown in photo to indicate the bolt has been torqued properly.

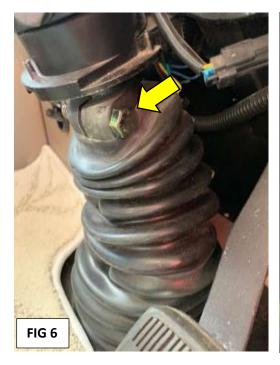
FIG 6:

- Upper steering shaft bolt is located on the steering column, beneath the steering wheel and under the large rubber boot.
- Lower the rubber boot on the steering column to see the bolt.

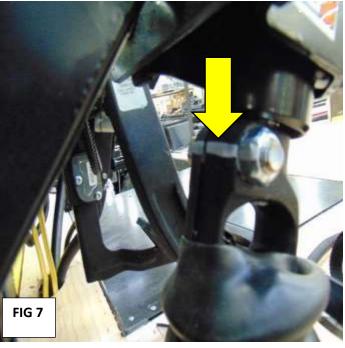
FIG 7:

- Examine the upper steering shaft bolt (front and back side of the steering column).
- If the bolt has been properly torqued at the factory there will be a white line running from the head of the bolt to the nut end of the bolt on the dash side of the steering column as shown in this photo (arrow).

IF THE WHITE LINE IS NOT VISIBLE PROCEED TO NEXT STEP TO COMPLETE REMEDY.

Bolt head will require a 5/8" wrench or socket.

Nut on the bolt will require an 11/16" socket.

Use a torque wrench (FT/LBS) and torque the nut end to 45 Ft/Lbs.

Mark the bolt with a white line as shown in photo to indicate the bolt has been torqued properly.

Replace the rubber boot back over the bolt.
