Dealer Principal	General Manager	Sales Manager	Service Manager	Parts Manager	Marketing	Finance
Date: September 24, 2019		Source: Aftersales			Replaces: n/a	
Bulletin #: A 09 2019 05		Name:			Supersedes: n/a	
		Title:			Group: 00 00	
		Phone #:				
		Email:

Aftersales Bulletin Phantom/PhantomEWB (RR11/ RR12) Cullinan (RR31) Reversing Camera - Programming

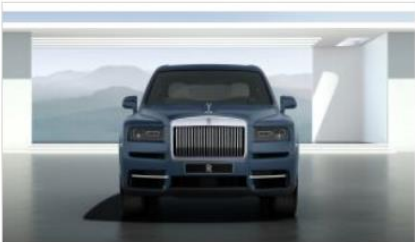
<table><tr> <td>Development code</td> <td>RR31</td> </tr><tr> <td>Actual integration level</td> <td>S15A-19-07-539</td> </tr></table>

Vehicle I-stage at or greater than S15A-19-07-539: No further action is required.

Vehicle I-stage at version below S15A-19-07-539: Update vehicle using the latest version of ISTA programming data (4.18.3x or higher):-
